Re: As Built monitoring report for Haley's Ditch Restoration Project
USACE Application number 2008-01179

Haley's Run Restoration Report

**Lockheed Martin
Haley's Run Restoration Report**

The following information is the third year monitoring report for the restoration of Haley's Run, required by the USACE Nationwide 38 permit for the remediation and restoration of Haley's Run (permit number 2008-01179). EnviroScience Inc. and the RiverWorks Team completed the stream and wetland restoration of Haley's Ditch on June 30, 2010. The restoration of Haley's Run centered on enhancing the remediation area within the limits of contaminated sediment removal. Lockheed Martin made the conscious decision to spend additional resources to provide a functional stream valley, floodplain and riparian corridor as a foundation for ecological recovery. Therefore, the limits of remediation became the limits of restoration. The restoration also focused on repairing existing impairments and limitations of channel morphology, habitat and riparian zone that occurred historically to Haley's Ditch. For additional information on Haley's Run regarding existing conditions prior to remediation and restoration a

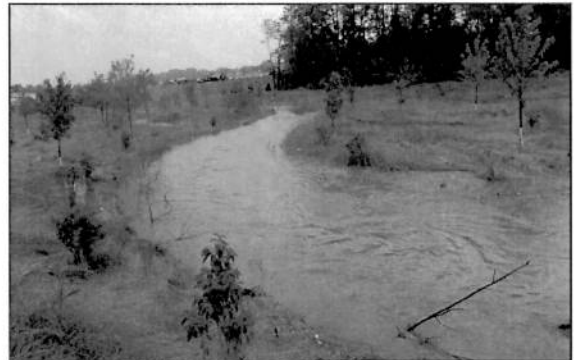
Figure 1. Haley's Flood Stage

To date, the restored stream is functioning very well. There have been significant precipitation events in 2012 and in 2011, and the channel and banks have demonstrated exceptional stability throughout different stages of channel maturity (i.e., vegetation growth). The erosion fabric and grass seed mix has performed well and minimized erosion. However, some erosion has occurred near the second pool downstream of the beginning of the project area in 2011. When this was first observed, willow live stakes were planted along the outside meander, as well as installation of layers of branches. This was done to help decrease sheer stress on the bank and reduce future erosion. The live stakes and branch layering techniques worked in that immediate area, but erosion has continued on the downstream side of the protection. Besides that, deposition has occurred along inside meander bends, maintaining point bars, and pools have maintained their depths. More importantly, floodwaters are able to access the floodplain which is evident by Figure 1.

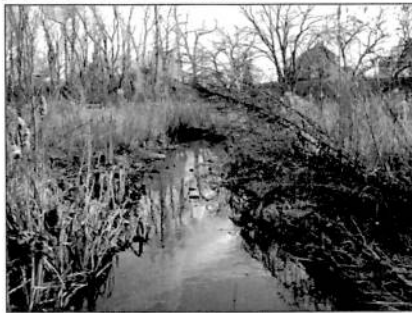
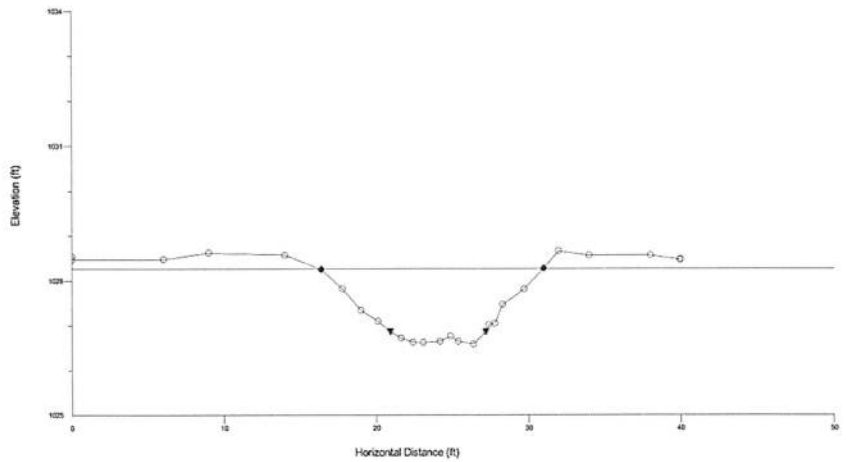
Figure 2. Cross Section Station 17+25 I

Variable	Value
Bankfull Width	15.8 ft
Bankfull mean depth	1.35 ft
Width/Depth Ratio	12
Cross Sectional Area	21.4 sq ft.

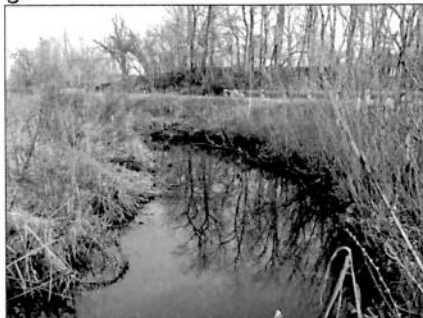
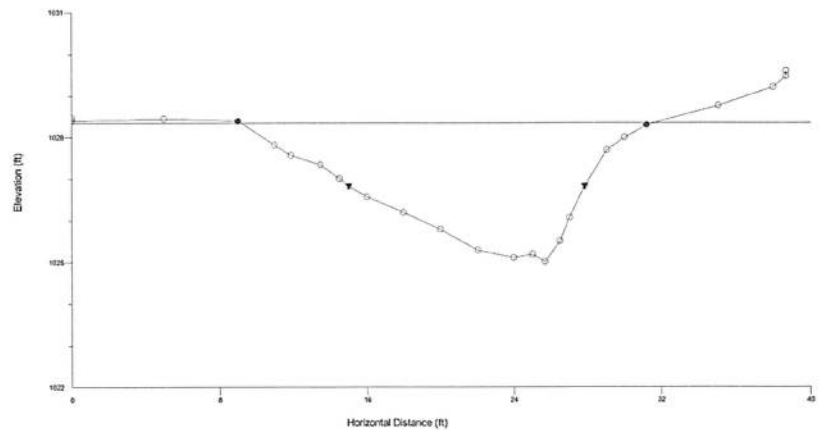
Figure 3. Cross Section Station 16+00 Pool

Variable	Value
Bankfull Width	24.9 ft
Bankfull mean depth	2.03 ft
Width/Depth Ratio	12.25
Cross Sectional Area	50.5 sq ft.

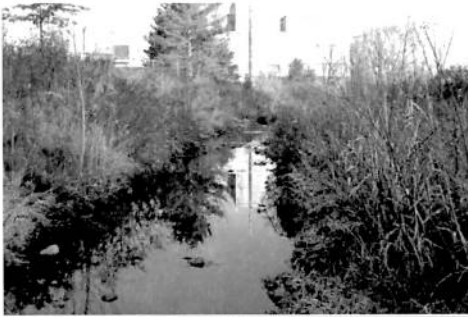
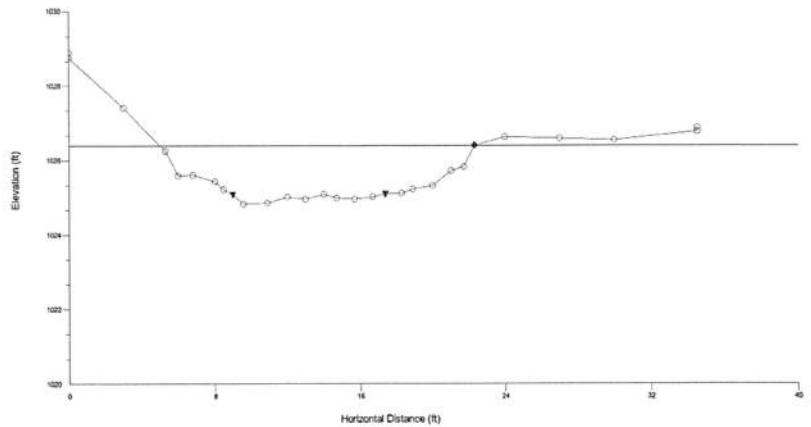
Figure 4. Cross Section Station 11+50 Riffle

Variable	Value
Bankfull Width	18.4 ft
Bankfull mean depth	1.3 ft
Width/Depth Ratio	14.2
Cross Sectional Area	24.0 sq ft.

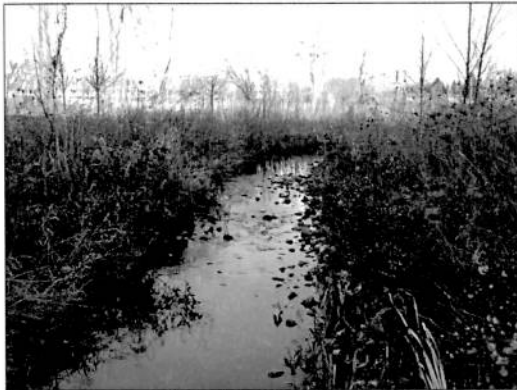
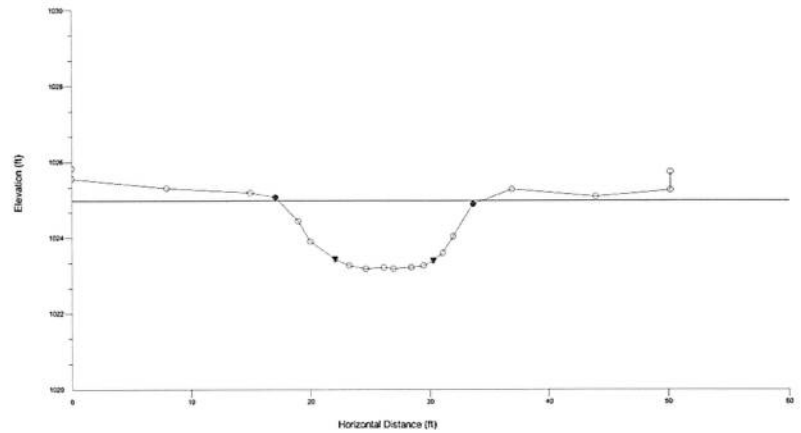
Figure 5. Cross Section Station 6+75 Riffle

Variable	Value
Bankfull Width	18.75 ft
Bankfull mean depth	1.27 ft
Width/Depth Ratio	14.75
Cross Sectional Area	23.8 sq ft.

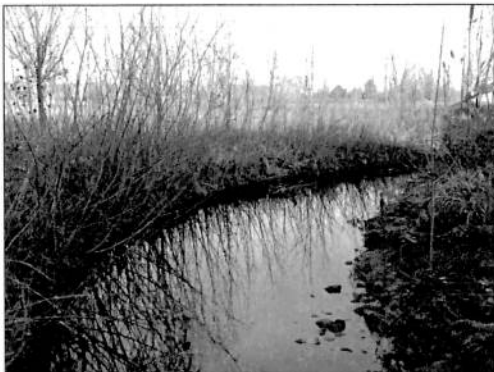
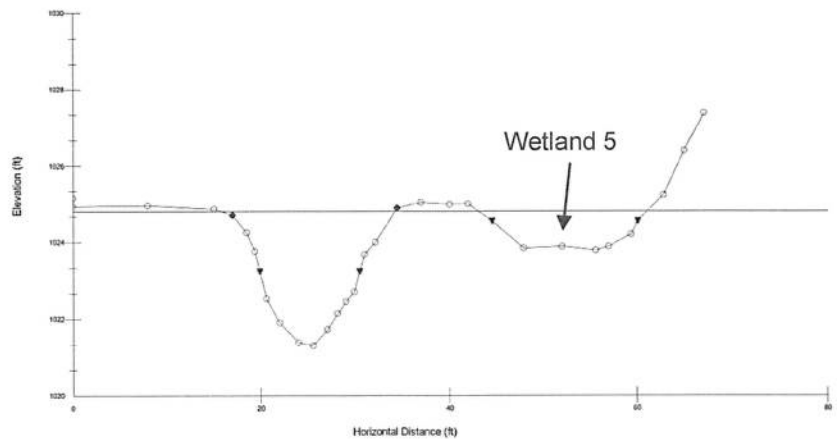
Figure 6. Cross Section Station 6+25 Pool

Variable	Value
Bankfull Width	19.7ft
Bankfull mean depth	1.78ft
Width/Depth Ratio	11.08
Cross Sectional Area	35.1 sq ft.

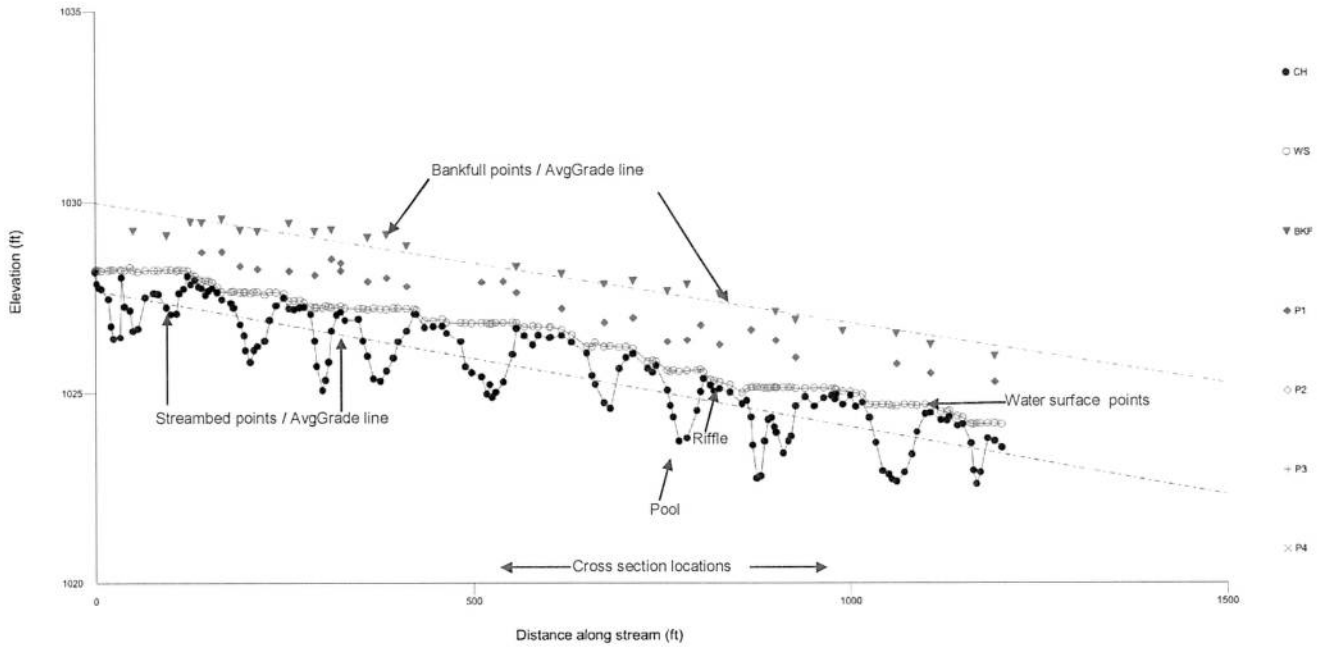
Figure 7. Haley's Run Longitudinal Profile Station 0+00-12+00

The stream bed profile was constructed as per plan with only minor horizontal shifts in the start or end of a feature. No riffles/pools were eliminated or significantly altered from the design plan. The profile also indicates that the average bankfull slope 0.0033ft was achieved with bank construction and floodplain grading. Some profile adjustment was observed at the most upstream reach of the project area. This adjustment was limited to deposition in the pool immediately downstream of the Triplett Rd culvert, and did not adversely affect the project area downstream.

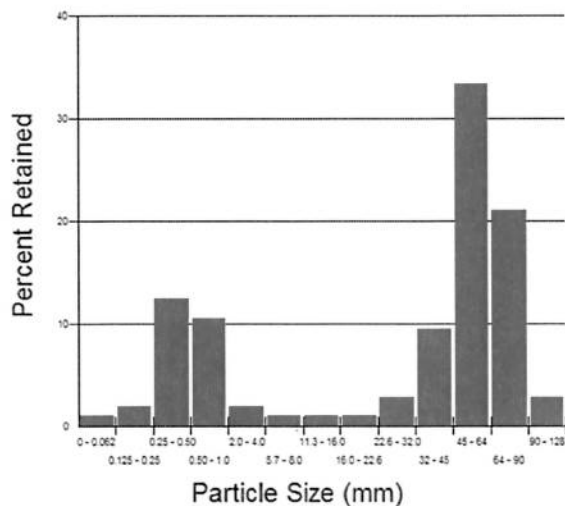
Figure 10. Cobble/Gravel Distribution

The results (Figure 10) indicate a distinct cohort of gravel/cobble material and sand component in the installed top layer of the substrate. The gap in the distribution relates to fine gravel (2.0-4.0 mm) and medium gravel (14.0-26.0 mm) that is anticipated to arrive from sediment transport upstream*. This is based on observations of the existing channel and of newly deposited material below the Triplett Rd culvert. The installed top layer of cobble/gravel material was intentionally biased towards larger particle sizes that would not be delivered from upstream bedload.

***2012 Update:** During the 2012 monitoring survey, the dominant substrate types observed were cobble, and both medium and fine gravel. As expected, sediment from upstream is being transported through the stream, contributing to more balanced substrate heterogeneity. No net aggradation or degradation was observed.
