Lockheed

SERVICE NEWS

VOL. 10, NO. 1, JANUARY—MARCH 1983

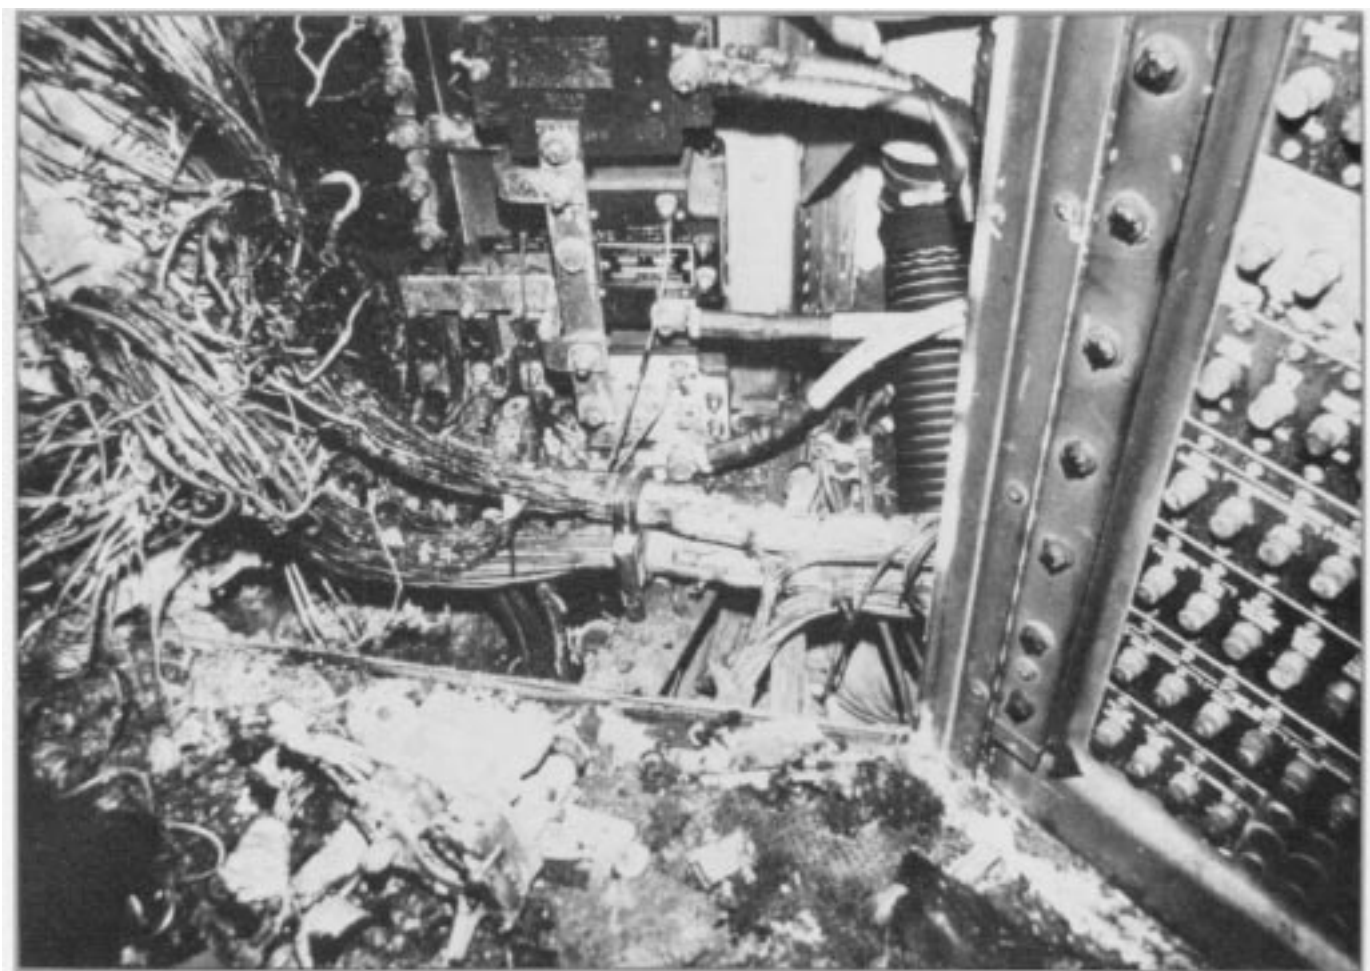
Figure 1. The aftermath. A well-intended effort to solve a minor problem ultimately yielded this scene of destruction.

creased in intensity as the aircraft was stopped and crew members made an emergency evacuation. Fire and crash equipment operators on the scene were able to save the airplane, but the flight station area sustained heavy damage (Figure 1).

When the aircraft began moving into position for its functional test flight, the pendulum motion of the nozzle end of the flexible filler tube during taxi caused the nozzle to touch the bus bar behind the copilot's side circuit breaker panel, creating a short to ground at the point where the flexible tube contacted the rigid, oxygen-filled line. The rigid oxygen line then started to melt and quickly developed a leak. The result was a rapid sequence of smoke, flame, and then an oxygen-fed blowtorch fire.

Engineering review is currently in process to block unwanted access to Hercules aircraft power distribution areas, but hardware alone cannot provide total protection against the consequences of innovative "solutions" to transient problems that fail to take all possible risk factors into account.

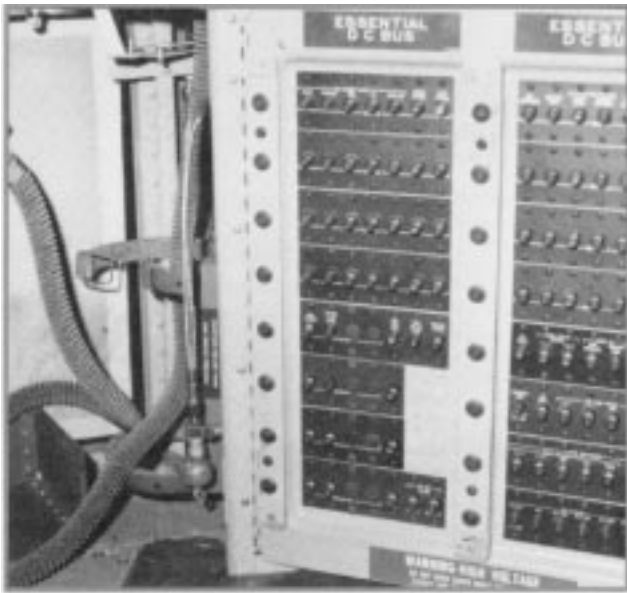
Post-mishap investigation and analysis revealed that there had been an extensive rehabilitation effort in the airplane during the maintenance layup. The refurbishing work included a thorough repaint of the flight deck. To facilitate the repainting process, many cockpit furnishings and hardware items were either removed from the airplane entirely or placed far enough out of the way to protect them from being unintentionally painted. Among those items moved “out of the way” was an externally braided flexible tube in the oxygen supply system (Figure 2) that is used to recharge the copilot’s MA-1 portable oxygen unit.

Figure 2. The oxygen filler tube in normal stowed position. Note nearby bracket for copilot's MA-1 oxygen bottle.

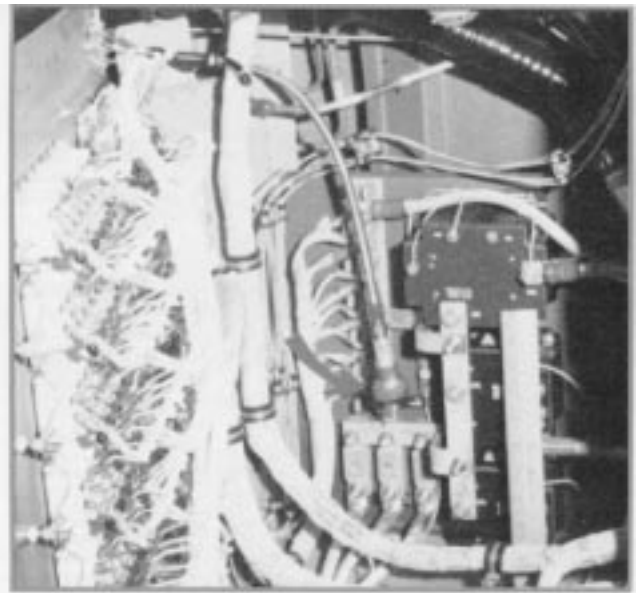
opening. And this was the solution to the cockpit painter’s dilemma of where to place the tube to avoid inadvertent painting. Figure 3 shows the flexible filler tube pushed through the opening at the top of the forward end of the DC power distribution area. Notice that the filler nozzle is hanging down like a pendulum near the bus bar, and that the filler tube is resting on top of a rigid, oxygen-filled supply line (Figure 4).

Figure 3. A solution that bred a problem: this reconstruction shows how the filler tube was left in the accident aircraft. The nozzle (arrow) hangs free near a bus bar.

So far, there is nothing obviously amiss in the arrangement. And in fact, as long as the airplane remained stationary in the maintenance shop and without electrical power, there was no trouble. Unfortunately, when the painting work was finished and it came time to return the aircraft to service, no one remembered to pull the flexible tube back out of the distribution panel and return it to its retaining clip.

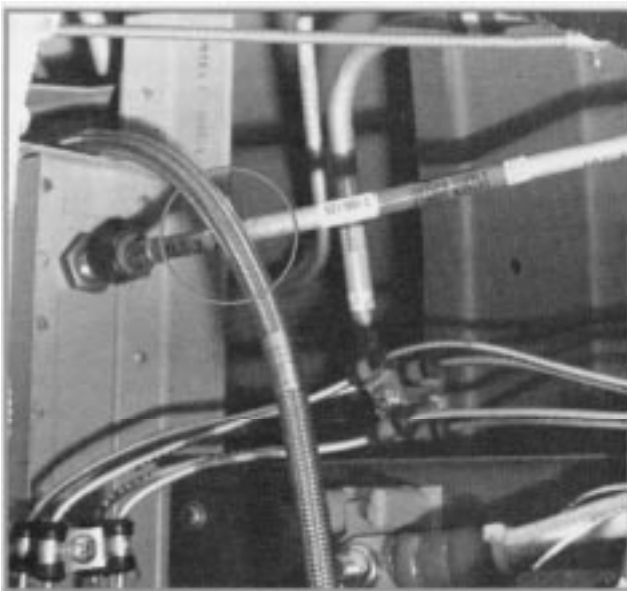
Figure 4. The electrical fire started where the metal braiding of the filler tube rested against a rigid oxygen line.

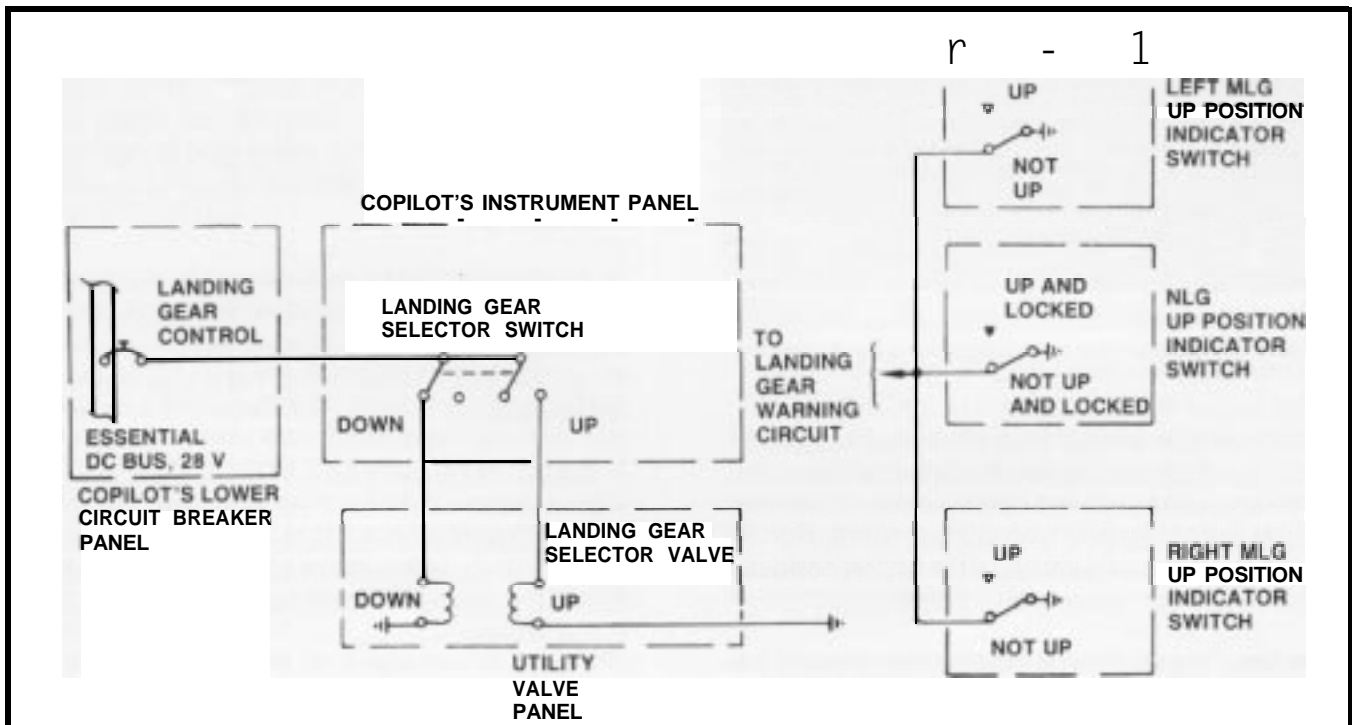
A change was made to Hercules aircraft wiring starting with Lockheed serial number LAC 4637 which keeps the “up” solenoid of the landing gear selector valve energized anytime the landing gear control handle is in the up position (Figure 1). Previously, the up solenoid deenergized as soon as all three landing gear up position indicator switches were actuated (Figure 2). At about the same time that the wiring change was made on new production aircraft, Lockheed issued Service Bulletins 82-380

Figure 1. Landing gear control wiring diagram for Hercules aircraft LAC 4637 and up, and earlier Hercules aircraft incorporating Service Bulletins 82-380 or 382-064, or TCTO 1 C-130-1065.

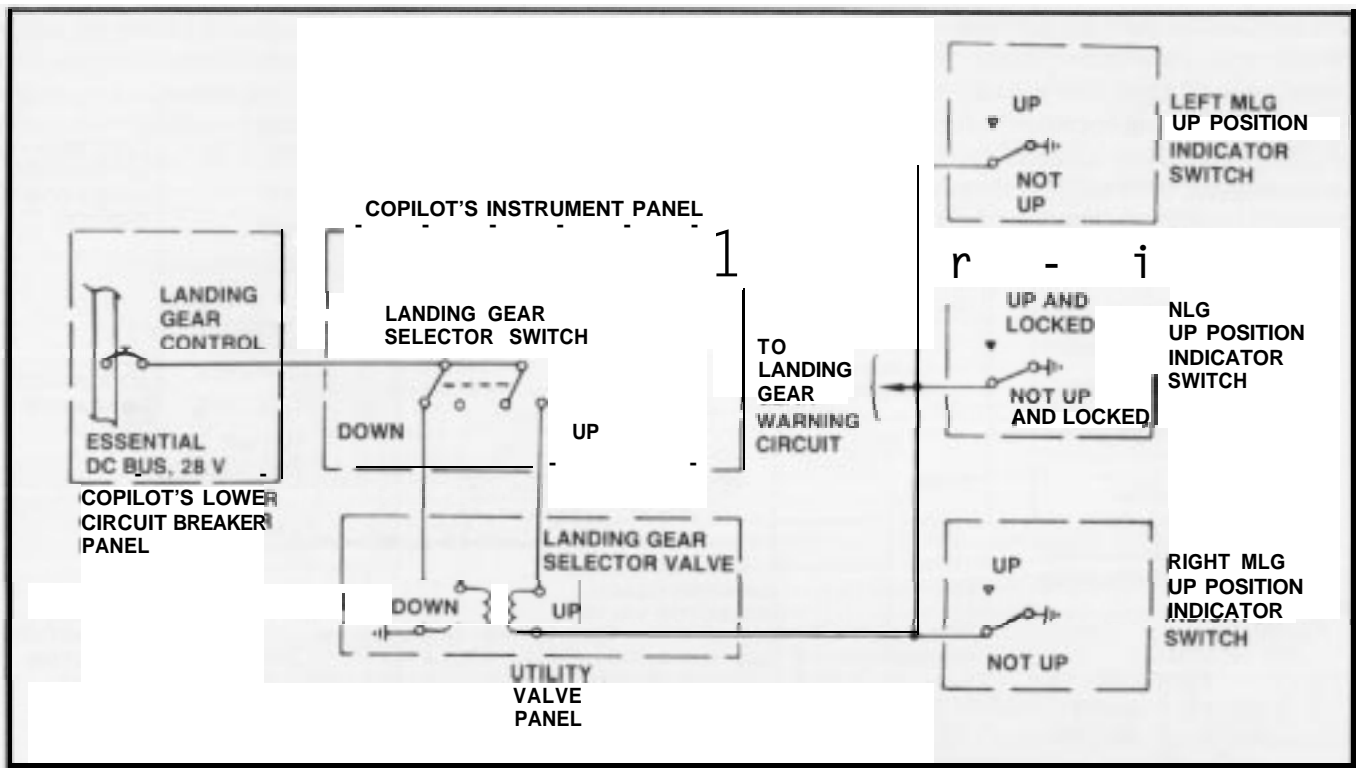
Figure 2. Landing gear control wiring diagram for unmodified Hercules aircraft built prior to LAC 4637.

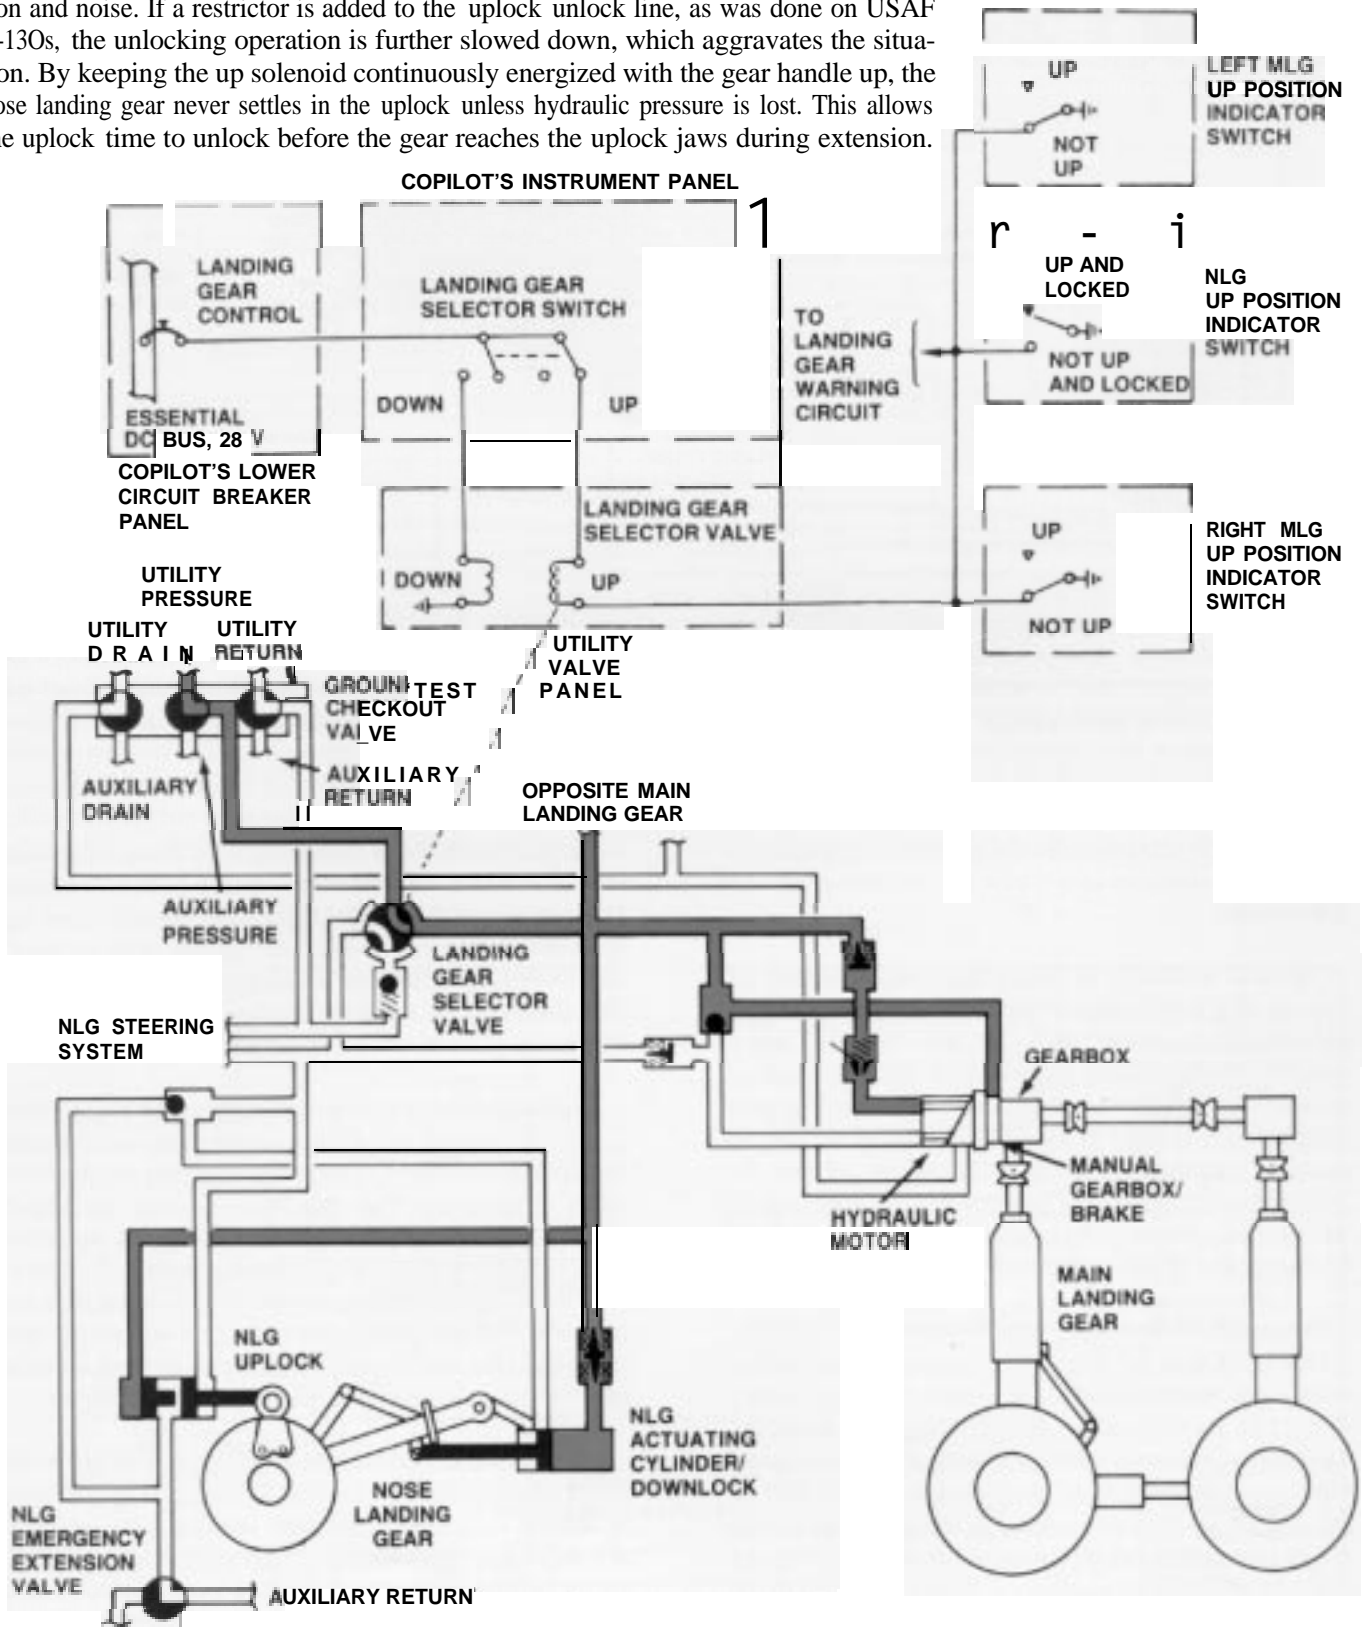
When the landing gear control handle is raised after takeoff, the nose landing gear is usually up and locked before the main landing gears reach the up position (Figure 3). As soon as the main landing gears reach the up position, the up solenoid is deenergized, causing the valve spool of the landing gear selector valve to shift to the neutral position (Figure 4). In the neutral position, utility system pressure is blocked at the selector valve and both the gear-up and gear-down ports are opened to the return line. This dumping of gear-up pressure causes a momentary pressure spike to bounce off the return line check valve poppet (attached to the return port of the landing gear selector valve) and back up the nose landing gear down line. This forces the nose landing gear uplock

Figure 3. Nose landing gear up and locked; main landing gears still in transit (old wiring configuration).

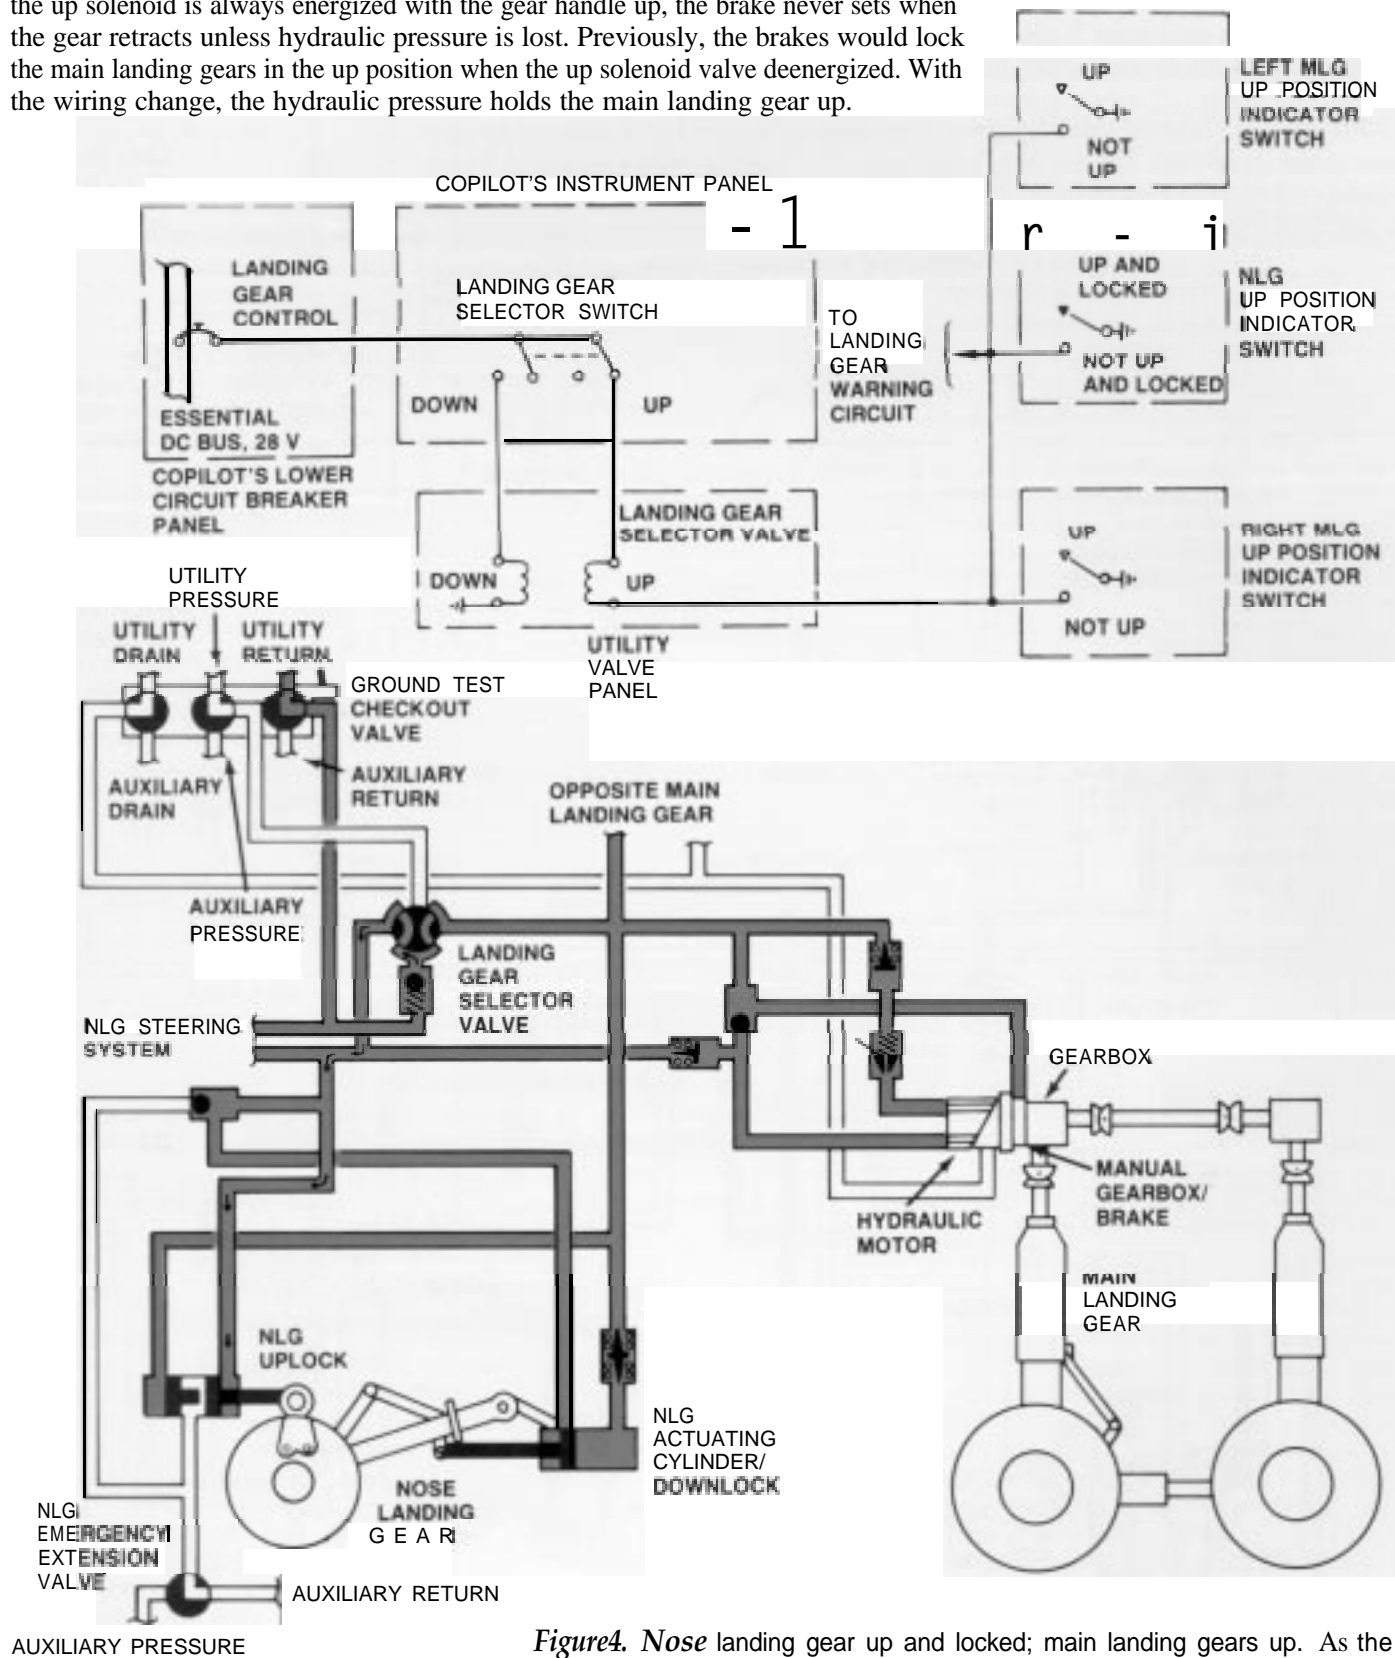
The first advantage of changing the wiring is that the nose landing gear indicator “blip” (momentary in-transit indication) associated with the main landing gears’ reaching the up position is eliminated. The blip is caused by a pressure spike that occurs when the landing gear selector valve returns to the neutral position and the up solenoid deenergizes. A brief discussion of the circumstances that cause the blip in airplanes with the old wiring configuration (also refer to Figures 3,4, and 5) will be instructive at this point.

Figure 4. Nose landing gear up and locked; main landing gears up. As the landing gear selector valve returns to neutral, a momentary pressure spike is transmitted through the nose landing gear down line (old wiring configuration).

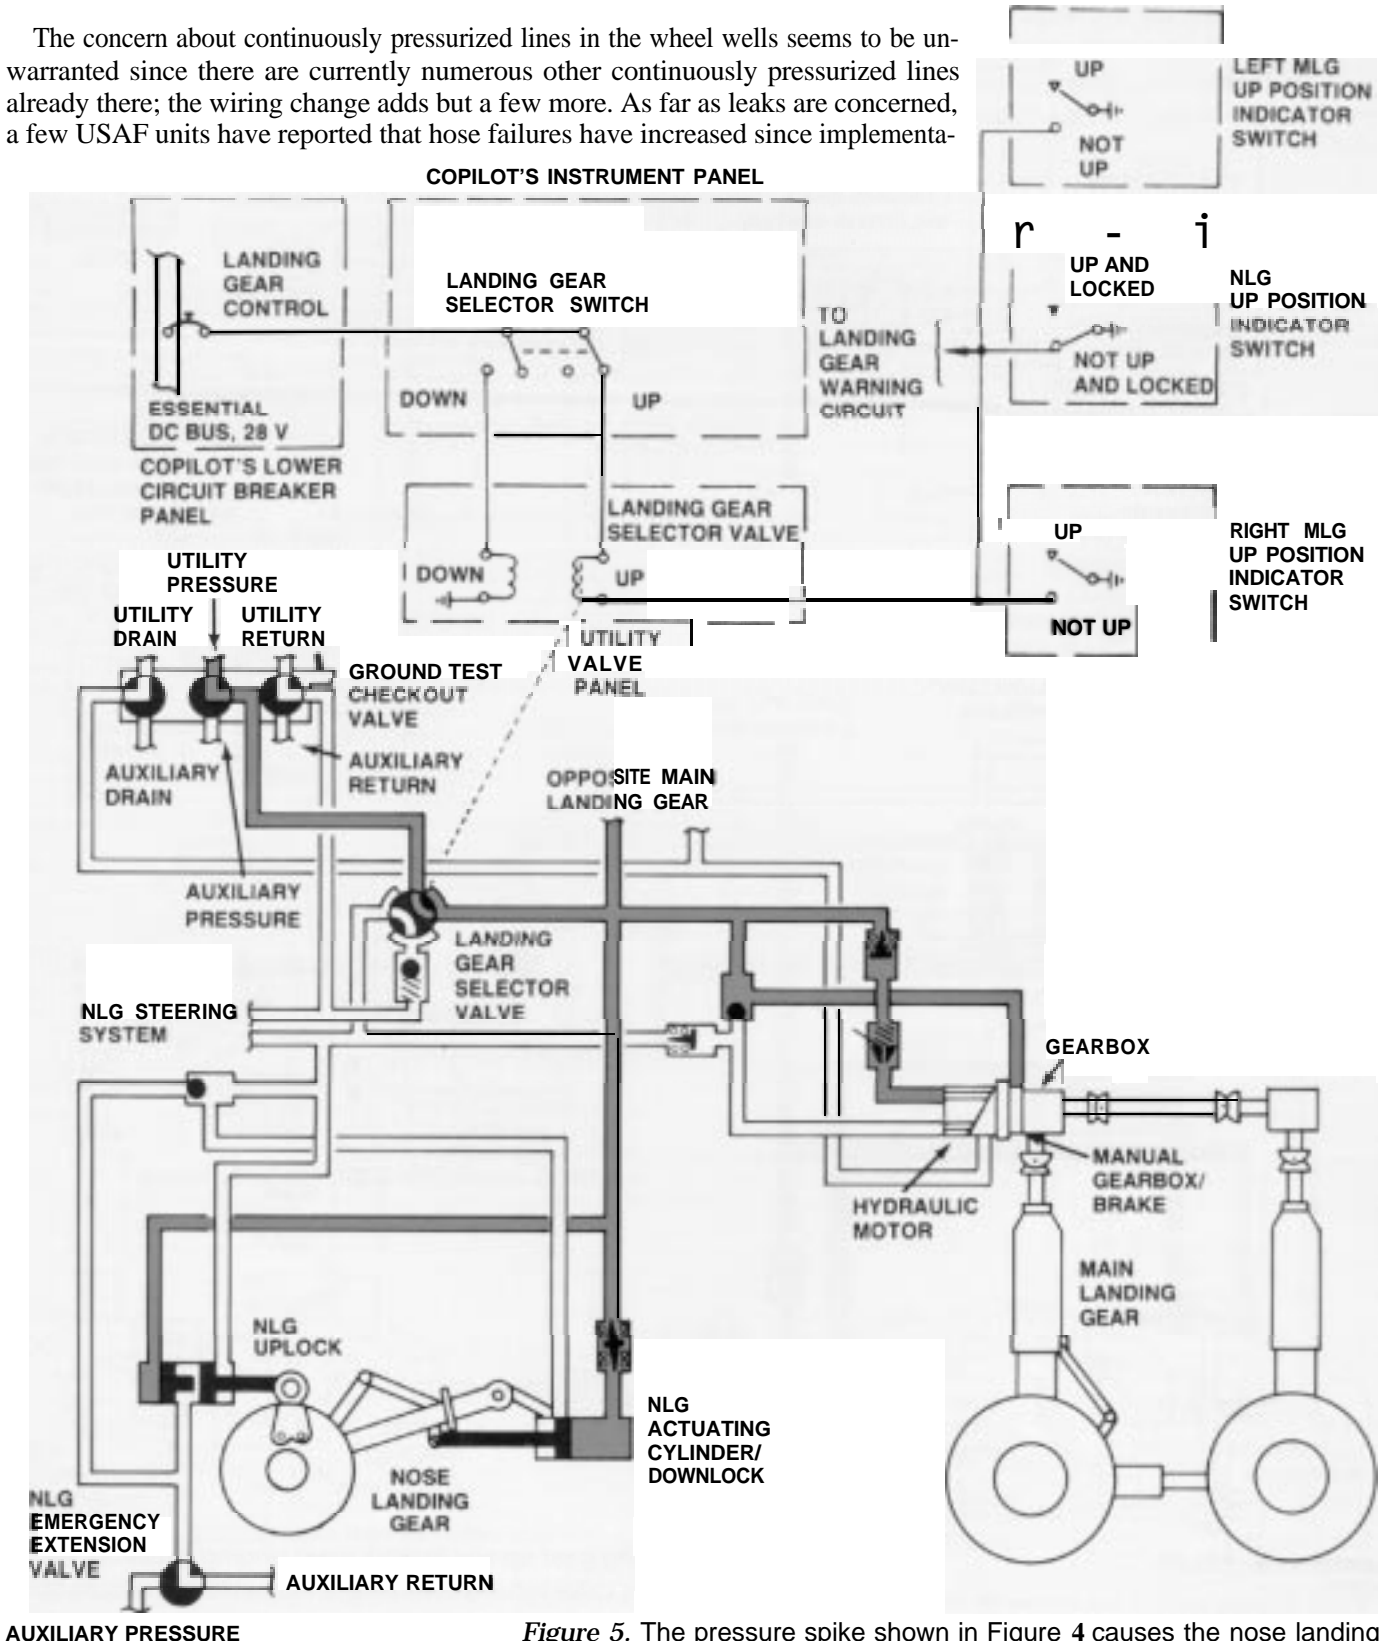
to unlock momentarily (Figure 5). As soon as the uplock is unlocked, the nose gear up position indicator switch provides a ground to reenergize the selector valve up solenoid and relock the nose gear uplock. This momentary unlocking of the nose landing gear uplock is the blip that shows up on the nose landing gear indicator as a momentary in-transit indication.

Figure 5. The pressure spike shown in Figure 4 causes the nose landing gear to unlock momentarily.

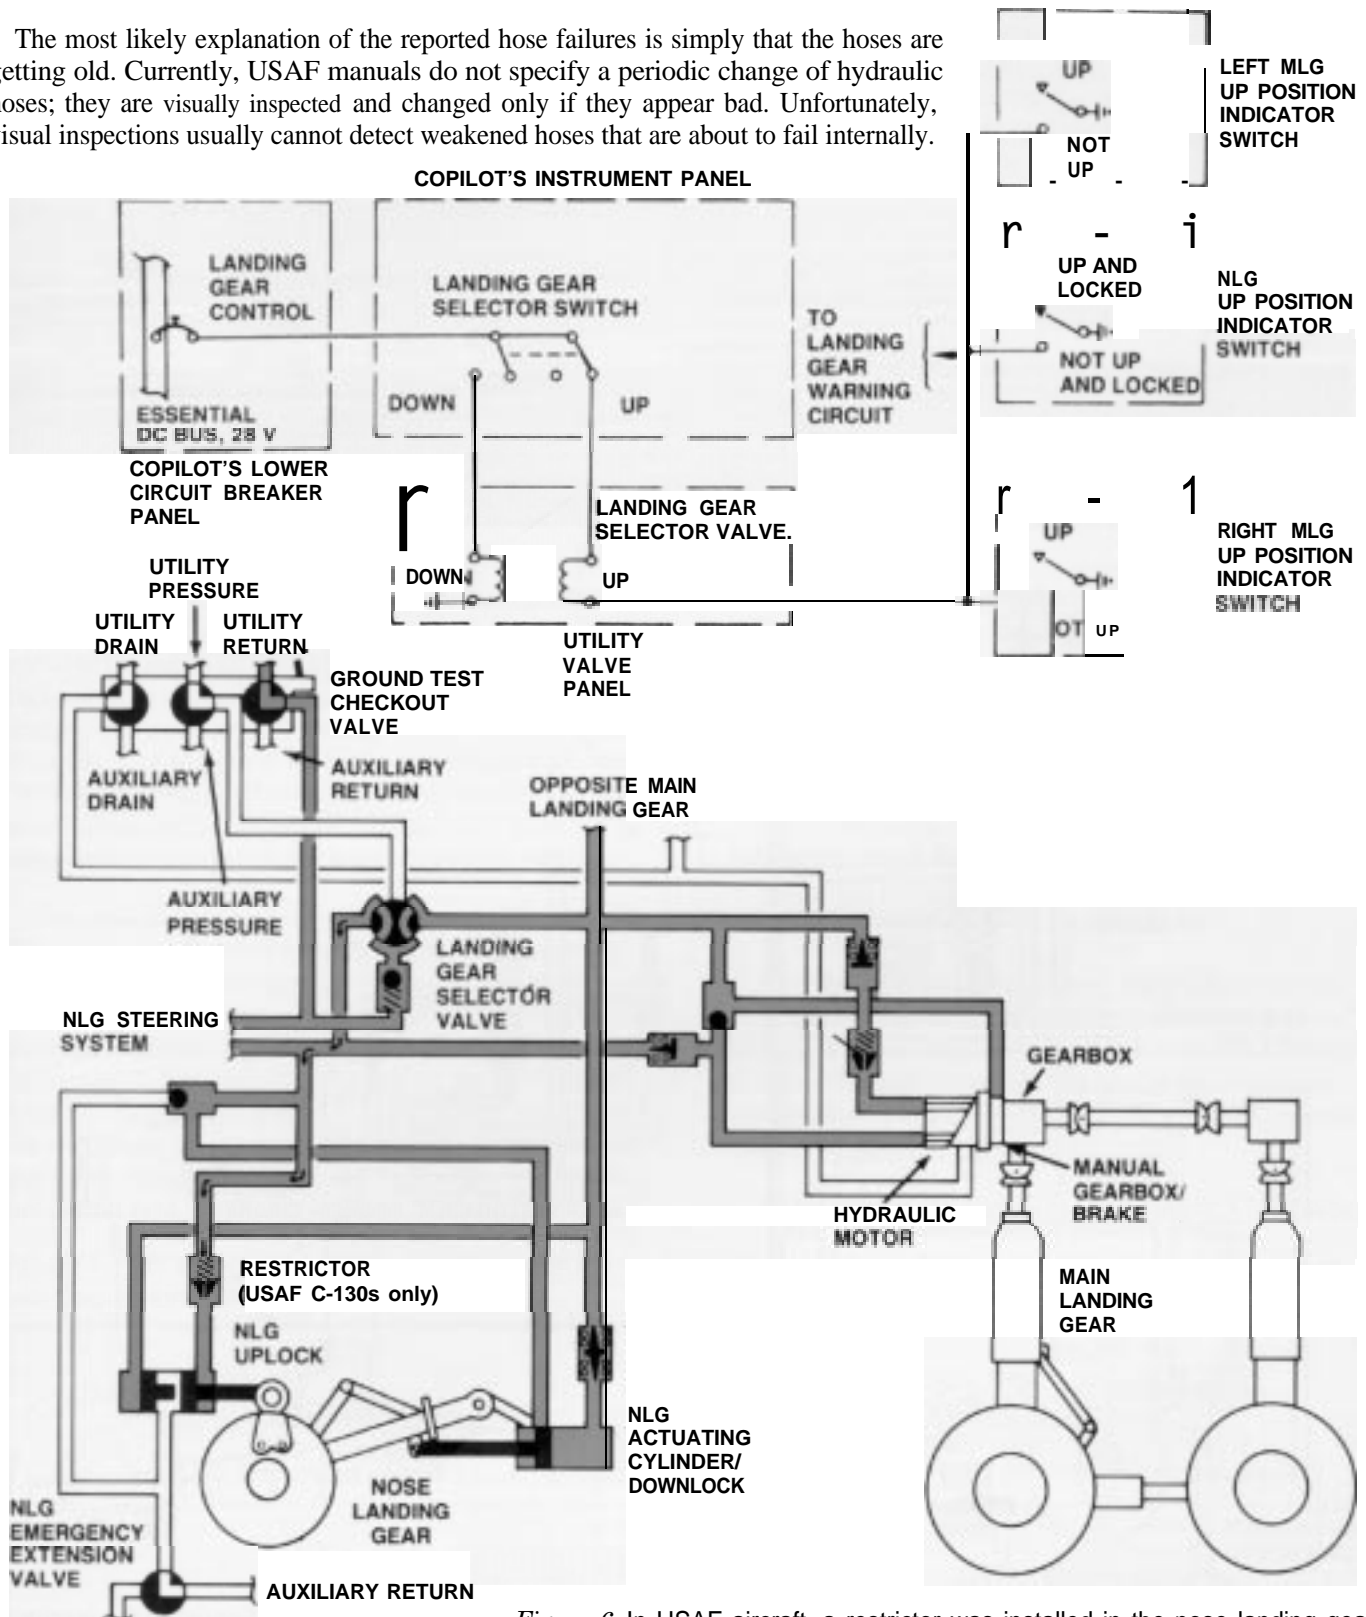
The United States Air Force eliminated the blip on their C-130s by putting a restrictor in the nose landing gear uplock line (TCTO IC-130-884) to dampen the pressure surge (Figure 6). The disadvantage that Lockheed engineering sees with this approach to solving the problem is that it has the effect of slowing the unlock operation of the uplock during normal nose landing gear extensions. Unfortunately, this can aggravate a nuisance condition that was already associated with nose landing gear extension operations, as we shall presently see.

Figure 6. In USAF aircraft, a restrictor was installed in the nose landing gear uplock unlock line to eliminate the indicator blip.

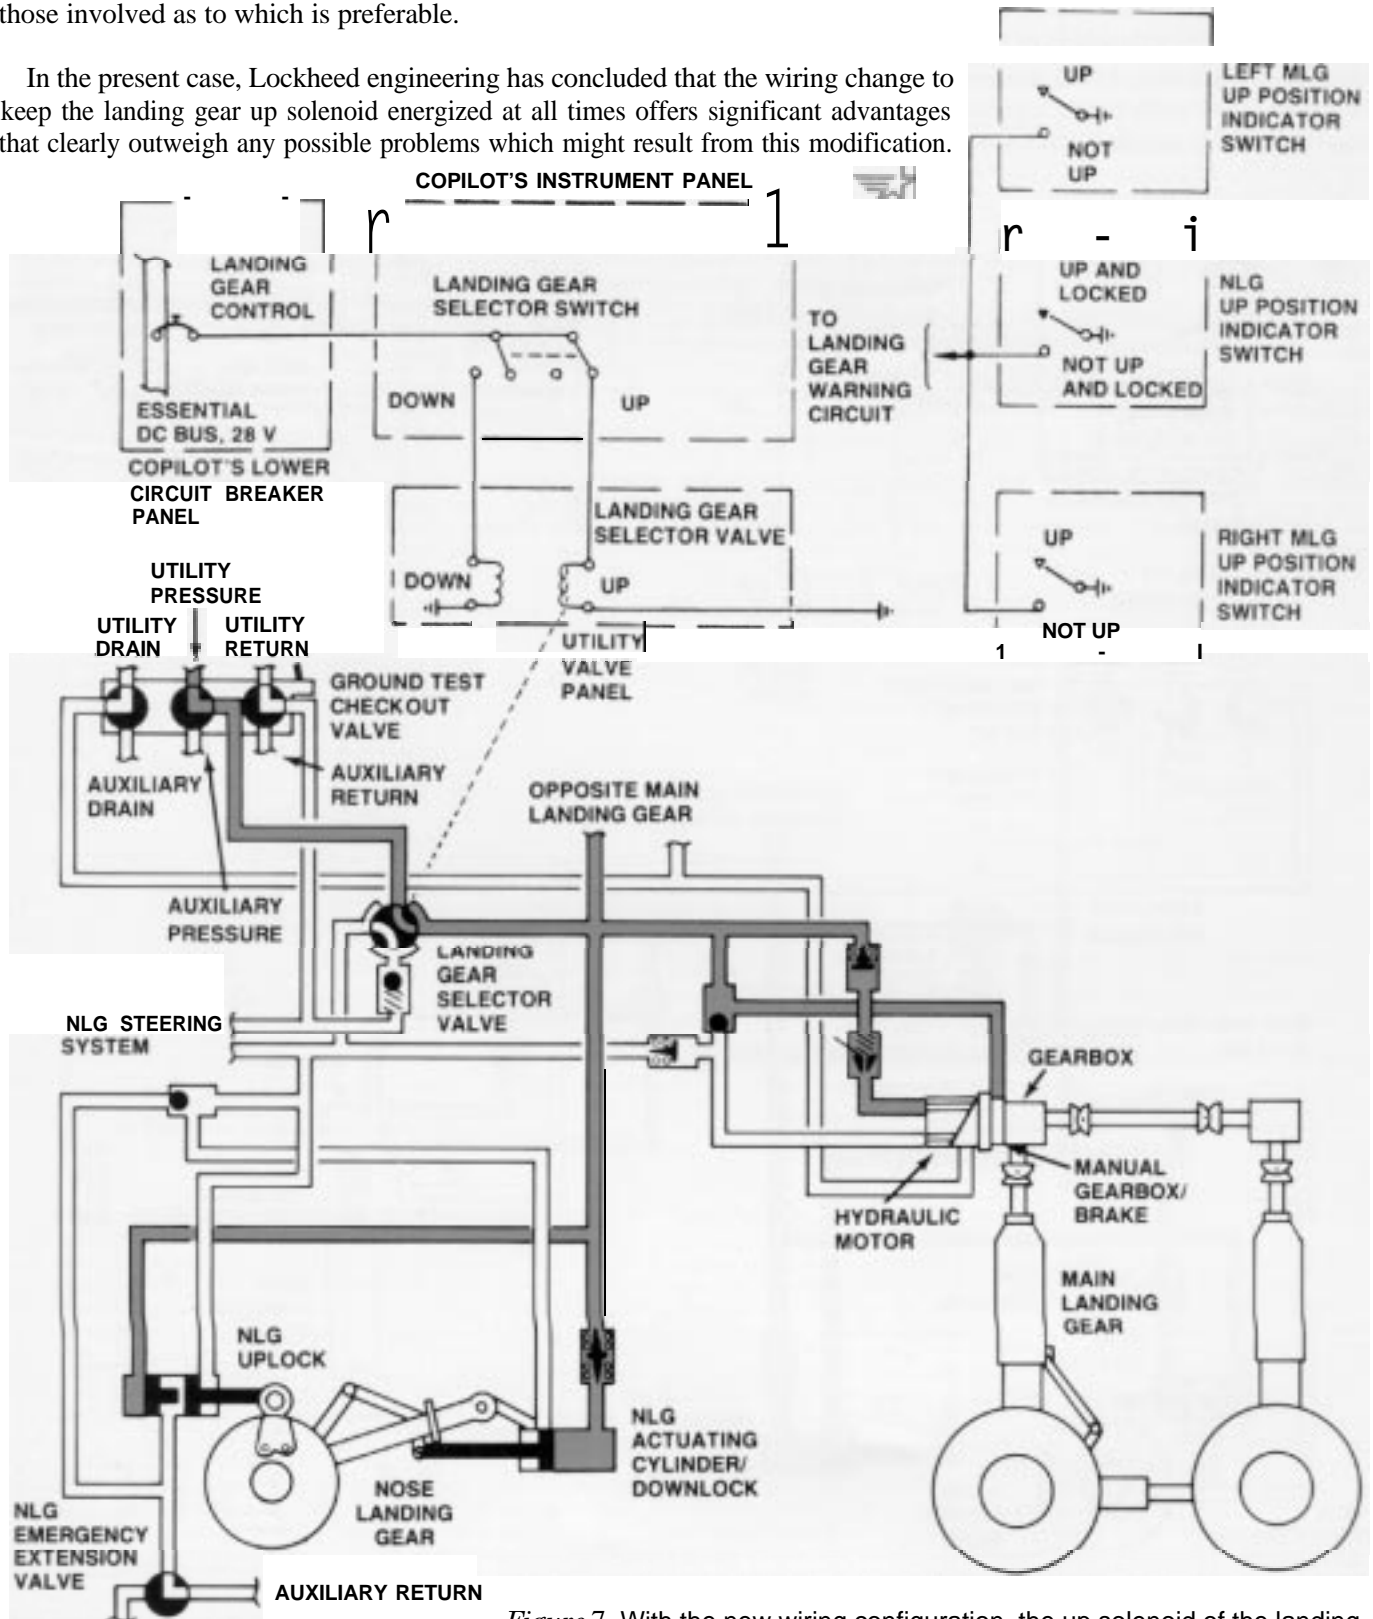
Some operators have asked whether the constant application of hydraulic pressure when the gear is up (Figure 7) does not result in a disadvantage by exposing the wheel wells to continuously pressurized lines and increasing the likelihood of leaks.

The concern about continuously pressurized lines in the wheel wells seems to be unwarranted since there are currently numerous other continuously pressurized lines already there; the wiring change adds but a few more. As far as leaks are concerned, a few USAF units have reported that hose failures have increased since implementa-

tion of the wiring change; however, the available evidence does not support the contention that hose failures are caused by the application of a steady 3000 psi pressure on the lines. Tests have indicated that flexing of the hoses with each application of pressure will result in a greater fatigue rate and cause hose failure sooner than continuously applied pressure.

Figure 7. With the new wiring configuration, the up solenoid of the landing gear selector valve remains energized anytime the landing gear control handle is up; the hydraulic lines remain pressurized.
