***T56 Oil System
Maintenance***

Lockheed SERVICE NEWS

Vol. 18, No. 3, July-September 1981

A Guide to Oil Loss Prevention

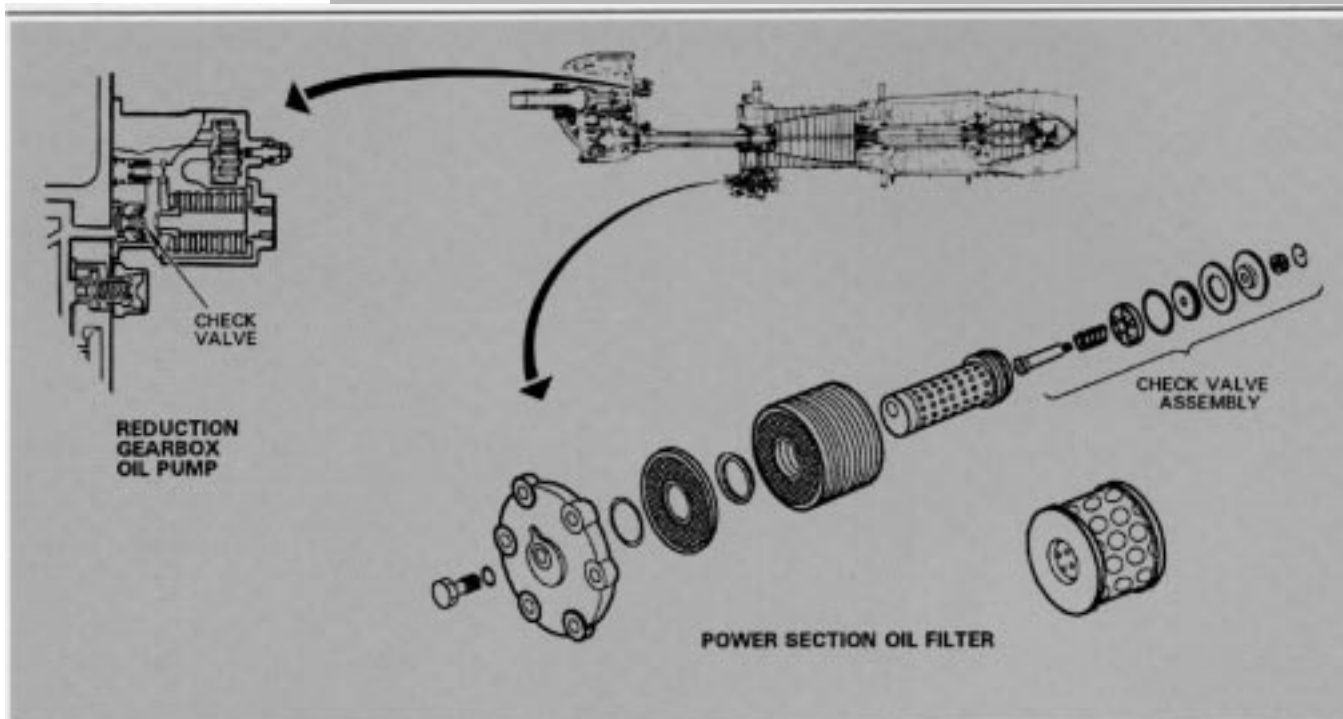
The most common cause of static leakage, also called gravitational flooding, is an improperly functioning oil retention check valve. This may occur either in the power section oil filter assembly or in the reduction gearbox oil pump assembly (Fig. 2).

Figure 2. Improperly functioning oil retention check valves are a common cause of static oil leakage.

When a static leak is suspected, perform the following confirmation check. Verify that the oil quantity gage of the affected engine shows at least four gallons present to provide lubrication, and then motor the engine briefly.

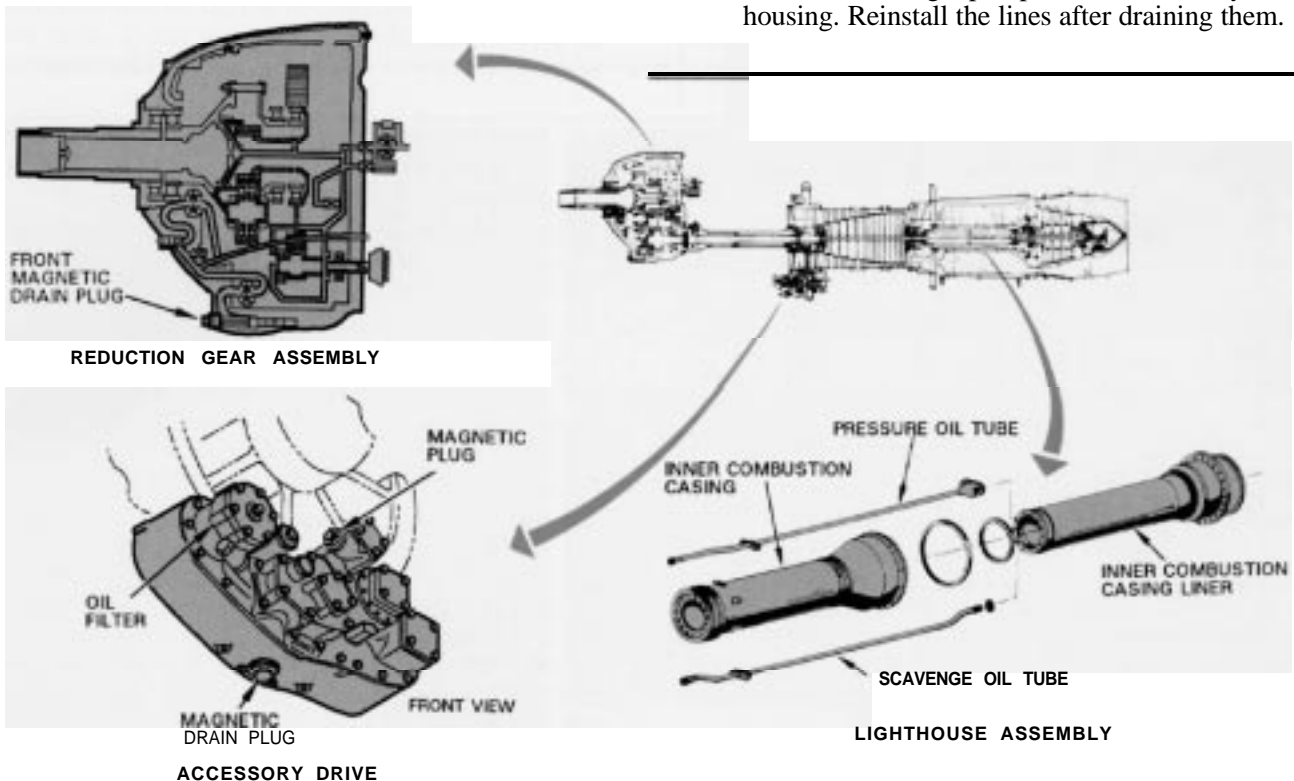
Figure 3. Accumulated oil will often collect in one or more of three major areas.

system. When an engine consumes or dumps oil, it will often do so after accumulating oil in one or more of three major areas: (1) the combustion assembly inner casing-the “lighthouse” assembly, (2) the reduction gear assembly, and (3) the accessory drive housing (Fig. 3).

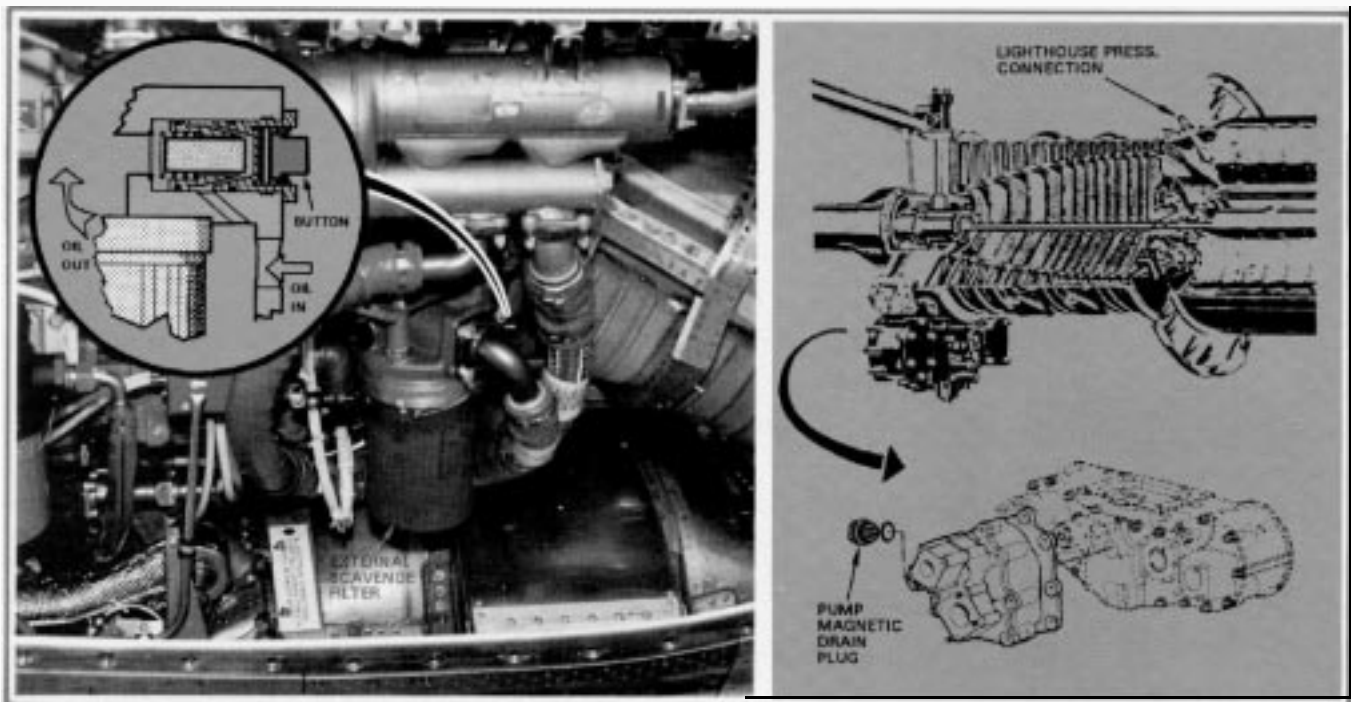
Figure 4. Determine "pump out" pressure at the main oil pump magnetic plug or the external oil filter "in" point, and lighthouse pressure at the pressure connection on the diffuser case.

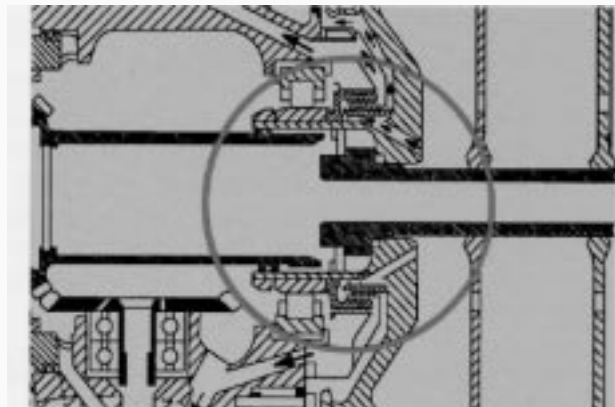
There are several locations where internal leakage most often occurs, all of which are in the power section. Worn or deteriorated O-ring seals, or a worn or damaged compressor front bearing labyrinth seal in the compressor front bearing and extension shaft area can cause internal leakage (Fig. 5).

Figure 5 Compressor front bearing labyrinth seal.

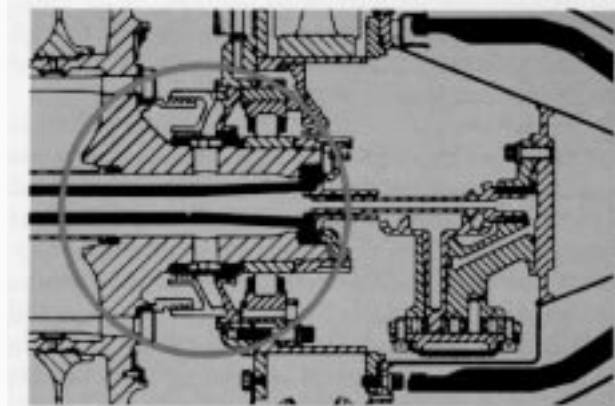
The lighthouse area can experience internal leakage from either end caused by damaged crush gaskets, worn or damaged labyrinth air or oil seals, or even a crack in one of the combustion chamber inner liners. The turbine rear bearing sump area can suffer leakage because of ineffective crush gaskets, turbine rear scavenge pump failure, or a worn or damaged turbine rear bearing labyrinth seal (Fig. 6).

Figure 6. Turbine rear bearing labyrinth seal.

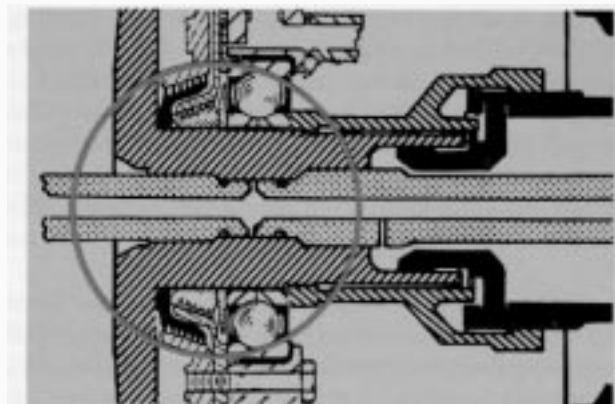
Figure 7. Compressor rear bearing labyrinth seal.

For example, if the **lighthouse pressure** is over 11 in. Hg, coupled with evidence of oil loss, the most probable cause is an ineffective compressor rear bearing labyrinth air seal (Fig. 7). This is due to the lighthouse being overpressurized by compressor discharge air flowing over the worn or damaged labyrinth air seal.

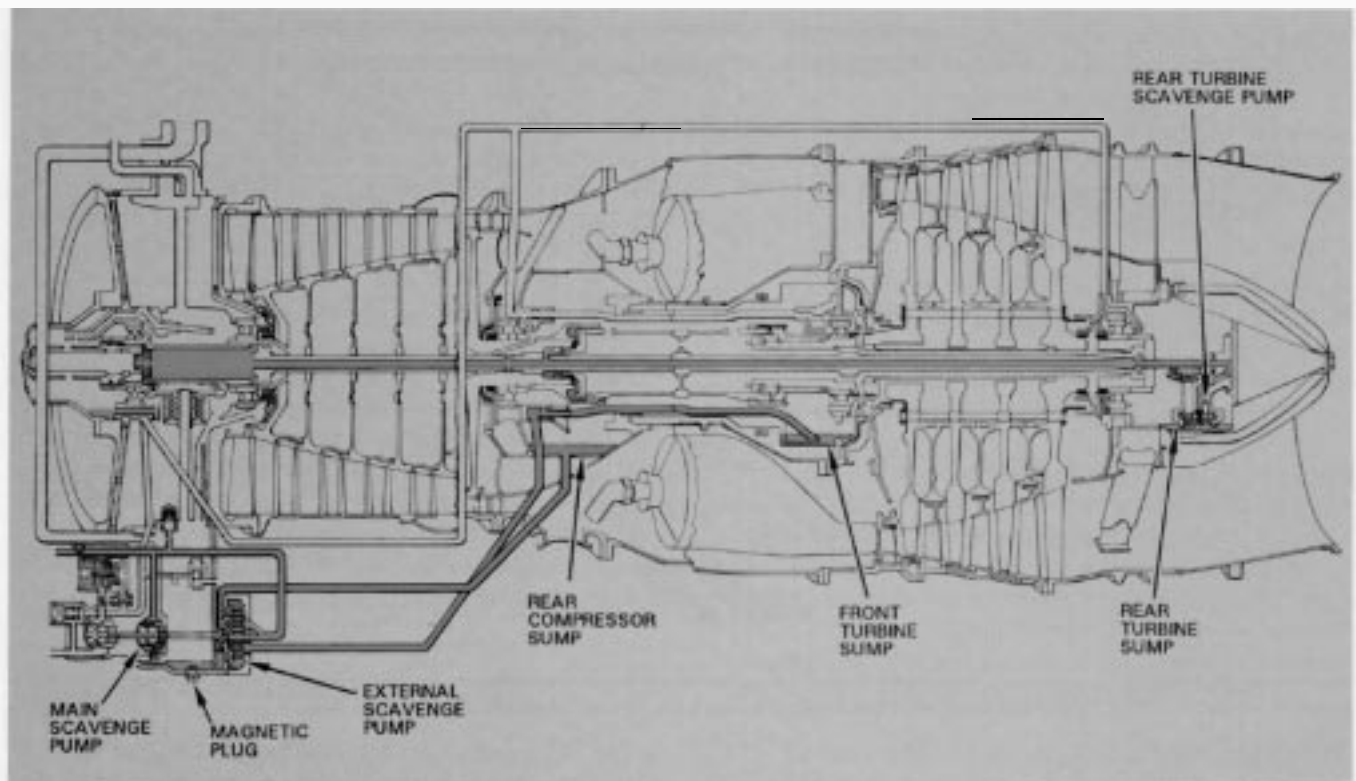
Figure 8. Power section scavenge problems can often be traced to ineffective pumps, leaking seals, and restricted scavenge oil tubes.

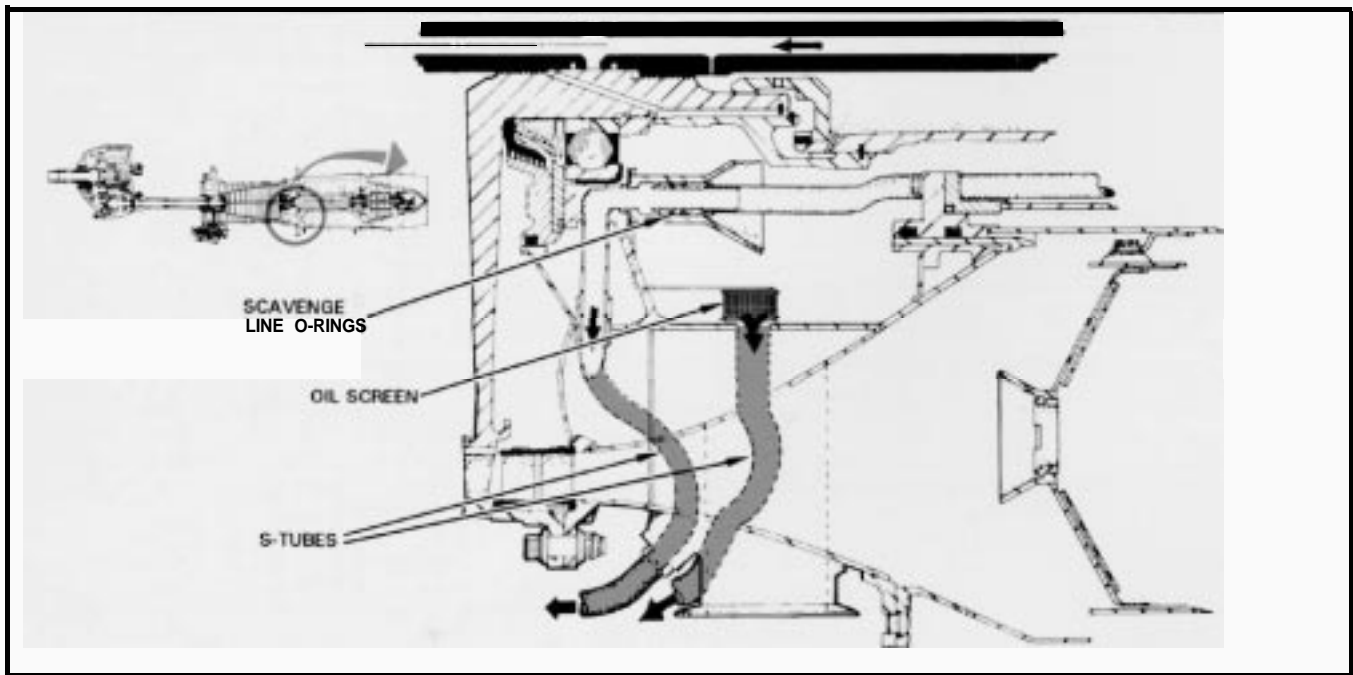
Figure 9. Good seals, unobstructed lines, and undamaged S-tubes are critical to proper scavenge oil flow.

The other cause for restricted oil tubes is air. Air is not really a restriction, but it can act to inhibit flow. Leaking scavenge line packings at the diffuser port connection allows lighthouse pressure to enter the oil tube. This breaks the suction to the turbine front bearing sump. There are two O-rings installed on the return scavenge line to help prevent this from happening.

Another place air can enter the system is at the diffuser S-tubes. These tubes are located inside the diffuser 5 o'clock and 7 o'clock struts. They serve as oil passageways to transfer the oil from the lighthouse area through the compressor air stream to the pump. If one of these tubes becomes cracked, compressor discharge air can enter the tube. The air pressure acts to break the suction and thus inhibits the free flow of oil to the pump.

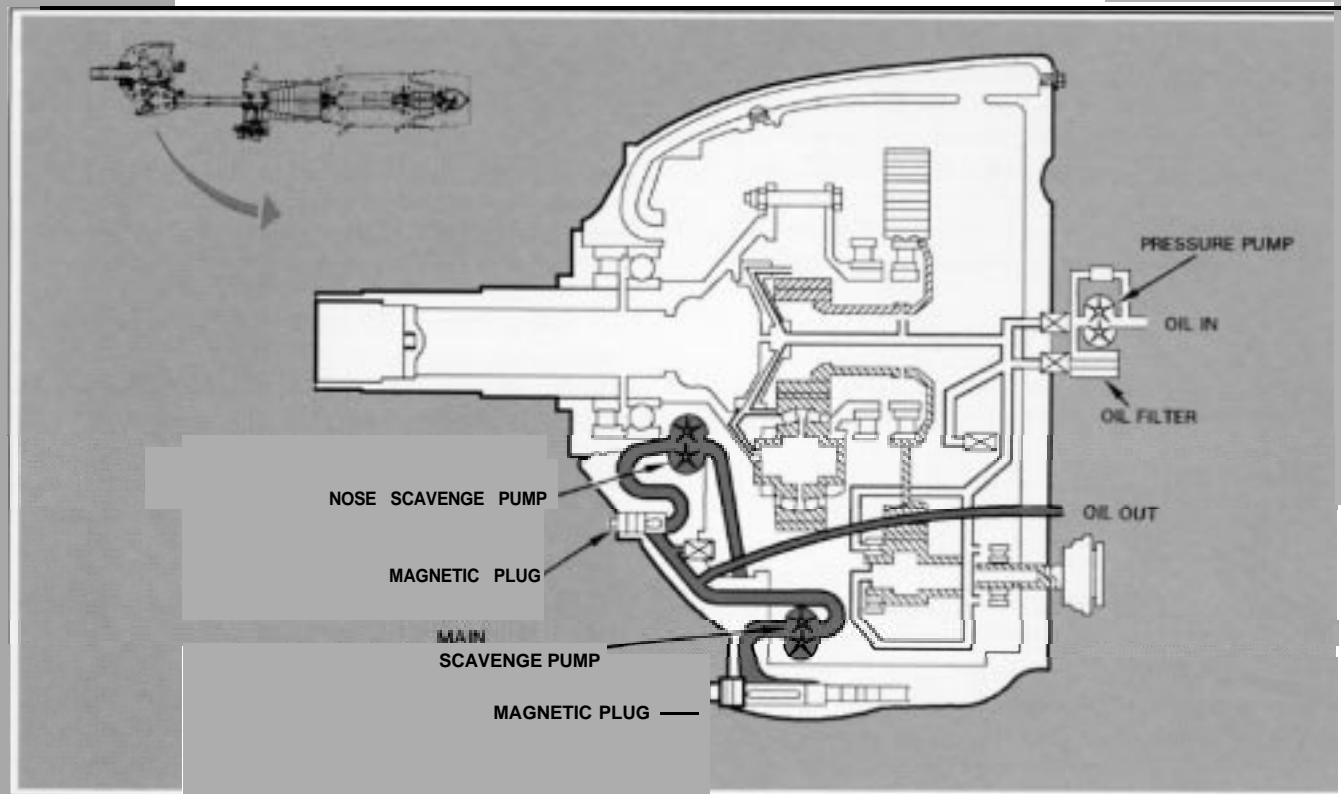
Figure 70. Effective reduction gearbox scavenging at altitude depends on efficient operation of both nose and main scavenge pumps.

This occurs because one pump cannot keep up with the oil flow at altitude and oil accumulates. The single good pump may be able to prevent further accumulation at lower altitudes, but it does not have enough capacity to completely recover the oil that has been accumulated at altitude. The oil simply stops accumulating.

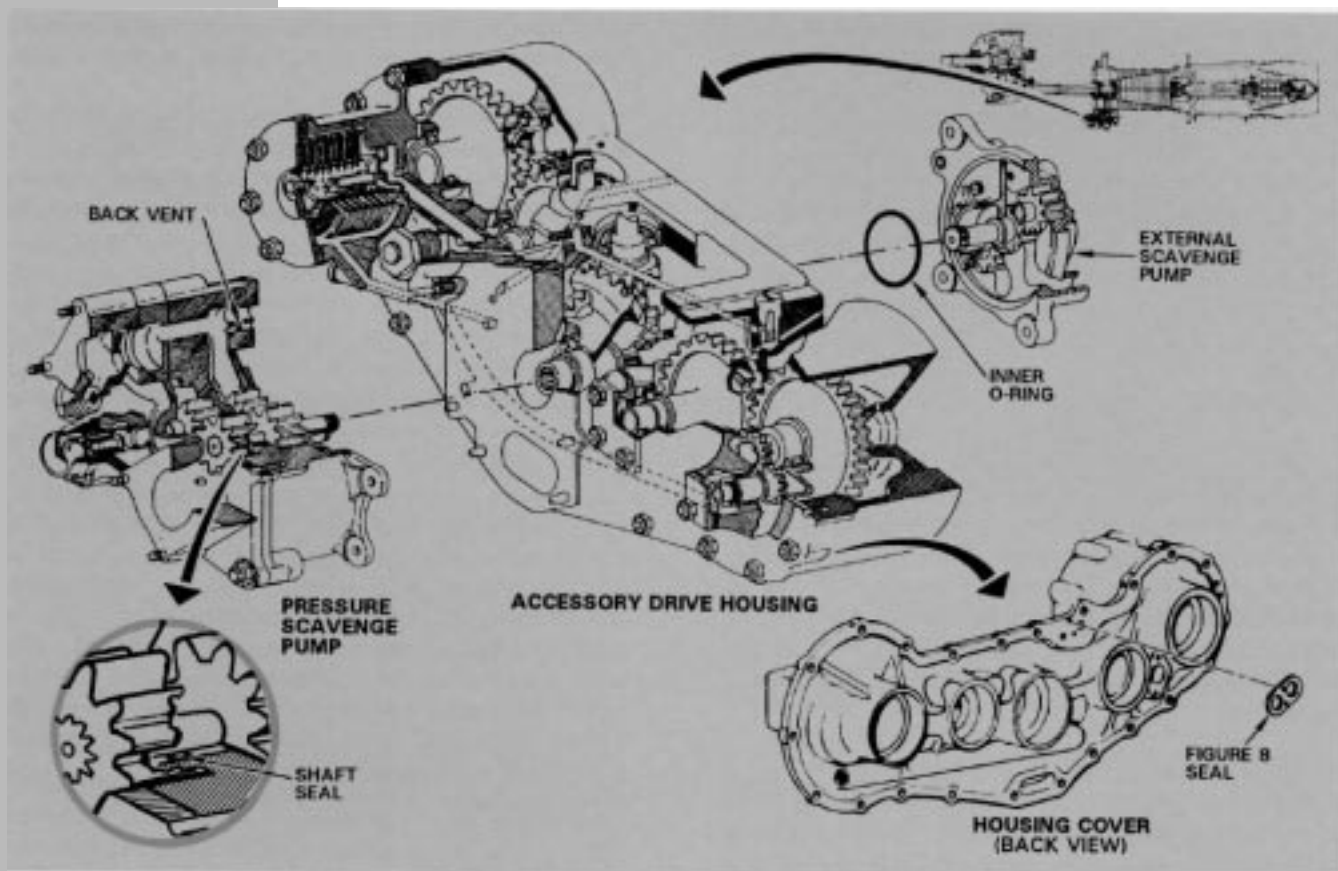
All too often, an external scavenge pump is replaced because it is thought to be worn, when in fact it only has a leaking O-ring. The inner O-ring on the pump cover, if leaking, can cause one element of the pump to cavitate. This causes the pump to lose its efficiency (see Fig. 11 on page 15).

Figure 11. Accessory drive housing oil accumulation is often caused by wear, obstructions, or seal problems affecting the main pressure scavenge pump.

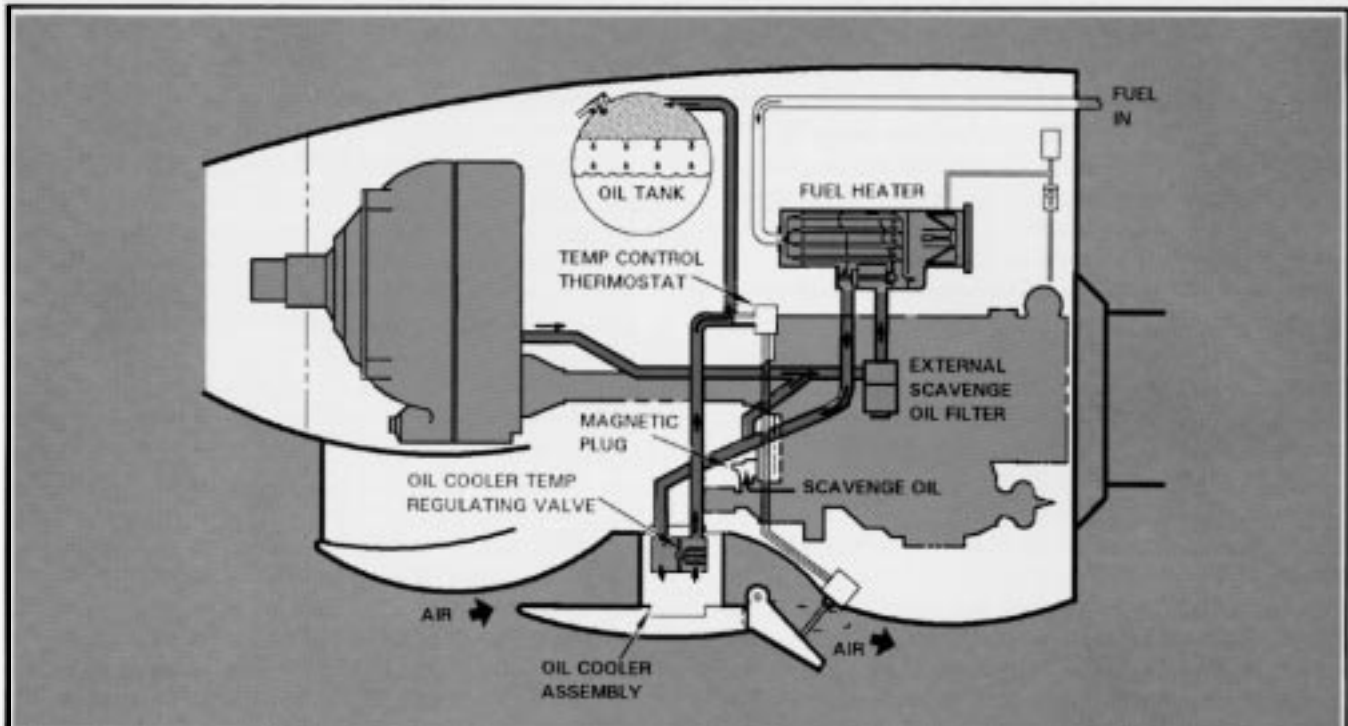
Figure 12. Nacelle-mounted oil system components such as the oil cooler, fuel heater, and external scavenge oil filter are important contributors to scavenge system back pressure.

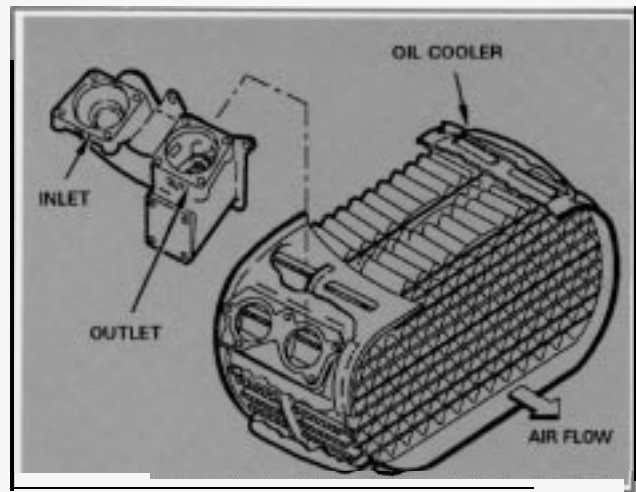
Figure 73. Even in full operation at 80°C, the AP of the oil cooler should not be more than 9 psi.

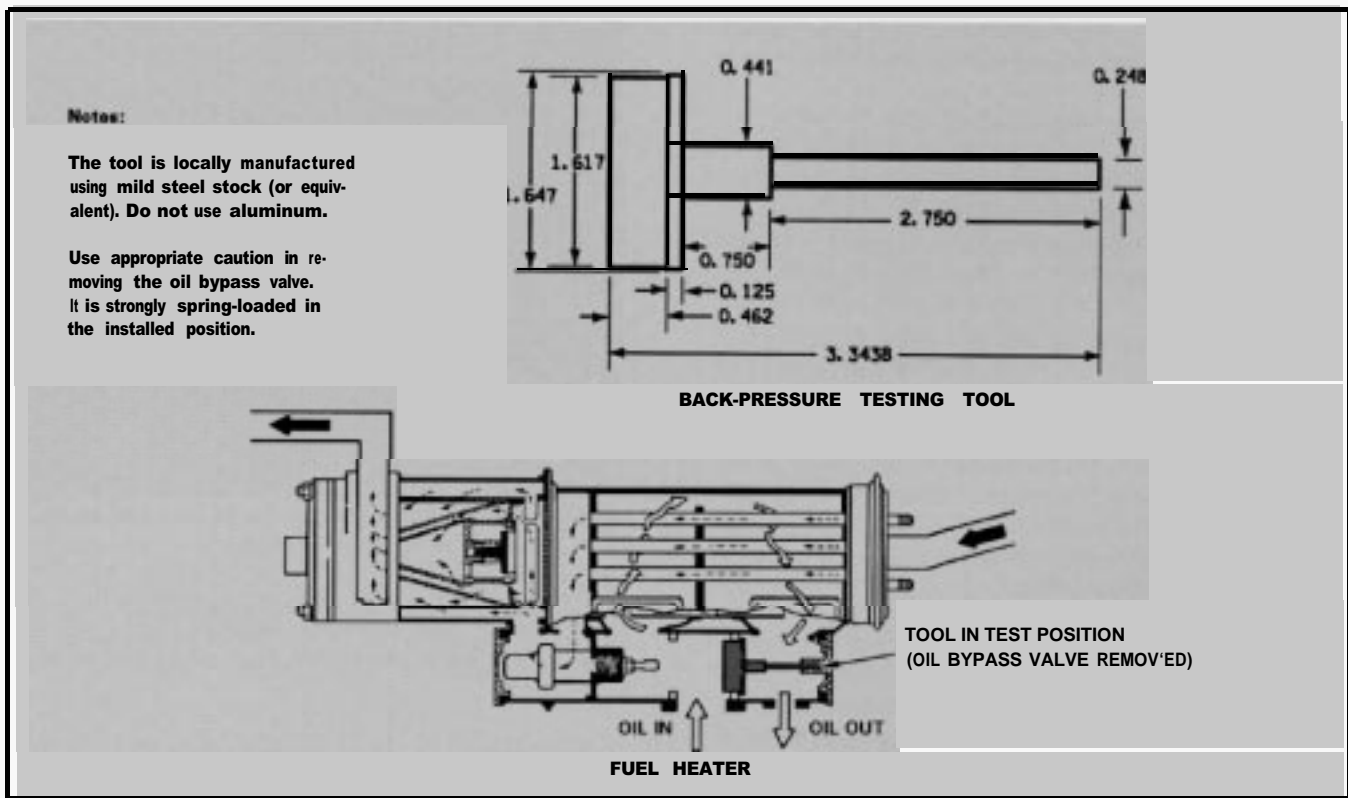
Figure 14. Installed in the fuel heater, this locally manufactured tool will allow the unit's maximum back pressure to be measured.
