# SERVICE NEWS

VOL. 10, NO. 2, APRIL—JUNE 1983

*Engine-Driven Hydraulic Pumps*

# Engine-Driven Hydraulic Pumps:

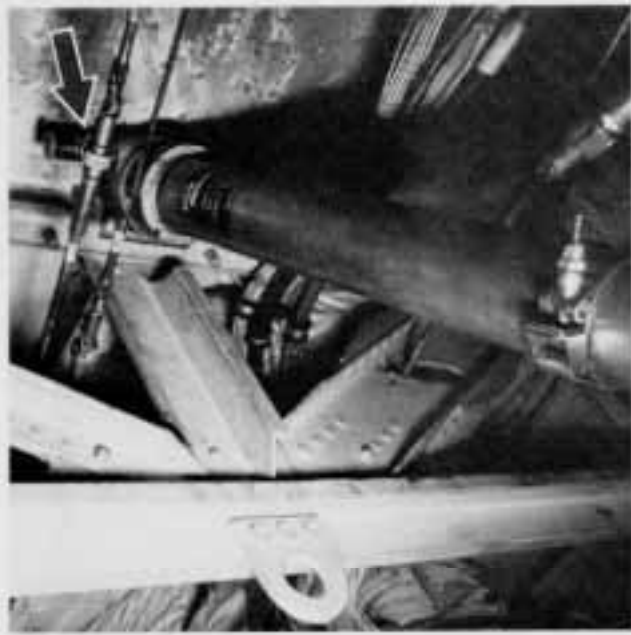
After a paratroop, the aft cargo door switch was left in the neutral position and the emergency manual release cable was used to close the cargo door. Unfortunately, air had become trapped in the associated hydraulic lines and the heavy door dropped suddenly and with considerable force. This applied excessive stress to the structure supporting the upper end of the cargo door actuating cylinder at FS 968, causing it to fracture.

In itself, this would not have resulted in anything more serious than an inoperable door system. But the bleed valve on the actuating cylinder snagged one of the elevator control cables that run beneath it as it dropped, causing the aircraft to assume a nose-down attitude. The aircraft did not prove uncontrollable, however, and landed safely.

Aft cargo door actuator. Note the protruding bleed valve.

To avoid any possible repetition of this type of problem, Lockheed engineering recommends that two actions be taken by Hercules aircraft operators. First, if there is a bleed valve on the aft cargo door actuating cylinder of any of your aircraft, it should be replaced with a bleed plug. Lockheed engineering will soon

issue Service Bulletins SB 82-532 and 382-29-6, "Bleed Plugs - Aft Cargo Door - Bleed Valve Replacement," which describes replacement of the bleed valve. The bleed plug, which is used in place of the bleed valve on all current production Hercules, is too short to foul the elevator cables should the aft cargo door actuating cylinder become loose for any reason.

The second recommendation is that Hercules aircraft operators who have not accomplished Service Bulletins SB 82-299 or 382-093, "Doors - Installation of Snubber and Attaching Structure on the Aft Cargo Door," do so as soon as possible. These service bulletins install a snubber on the aft cargo door which will prevent the door from dropping too rapidly when it is allowed to close of its own weight.

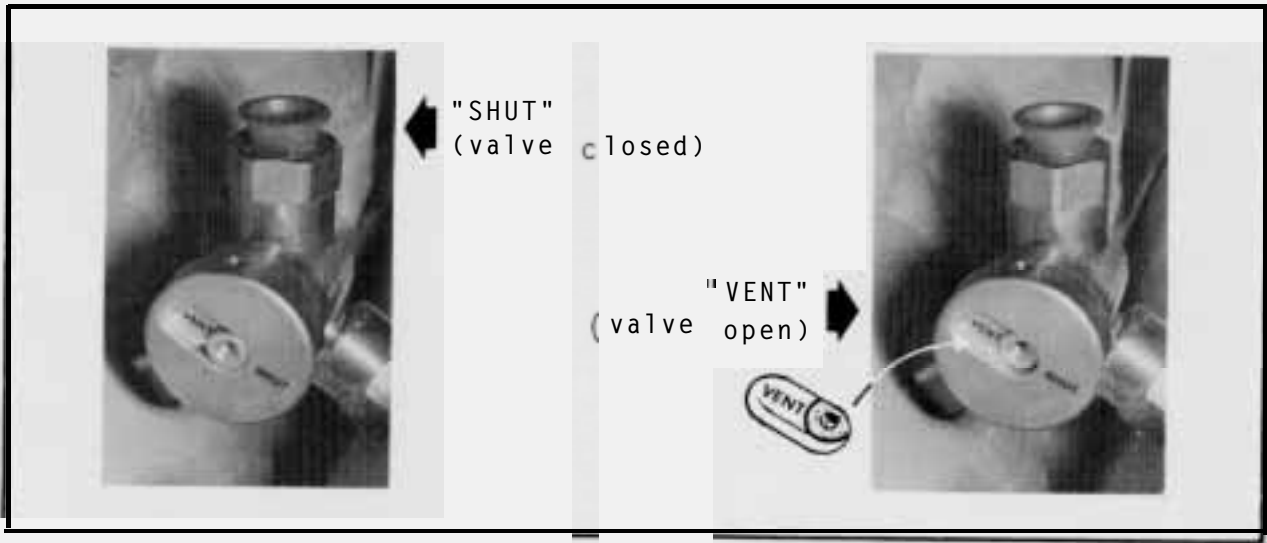
**Figure 1. Vent valve positions.**

this partial inflation occurs. Lockheed engineering has long suspected that the majority of these unscheduled life raft deployments occur either because the raft was incompletely evacuated prior to installation, or because the P/N 9153 vent valve on rafts so equipped has been left in the closed position. Figure 1 illustrates the appearance of the vent valve in both the closed (SHUT) and open (VENT) positions.

It is very important that the vent valve be left in the open (VENT) position once the life rafts are installed in their compartments. The porosity of the life raft material will not permit the raft to remain evacuated indefinitely, and venting of the raft is therefore required to avoid expansion at altitude. Also, if the vent is left closed, any leakage from the CO2 cylinders used to inflate the rafts for use cannot escape to the atmosphere and will enter the raft itself.

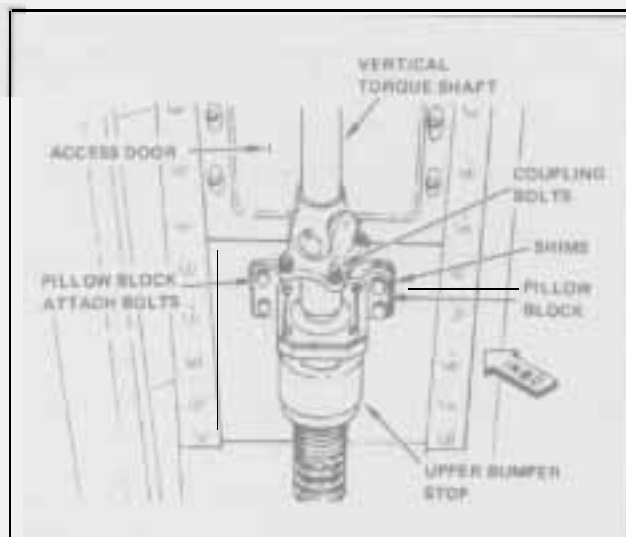
**Figure 1.** Remove the access door to reach the vertical torque shaft and the upper bumper stop.

Recently, a military operator whose Hercules aircraft were in virtually continuous operation carrying heavy loads into areas where extreme weather conditions prevailed noted a significant increase in discrepancies involving excessive axial play in the MLG upper bumper stop assemblies. Some of the ballscrew assemblies had only recently been installed and were apparently in good condition otherwise.

Investigation determined that in each of the cases the ring spring assembly had jammed, which accounted for the excessive axial clearance. The exact cause of the condition was more difficult to pinpoint, but it appears that heavy loads, harsh climatic condi-

Whenever excessive axial clearance is discovered in a MLG upper bumper stop, the possibility that a jammed ring spring assembly may be the cause should be considered. A worthwhile initial step is to try to free it without disassembly. Look for a lubrication fitting on the upper bumper stop housing. If one is provided, pump MIL-G-81322 grease into the bumper stop with a grease gun. Then give the bumper stop a sharp blow or two with a rubber or leather mallet. If this frees the spring and the excessive axial play disappears, no further action is required other than periodic lubrication with MIL-G-81322 grease.

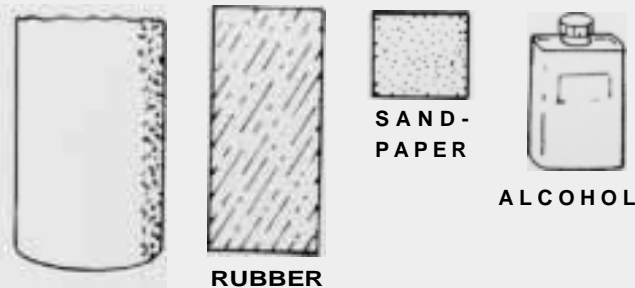
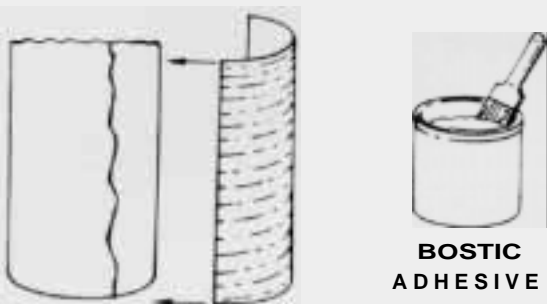
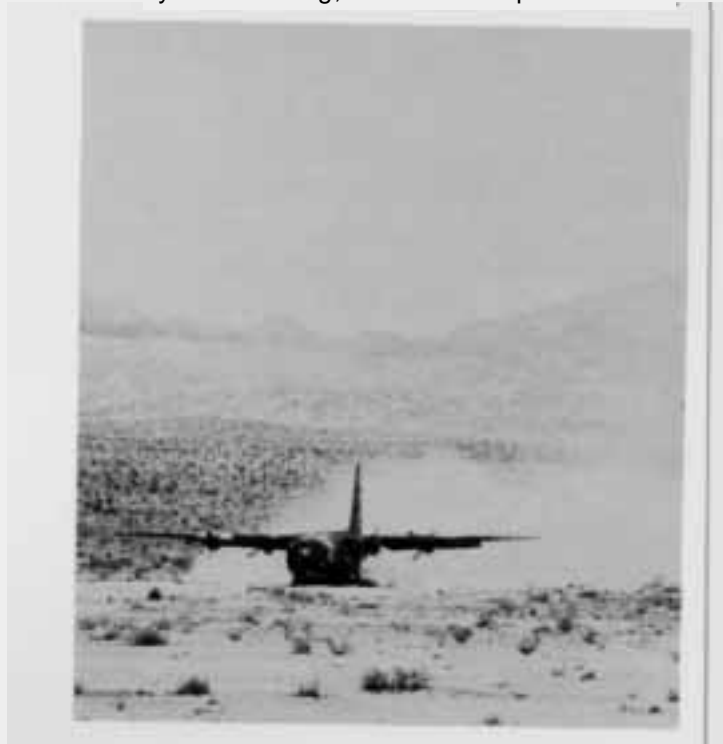
The leading edges of the blade-type UHF and VHF antennas located on the lower part of the Hercules aircraft fuselage are often gradually eroded by sand, gravel, and other solid particles tossed up by the propellers and nose wheels during landings and ground operations. Ice crystals and hail encountered in flight can also cause significant wear and tear on these surfaces.

A simple but effective approach to protecting the leading edge of an antenna of this type is to glue on a strip of rubber cut from an old inner tube. The rubber strip should be large enough to overlap 3/4 inch to 1 inch on each side of the antenna leading edge, and it should be long enough to run the full length of the antenna. Both the antenna and the rubber strip need to be prepared for adhesion by roughening the surfaces that will be in contact. Use medium-grade sandpaper for this purpose, and then clean the surfaces with solvent. Alcohol is a good choice because it leaves no residue.

Any strong adhesive can be used to cement the rubber strip to the antenna leading edge. One recommended brand is Bostic No. 1096, used with Boscodur No. 9 accelerator. Be sure to follow the manufacturer's instructions carefully to ensure maximum adhesion and durability.
