# *SERVICE NEWS*

CONSERVING TURBINE LIFE

**Vol. 14, No. 1, January-March 1987**

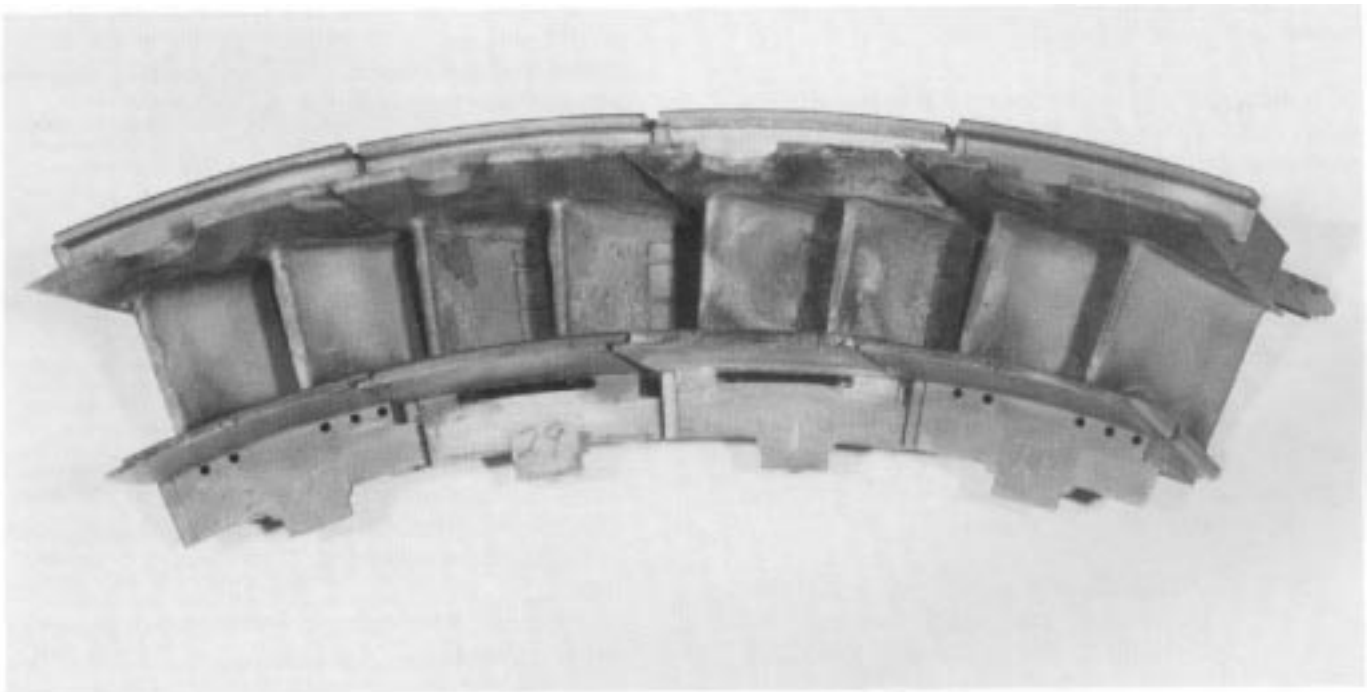
First stage turbine vane sulfidation.

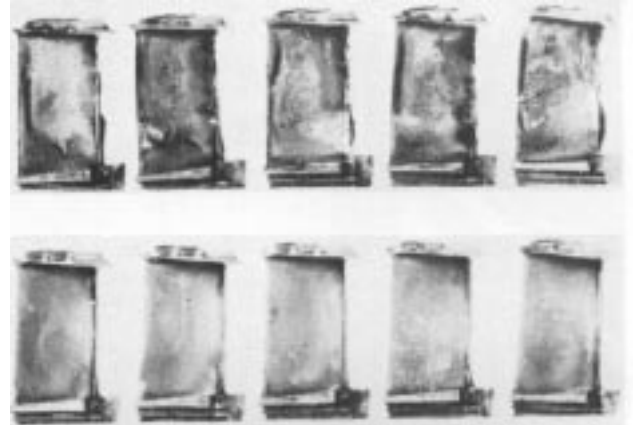
First stage turbine blades after service test.  
Top row: uncoated alloy.  
Bottom row: the same alloy protected with Alpak.

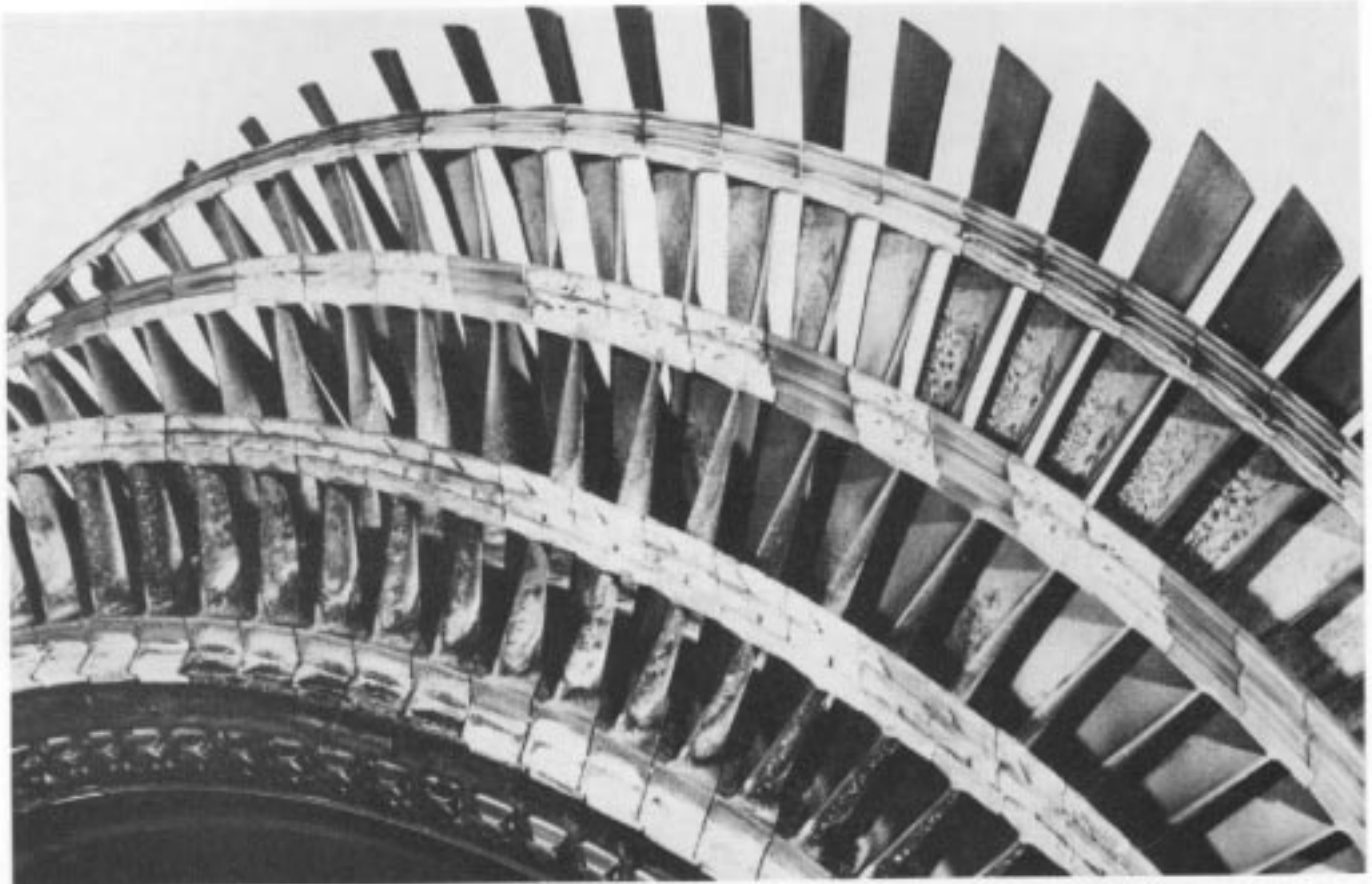
Air-cooled turbine rotor after accelerated sulfidation testing.

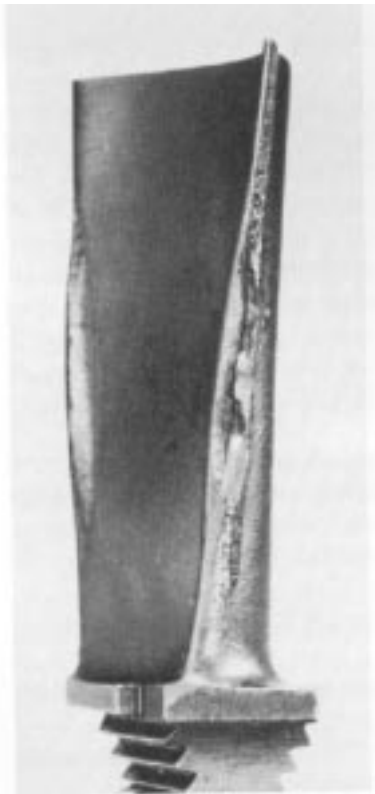
Close-up of turbine blade sulfidation damage.

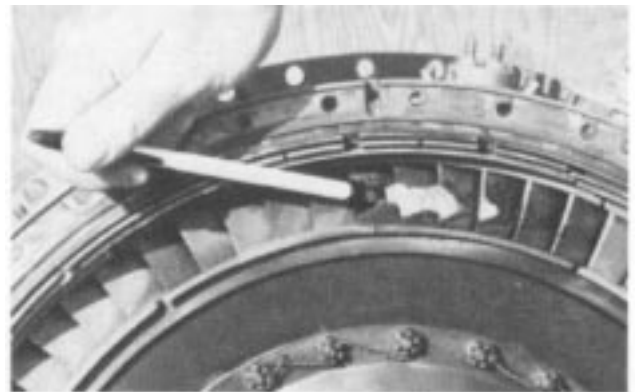
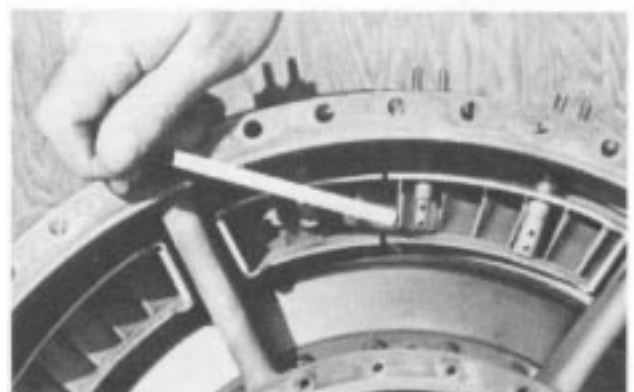
This turbine vane burn-through was caused by the use of thermocouples of the incorrect type.
