Lockheed

VOL. 18, NO. 2 APRIL-JUNE 1991

# ***SERVICE NEWS***

***Engine Run Safety***

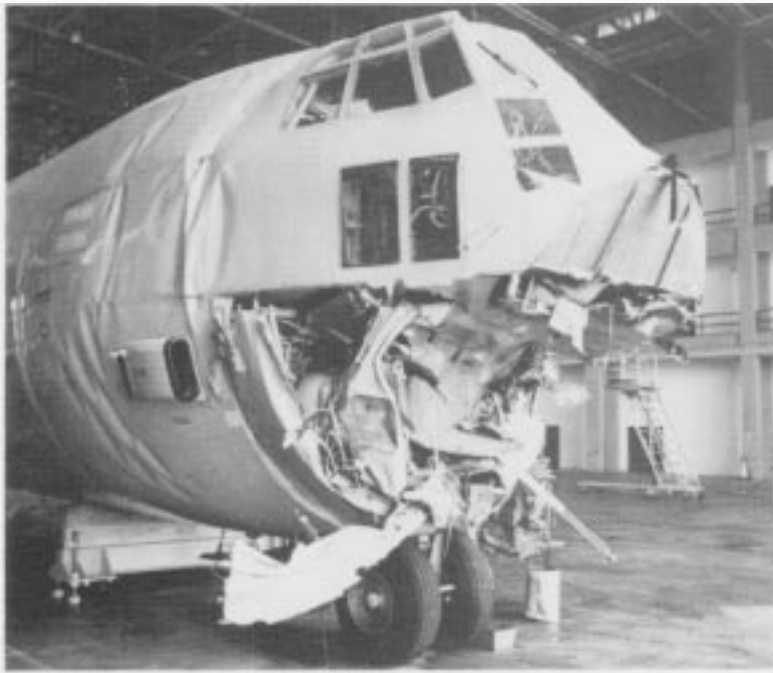
This aircraft was damaged beyond repair as the result of an engine-run accident. Inadequate training is the single most important cause of such mishaps.

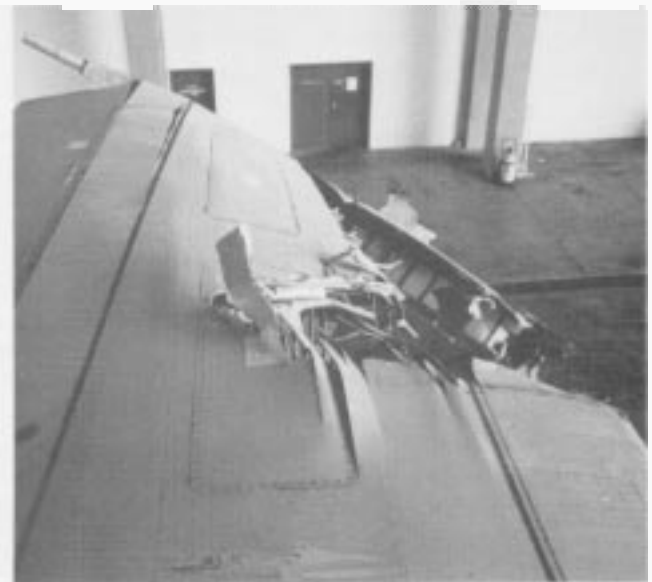
The wing of this airlifter sustained severe damage when it stuck a hangar after the engine-run crew lost control.

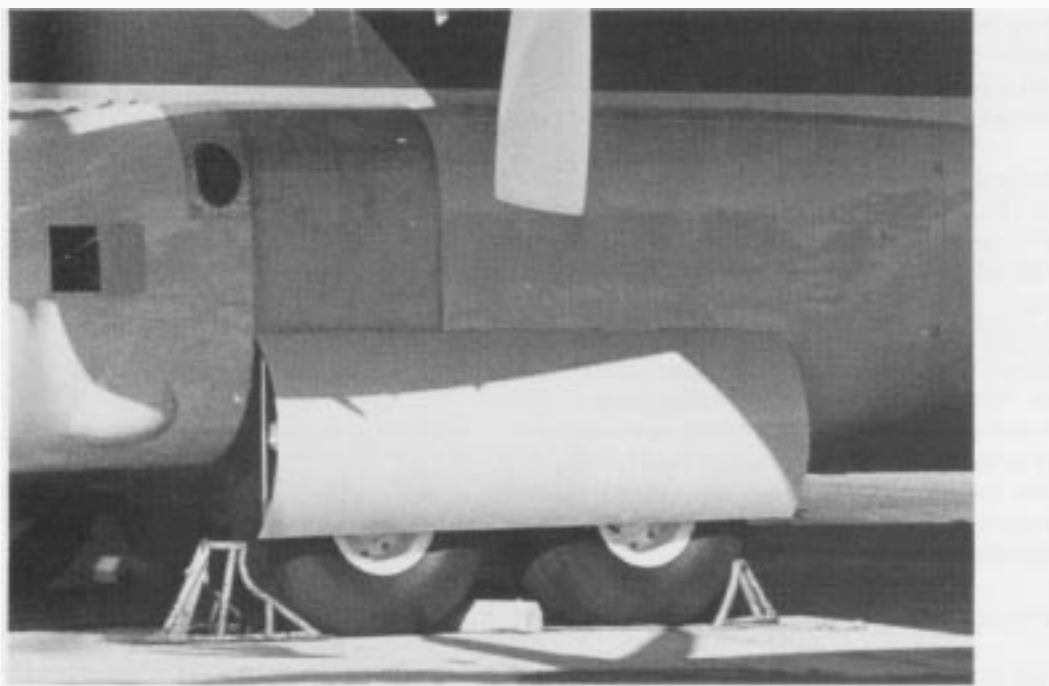
Properly designed, cage-type chocks can go a long way toward preventing “jumped chocks” incidents.

To prevent mishaps, a unique chocking system was devised. It consists of very large, cage-type chocks which pin into steel plates anchored to foundation blocks in the ramp (see photo above). Aircraft cannot roll up and over these chocks. Once the main landing gear tires are up against them, the aircraft is completely secure.

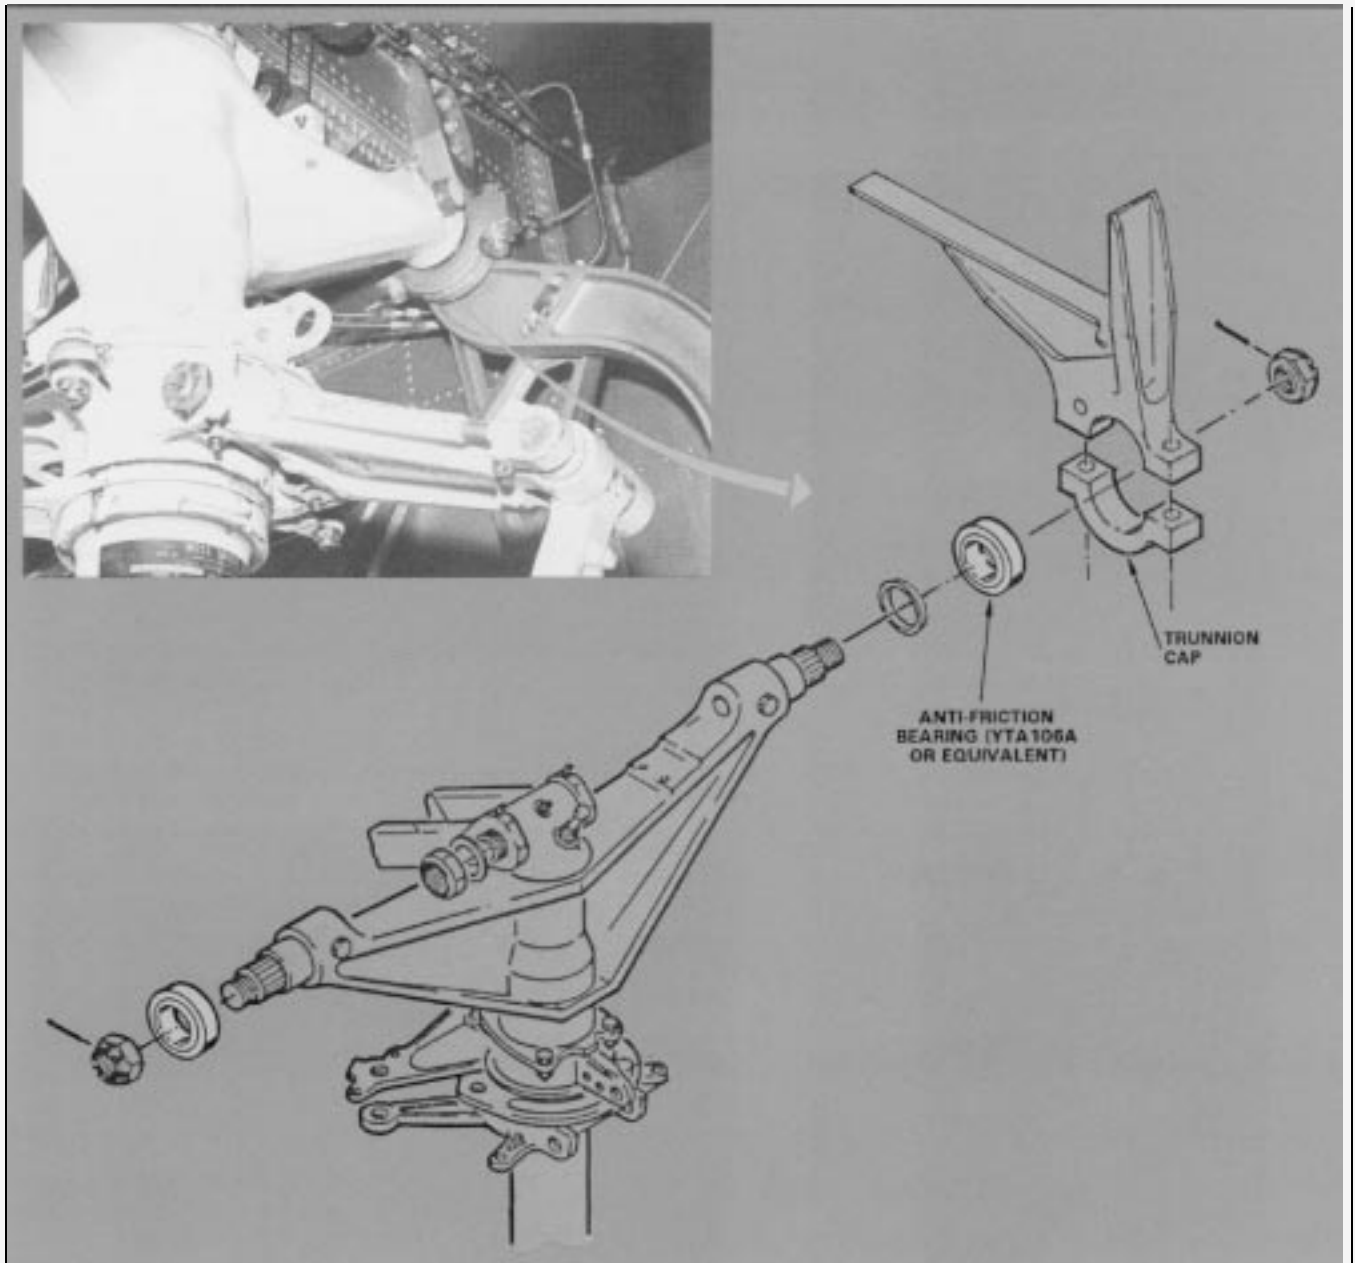
Grinding or popping sounds from the nose wheel well during taxi may indicate the presence of wear in the PN YTA106A fulcrum anti-friction bearings. These bearings have a number of critical functions to perform. They must support the weight of the nose of the aircraft during landings and operations on the ground, and they must also operate smoothly during extension and retraction of the NLG strut.

In addition to the stresses imposed by these important functions, the NLG fulcrum anti-friction bearings are located in an area where they are exposed to a host of abrading and corrosive agents such as sand, salt, dirt, dust, and ice. Over a period of time, these environmental hazards can take a toll. It is no coincidence that the aircraft affected by wear in these areas have usually been in service for a number of years.

Hercules nose landing gear assembly-note PN YTA106A anti-friction bearing.

Worn bearings should be replaced. The inner race of new bearings should be lubricated with a film of fresh, general-purpose grease. If the inside diameter of the outer race is Teflon-lined, only the inside diameter of the inner race need be lubricated. The strut should then be reassembled as described in the authorized maintenance instructions. If new bearings are not immediately available, a temporary solution that will usually eliminate the noise is to rotate each bearing 90° and reinstall it. This serves to expose a different area to the load, which ensures a better fit and helps protect the already affected areas from further wear until new bearings can be installed.

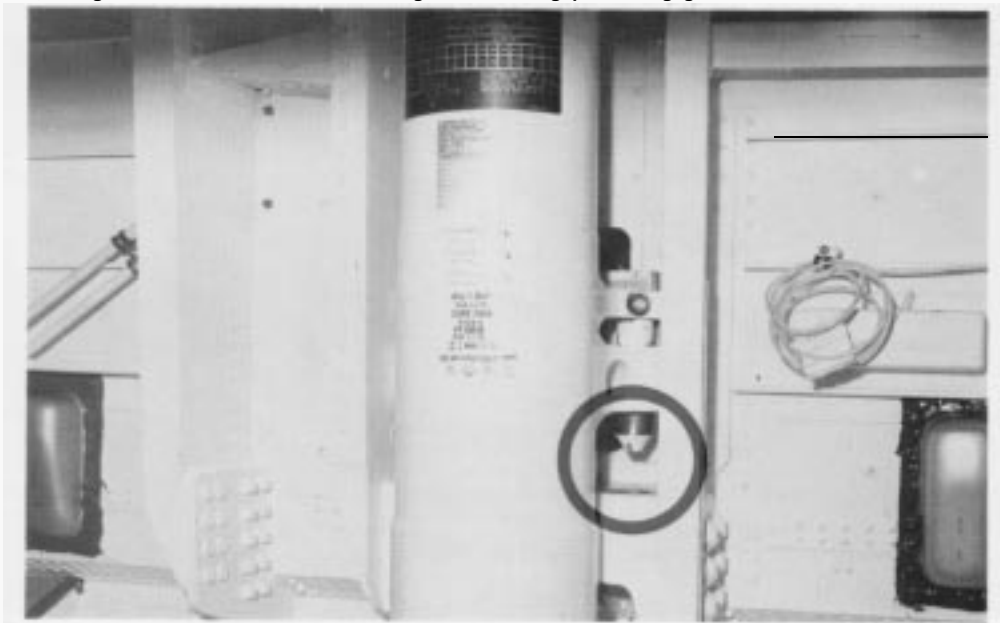
If it proves impossible to lower the gear far enough for the drag pins to engage the shelf bracket fully (Figure 2), or in situations where the shelf bracket itself has been damaged, some other method of securing the gear against these loads must be found. Historically in such cases, aircrews have had to thread 10,000- or 25,000-

Figure 2. In this case, the gear has not descended far enough for the drag pin to engage.

pound capacity tiedown chains through the lower access panel openings in the wheel wells and tie the landing gear struts on either side of the aircraft firmly together. This serves to hold them against the lateral forces that might otherwise tend to drive the struts outward when side loads are applied during the landing.

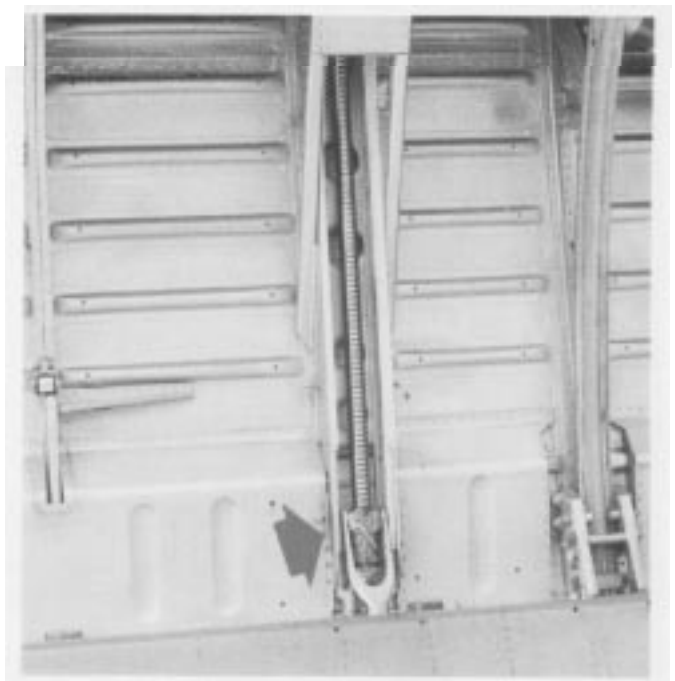
With continued use, jackscrews tend to wear on those surfaces where the shaft rotates inside the ball nuts, as well as in the bumper regions. The normal 50% flap takeoff and 100% flap landing settings will also tend to concentrate wear in these areas. Over time, this will necessitate removal of the jackscrews and their replacement with new, compatible units.

**With continued use, the flap jackscrews tend to wear on the surfaces where the shaft rotates inside the ball nuts.**
