**Stormwater Drain Pipe North  
Segment Debris Removal Report**

Akron, Ohio

Prepared for:  
Lockheed Martin Corporation

Date:  
May 15, 2009

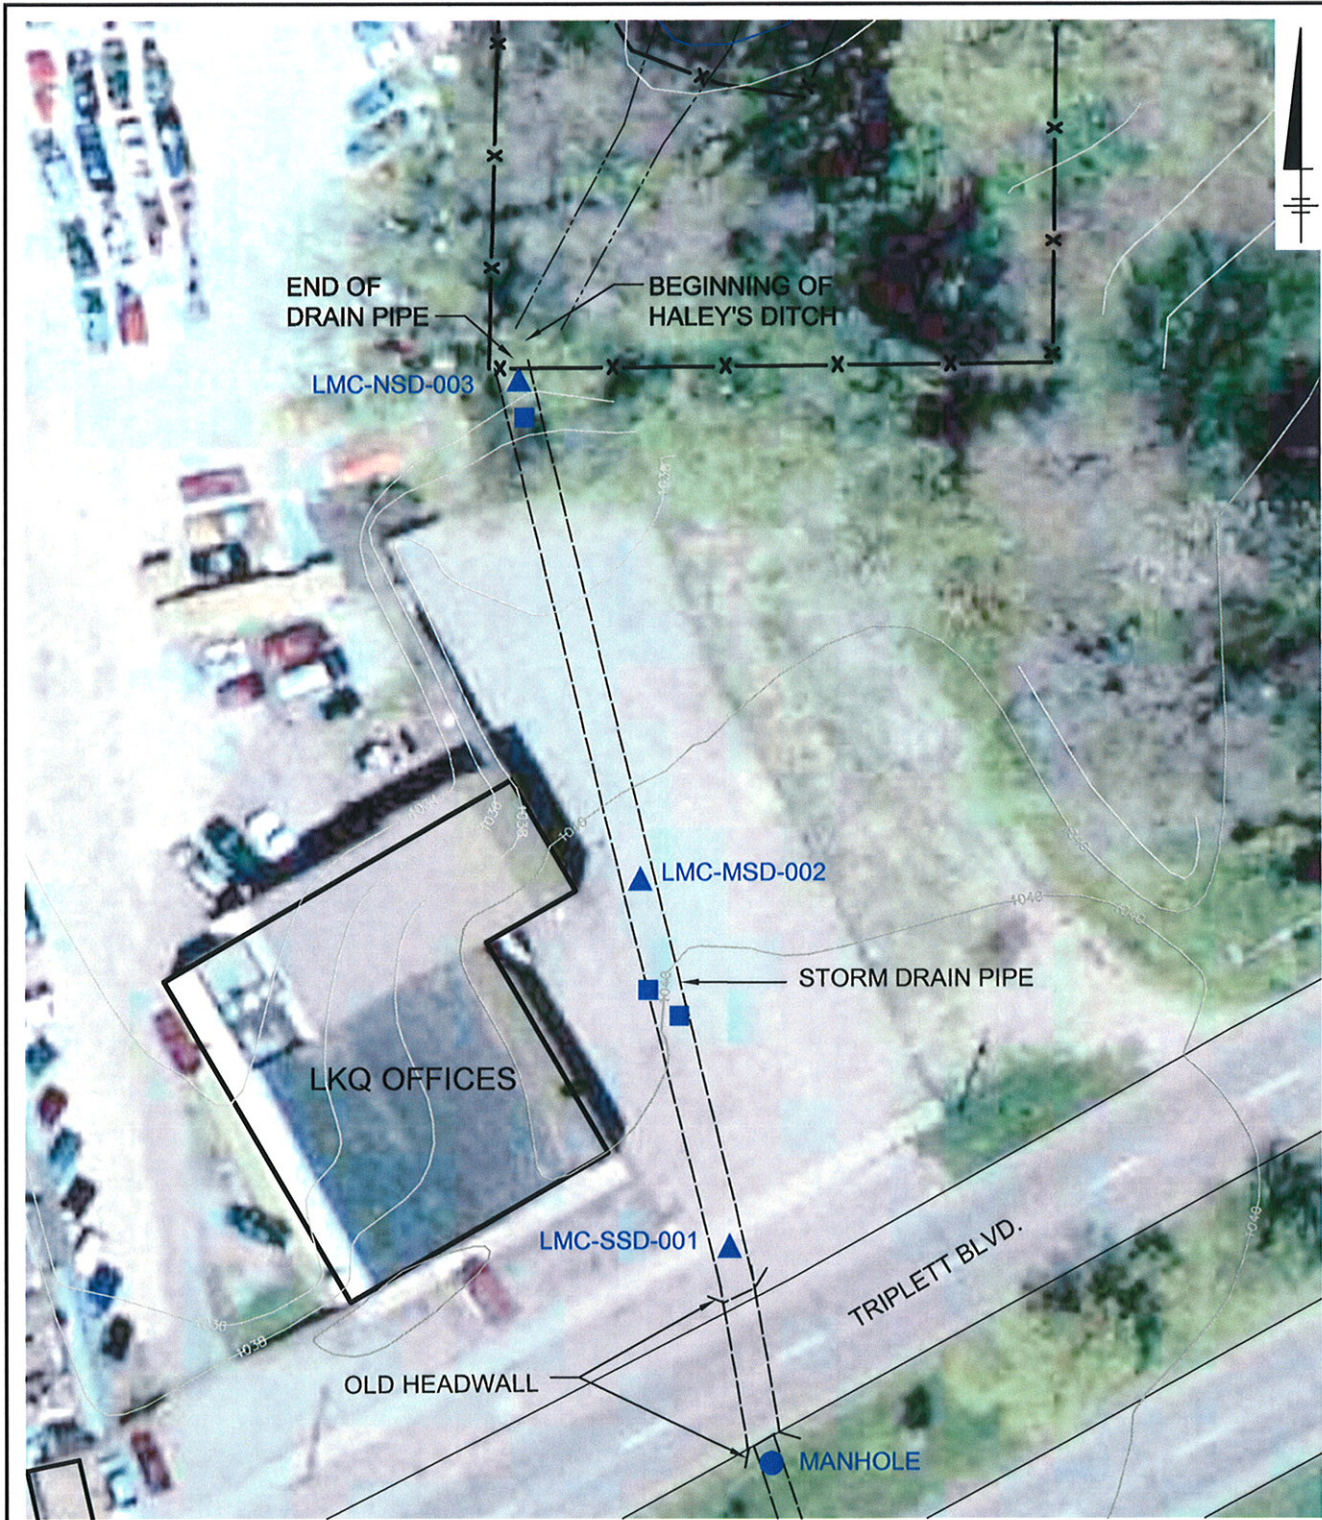
LOCKHEED MARTIN CORPORATION AKRON AIRDOCK FACILITY AKRON, OHIO	
<b>HALEY'S DITCH          STORM DRAIN PIPE          LOCATION MAP</b>	
<b>ARCADIS</b>	FIGURE <b>1</b>

- To test the in-place sediment before removal, three samples were collected: at the south end, middle, and north end of the drain pipe. The samples were tested for total PCB's using USEPA Method SW846 8082. The results of the laboratory analyses are provided in the table below and are shown in Figure 1.

- The steel storm drain pipe was degraded in three areas, such that openings were observed to the fill material surrounding the pipe. These locations are shown on Figure 1. Each of these openings was sealed with concrete.
