SERVICE NEWS

Troubleshooting APQ-122 Radar
The Amazing Hercules

Vol. 5, No. 2, April-June 1978

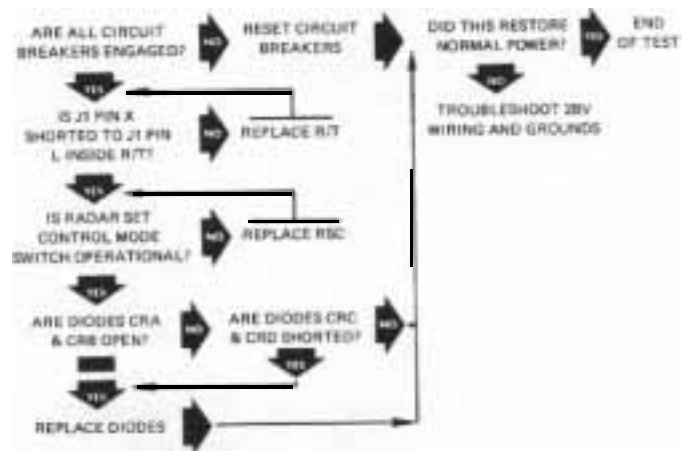
TROUBLESHOOTING CHART 1

Problem: No power to system with mode switch in STBY.

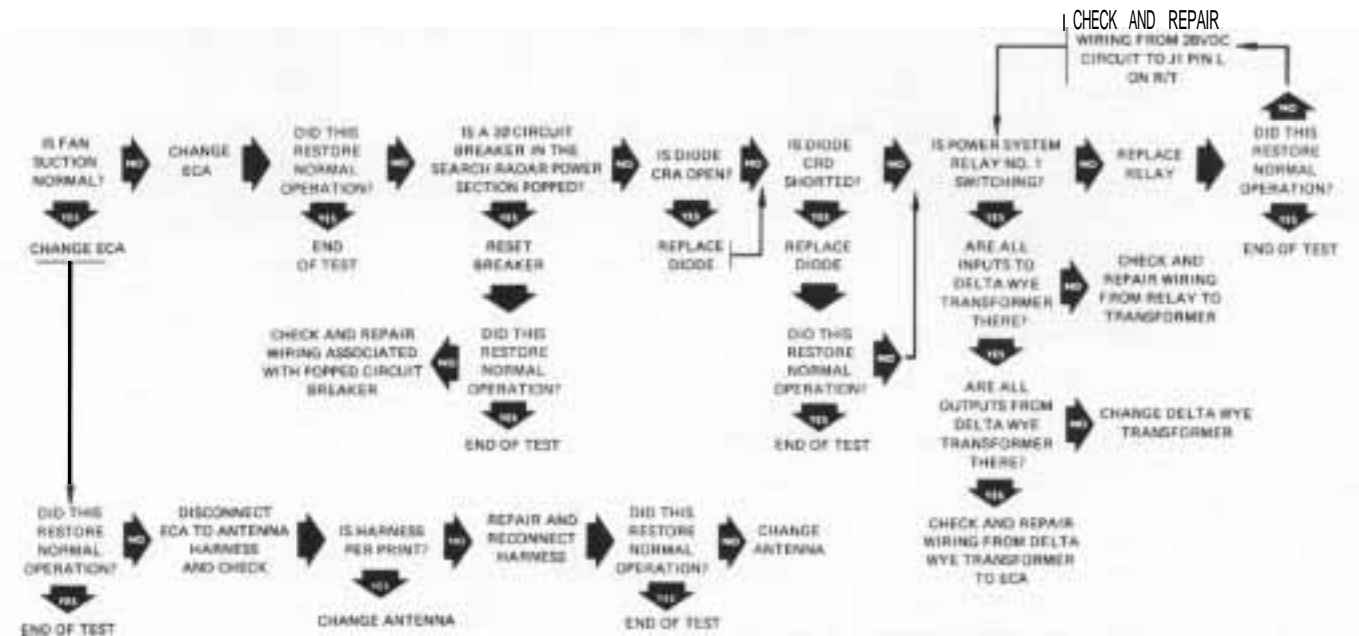
TROUBLESHOOTING CHART 2

This can indicate a loss of phase to the ECA. Make initial check by holding hand at rear of ECA to feel for fan suction.

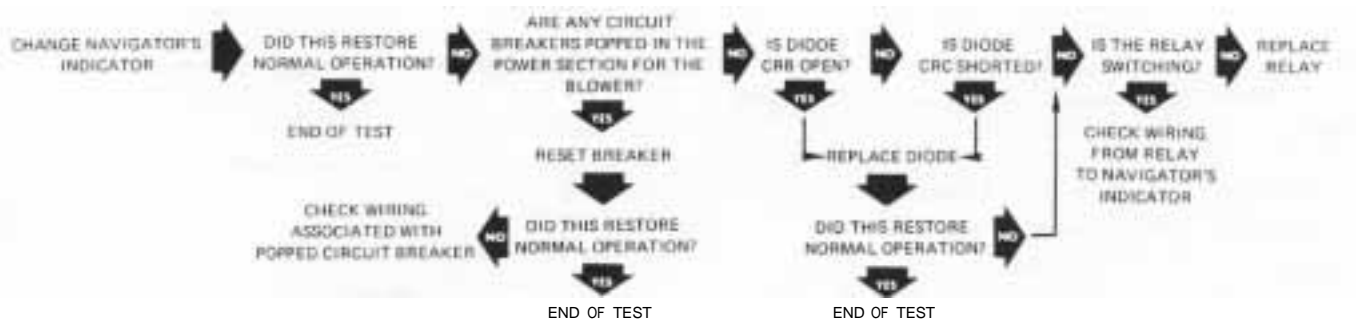
TROUBLESHOOTING CHART 3

Problem: No power to navigator's indicator, indicated by lack of fan noise at navigator's station.

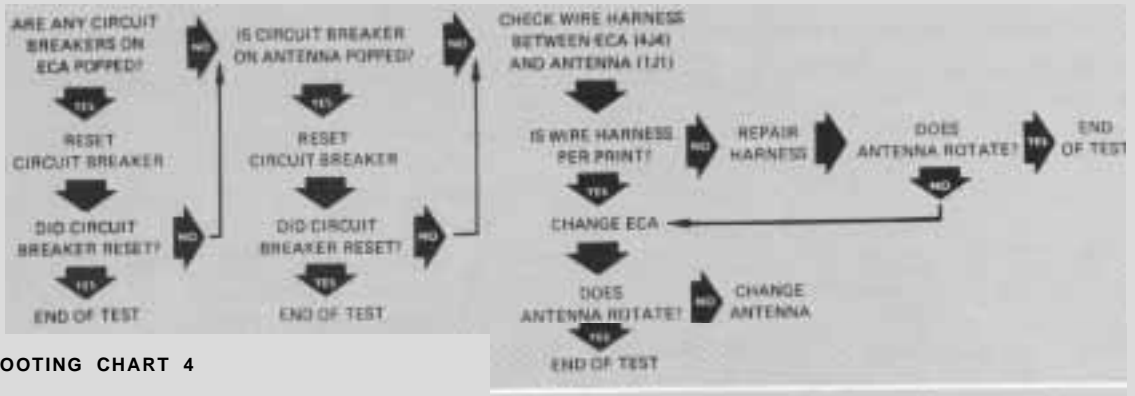
TROUBLESHOOTING CHART 4

Problem: Antenna fail light illuminates and antenna is not rotating.

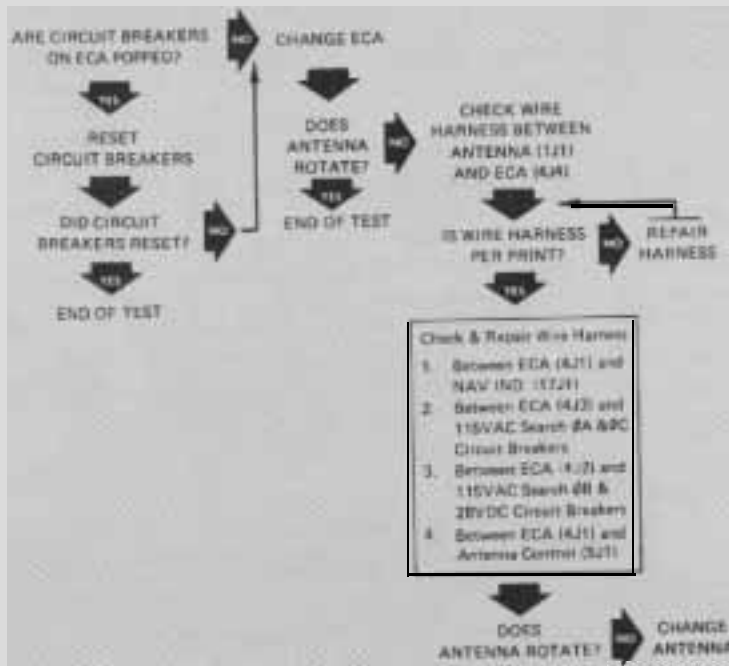
TROUBLESHOOTING CHART 5

Problem: ECA fail light illuminates and antenna is not rotating.

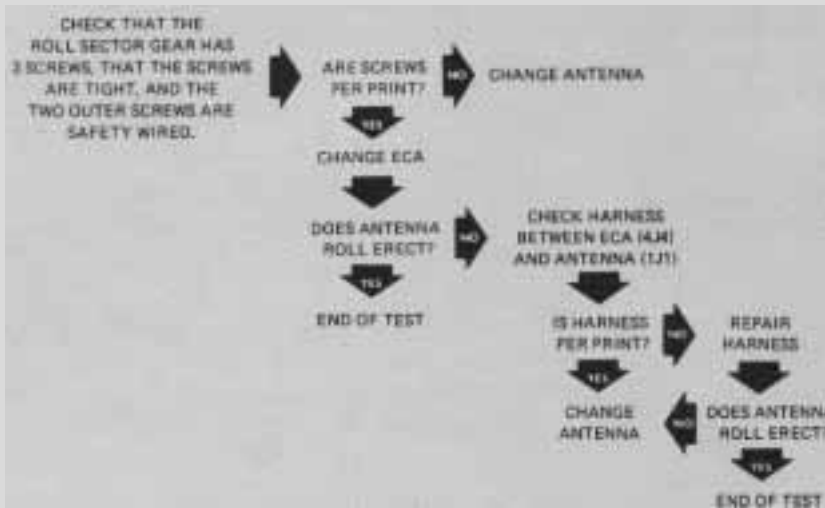
TROUBLESHOOTING CHART 7

Problem: Antenna is not level in the roll axis throughout all positions of the radar stabilization switch,

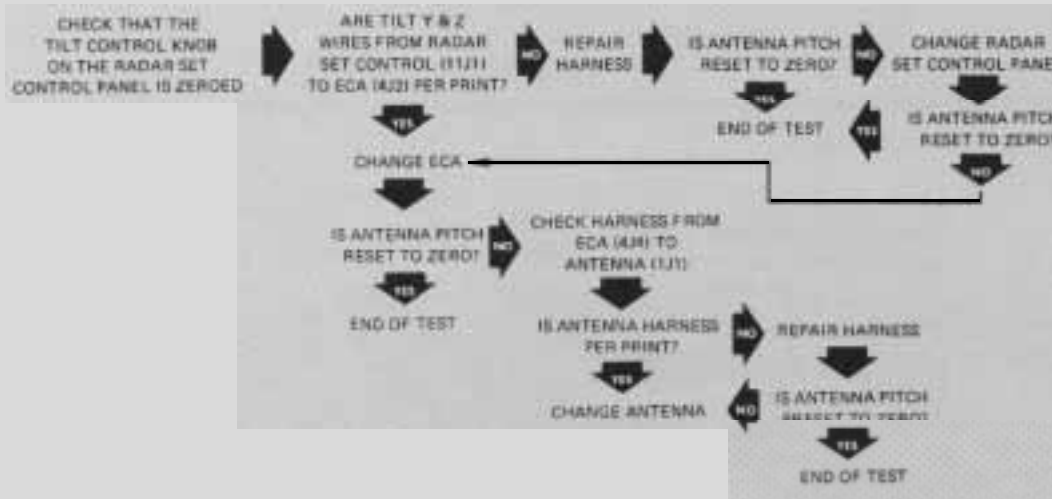
TROUBLESHOOTING CHART 8

Problem: Antenna is inoperable in the tilt axis throughout all positions of the radar stabilization switch.

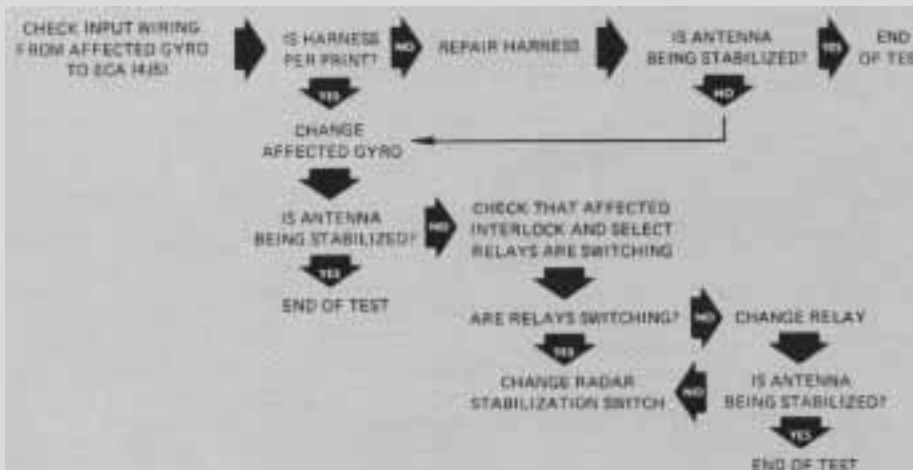
TROUBLESHOOTING CHART 9

Problem: Antenna operates properly in the roll and pitch modes while in the STAB OUT position of the radar stabilization switch, but is inoperable in the GYRO 1 and/or GYRO 2 positions of the switch.

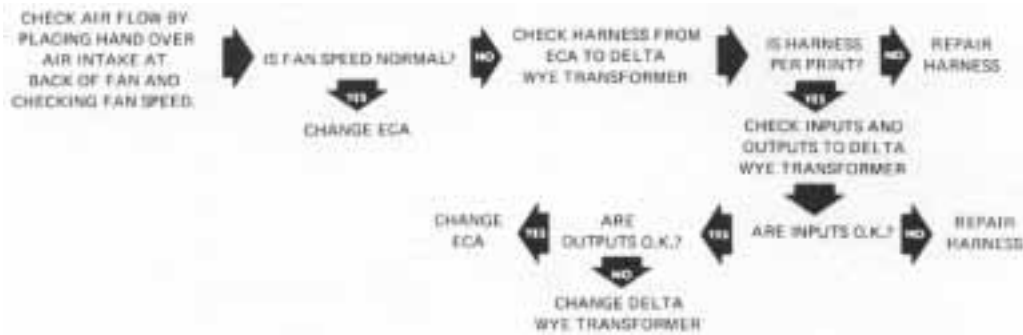
TROUBLESHOOTING CHART 10

Problem: The antenna fail light on the radar set control panel and the ECA fail light on the ECA illuminate but antenna operation is normal.

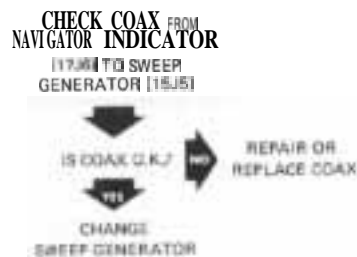
TROUBLESHOOTING CHART 11

Problem: No video on the pilot's indicator. Sweep and range marks are normal.

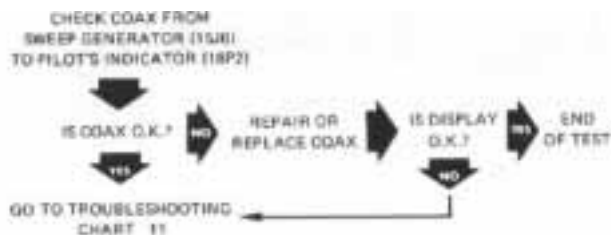
TROUBLESHOOTING CHART 12

Problem: No video or range marks on the pilot's indicator. Sweep is normal.

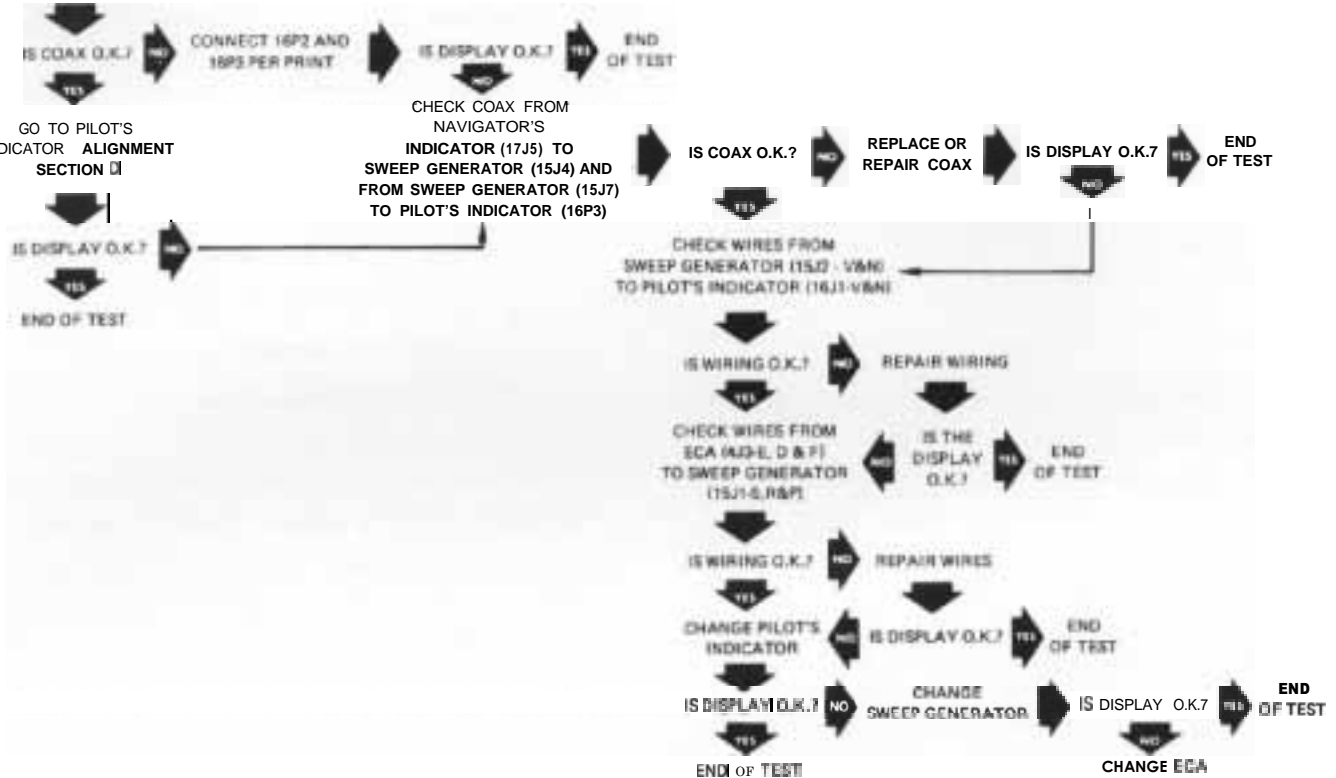
TROUBLESHOOTING CHART 13

Problem: No evidence of sweep but indicator has collimated.

CHECK COAX CONNECTOR
16P2 AND 16P3 ARE
INSTALLED PER PRINT
I.e., Not Crossed)

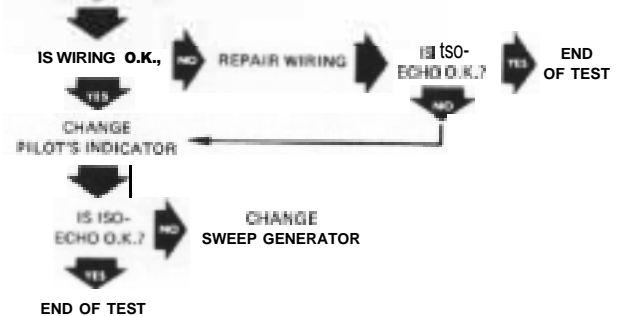
TROUBLESHOOTING CHART 15

Problem: Pilot has no control of iso-echo.

CHECK WIRES FROM
SWEEP GENERATOR
(15J2 - S AND T)
TO PILOT'S INDICATOR
(18P1 - S AND T)

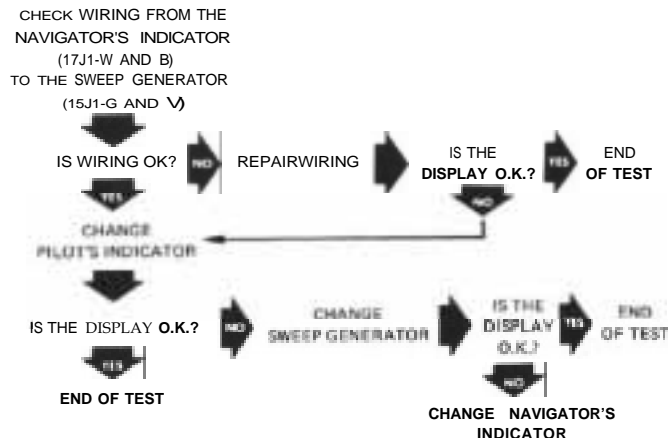
TROUBLESHOOTING CHART 18

Condition (a): AZ STAB switch is in the SLV position. There is no sweep on the pilot's indicator but the navigator's indicator does have sweep.

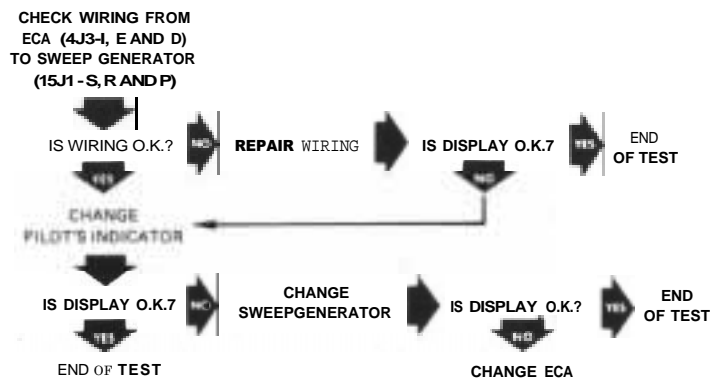
TROUBLESHOOTING CHART 19

Condition (b): AZ STAB switch is in HDG position. There is no sweep on the pilot's indicator, but the navigator's indicator does have sweep.

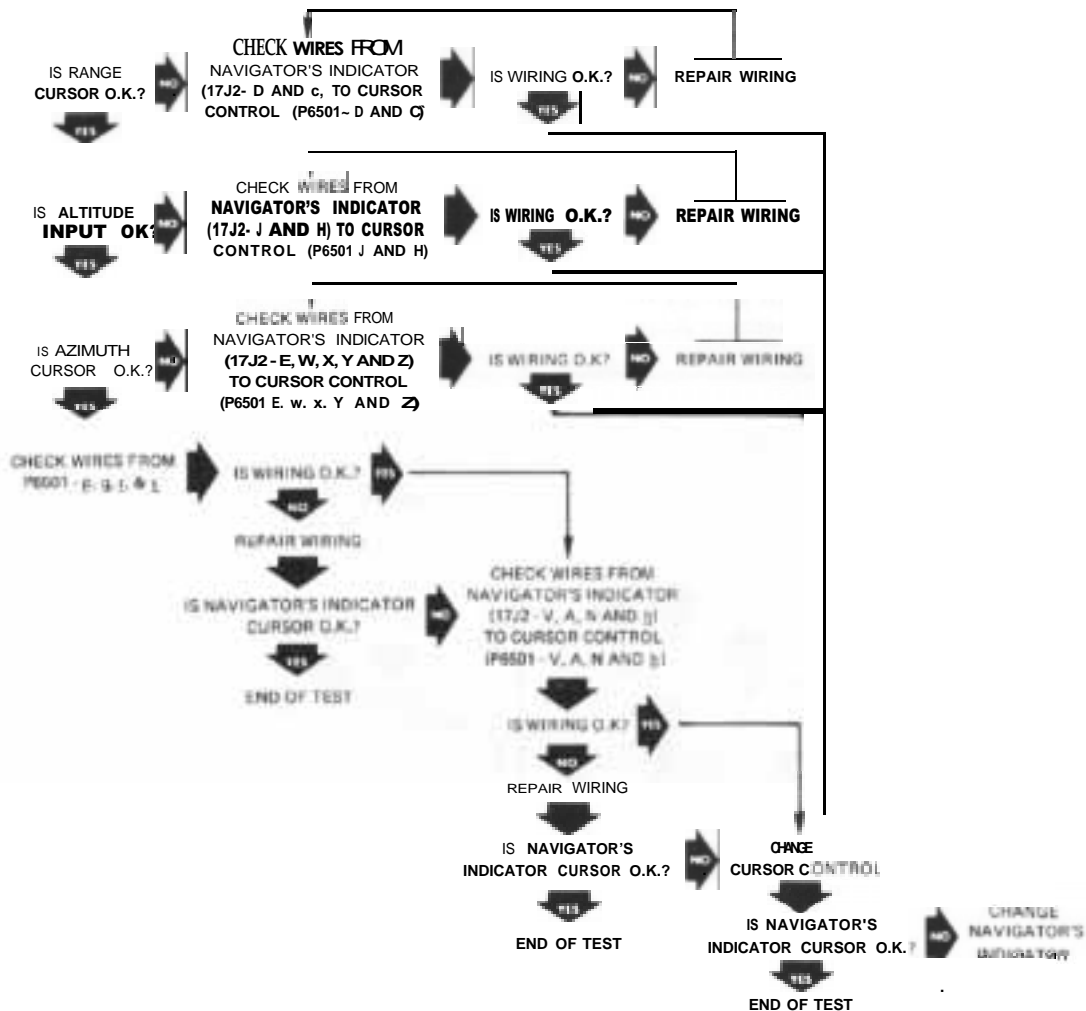
TROUBLESHOOTING CHART 21

Problem: Failure in the cursor mode.

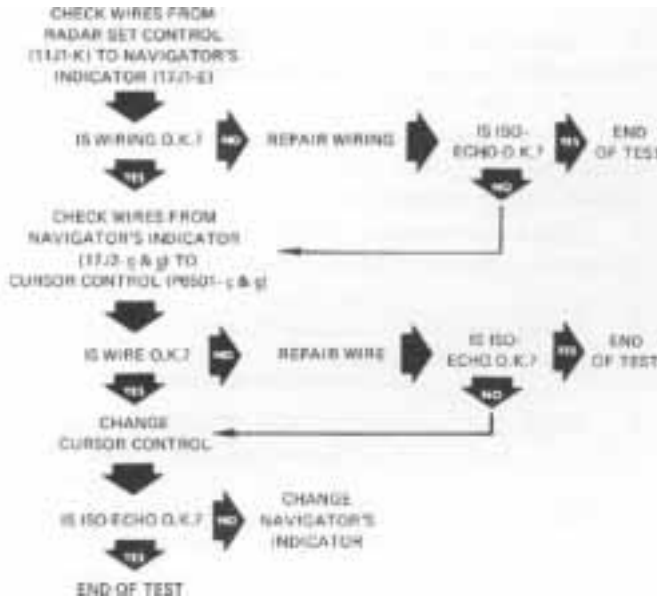
TROUBLESHOOTING CHART 22

Problem: No iso-echo control while operating in the weather mode.

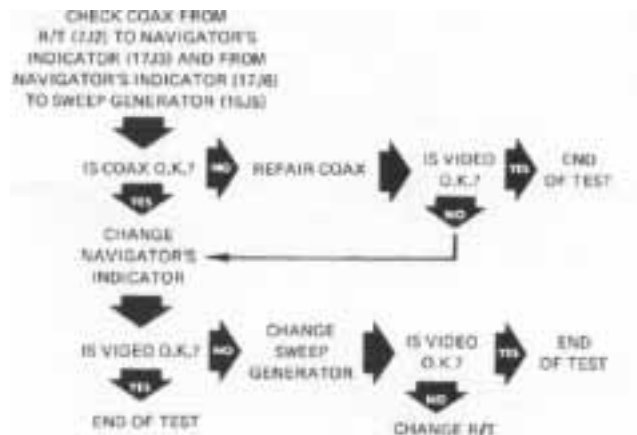
TROUBLESHOOTING CHART 24

Problem: No video on either indicator.

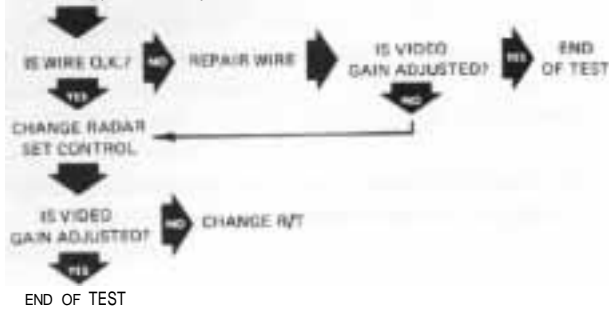
TROUBLESHOOTING CHART 25

Problem: Video at vertex only on both indicators.

CHECK RECEIVER GAIN
WIRE FROM RADAR SET
CONTROL (11J2-j) TO RT (7J1-j)
