VOL. 8, No. 2, APRIL-JUNE 1981

*Lockheed*  
**SERVICE  
NEWS**

**Vol. 8, No. 2, April- June 1981**  
**CONTENTS**

**3 Troubleshooting RPM Fluctuation**  
Understanding and troubleshooting  
the propeller control system.

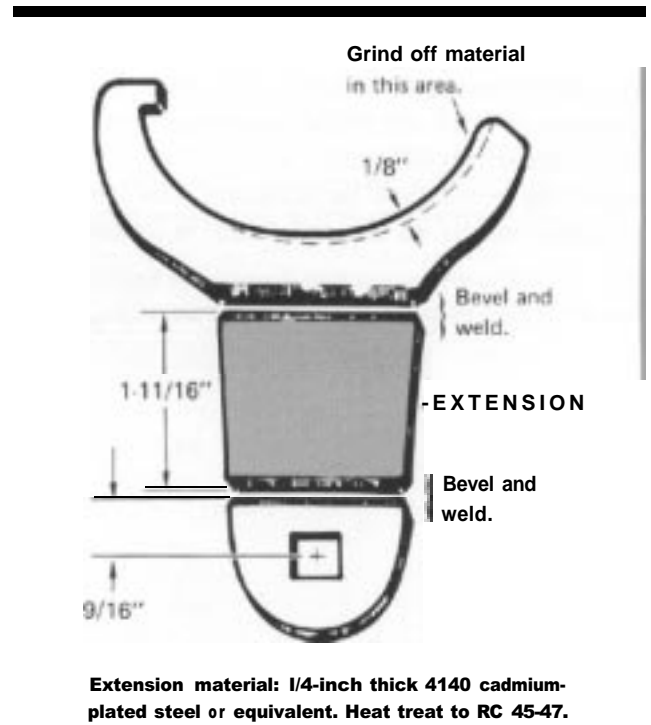
Figure 3. Fabrication details of the modified spanner wrench.
