VOL. 15, NO. 2, APRIL-JUNE 1988

# *SERVICE* *NEWS*

# TROUBLESHOOTING ENGINE OIL LOSS

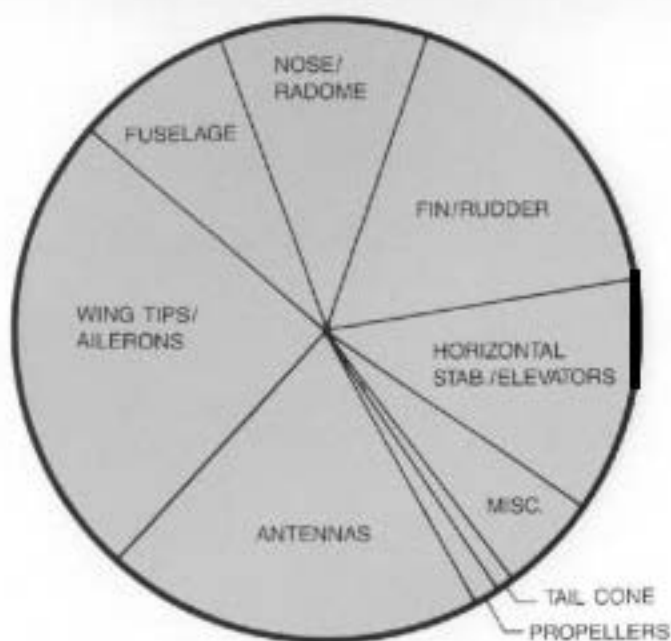
TYPICAL DISTRIBUTION OF LIGHTNING STRIKE LOCATIONS

Pointed structures, such as control surfaces and the tips of propellers, are also vulnerable because of their shape and location. These are the components that are most often damaged by lightning strikes, as shown in the pie chart on page 15.
