# SERVICE NEWS

## ~~NESA WINDOWS UPDATE~~

A SERVICE PUBLICATION OF  
LOCKHEED AERONAUTICAL  
SYSTEMS COMPANY

Vol. 19. No. 3, July-September 1992

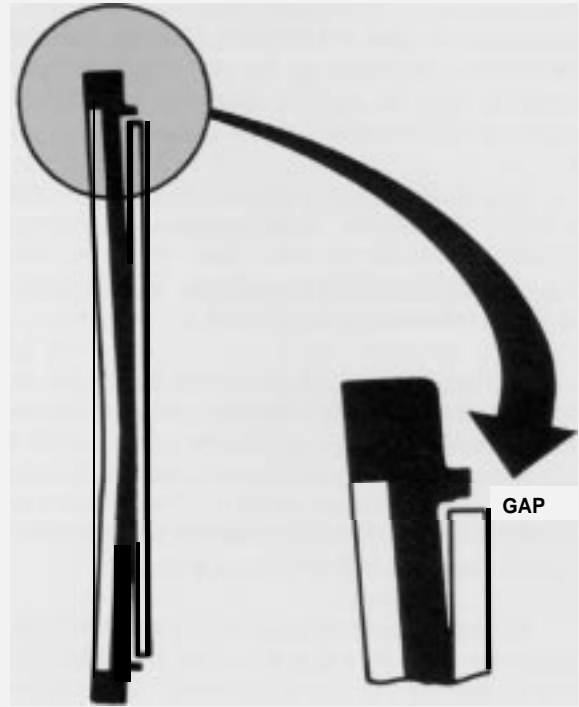
**Figure 70. Gap development caused by pressurization cycles and vinyl shrinkage.**

In many cases where arcing is noted, it is found in the vicinity of the bus bars. The problem can often be traced to an area along the top of the window where the vinyl layer and the outer glass have begun to separate. Separation of the layers allows moisture to enter and cause arcing, which in turn can cause further delamination and deterioration of the window.

Another cause of glass and vinyl separation is hardening of the vinyl with age. The vinyl contains a compound called a plasticizer, which keeps it pliable. The plasticizer tends to evaporate out of the exposed edges of the panel, causing the vinyl to shrink and recede along the edges of the glass.

These potential sources of trouble mean that it is advisable to inspect the edges of the glass periodically for loose, cracked, or weathered sealant. New sealant should be applied as necessary to prevent moisture from entering, even when the windows are not being replaced.
