SERVICE NEWS

VOL. 9, NO. 3, JULY-SEPTEMBER 1982

3 Thermocouples and TIT

Understanding thermocouples and their relationship to engine overtemperature conditions.

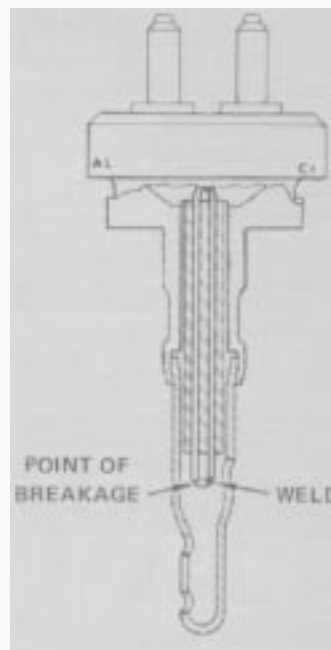
The failure of a thermocouple is an event that has the potential for initiating a whole series of further events, none of them good. Let us first look at what can happen when one or more thermocouples have open circuits. When a thermocouple develops an open circuit, it generally occurs adjacent to the weld point of the two platinum alloys in the sensing element (Figure 4). For the purposes of the following discussion, we shall assume that this has occurred and that both circuits in a thermocouple have failed simultaneously.

Let us also assume that the malfunctioning thermocouple was damaged because of a hot spot in the engine. This implies that the thermocouple that has become inoperable is the one that is located in the hottest part of the engine. The loss of a thermocouple in the hottest part of an engine causes the average temperature signal

Figure 4. Thermocouple (non-air-cooled) with an open sensing element.

sent to the TD amplifier and the TIT indicator to decrease. A reduced temperature signal to the TD amplifier no longer satisfies the reference signal, so more fuel is allowed to go to the fuel nozzles. This increased flow raises the turbine inlet temperature. The fuel flow will continue to increase until the reference signal is matched by the signal from the remaining thermocouples. Once this has occurred, the TD system will regard the situation as normal and the flight station TIT indicator will display a normal temperature reading. But the situation is not normal. The apparent restoration of normal operation after the loss of the thermocouple has been accomplished at the cost of increasing the actual TIT.

If thermocouples continue to fail more or less sequentially in order of exposure to highest temperature, it is obvious that the engine can operate at ever-increasing actual TIT while normal indications continue to be displayed on the TIT indicator. The true TIT can increase as much as 3.5 degrees C as each succeeding thermocouple fails. Thus with five open thermocouples, a normal reading of 1077 degrees C might be indicated during takeoff roll in an aircraft equipped with T56-A-15 engines, but the true TIT could be in the neighborhood of 1095 degrees C. Such exposure to excessive operating temperatures is very hard on engine components and will result in shortened service life.

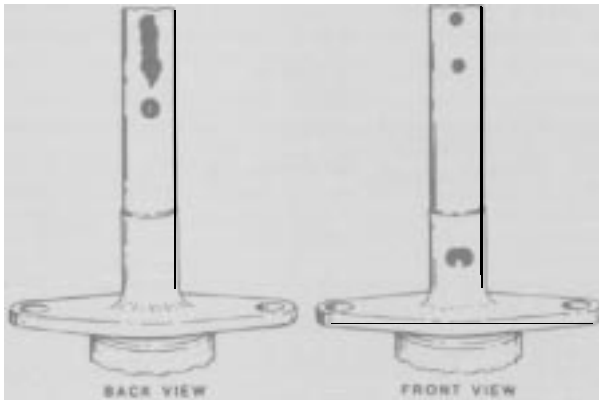
A different thermocouple problem affects mainly air-cooled thermocouples. This is erosion of the probe tip aft wall, and it has more serious possible consequences than an open-circuit condition. In this case, a hole is

eroded in the downstream side of the thermocouple probe tip (Figure 5). but the two sensing elements remain intact. This kind of damage destroys the ability of the thermocouple to measure the temperature of the gas stream accurately. The result is an erroneous signal that will be averaged into the temperature readings being passed along to the TD amplifier and the flight station TIT indicator.

Figure 5. Front and rear view of an air-cooled thermocouple with probe tip aft wall erosion.

Each thermocouple damaged in this way will cause the signal to be approximately 7.5 degrees too low. Since

the TIT signal will now be below the reference signal, the TD amplifier will initiate an increase in the fuel flow to raise the average TIT signal to satisfy the reference signal. When the system stabilizes, the real TIT will be 7.5 degrees C above the indicated value. Again we have an overtemperature condition, but in this case one of greater magnitude. Multiple failures of this type will compound the problem.

When the probe tip aft wall is eroded away, the gas-sampling function of the probe is upset. The combustion gases are not properly mixed and are not directed over the sensor elements before they escape through the downstream side of the thermocouple. This yields a temperature signal that is lower than normal.

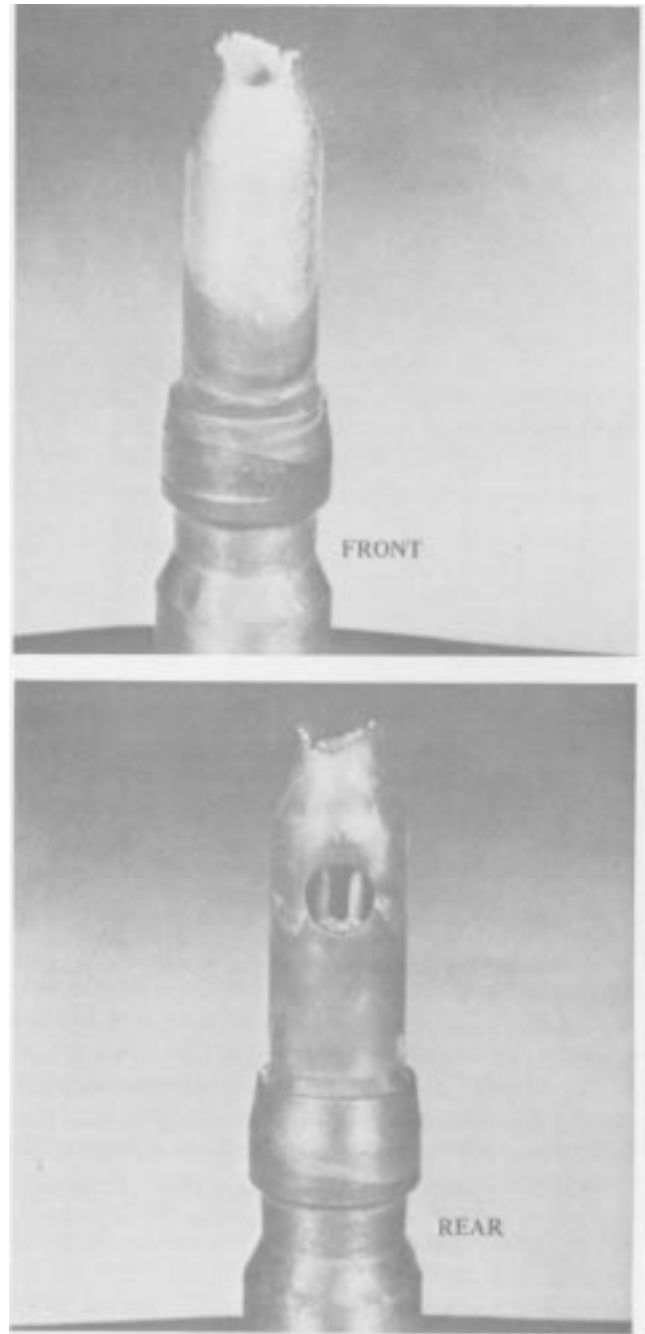
The last thermocouple problem we shall discuss in this presentation concerns non-air-cooled thermocouples with missing probe tips. This is potentially the most serious condition of all from the standpoint of the possible effects on the TD control system. In this case, the probe tip is completely missing from the affected thermocouple, but again, the two sensing elements remain intact (Figure 7).

In addition to whatever foreign object damage the separated probe tip may inflict on its way through the turbine, the presence in the system of a thermocouple without a probe tip has a marked effect on the average temperature signal being received by the TD amplifier and the TIT indicator. Each missing probe tip will cause the average temperature reading to be about 22 degrees C too low. Here again, since the TIT signal will then be below the reference signal, the TD amplifier will call for additional fuel to raise the average TIT signal to match the value of the reference signal. The result is a severe overtemperature condition, one much worse than any of those previously described.

When a thermocouple probe tip is missing, the ability of the probe to perform its vital gas-sampling function is completely lost. The gas sample cannot be obtained from deep within the gas flow where the temperatures are highest. Instead, the sensing elements are exposed to the relatively cool environment at the periphery of the combustion gas path. This means that the affected thermocouple will introduce an excessively low gas temperature signal into the system, with serious consequences for the operation of the engine.

Figure 7. Front and rear view of a non-air-cooled thermocouple with probe tip missing.

couple with a missing tip introduces an error that results in the average TIT signal being 22 degrees C below the true temperature. Since the error is cumulative and there are three thermocouples with missing tips, the indicated TIT for this engine is going to be approximately 66 degrees C below the real value. Figure 8 shows the correlation between the indicated and actual TIT of an engine that has one or more thermocouple probe tips missing. This means that at an indicated takeoff TIT of 971 degrees C, the actual TIT would be 1037 degrees C. Even at the maximum continuous permissible TIT of 932 degrees C indicated, the true TIT would exceed that of takeoff TIT, which is

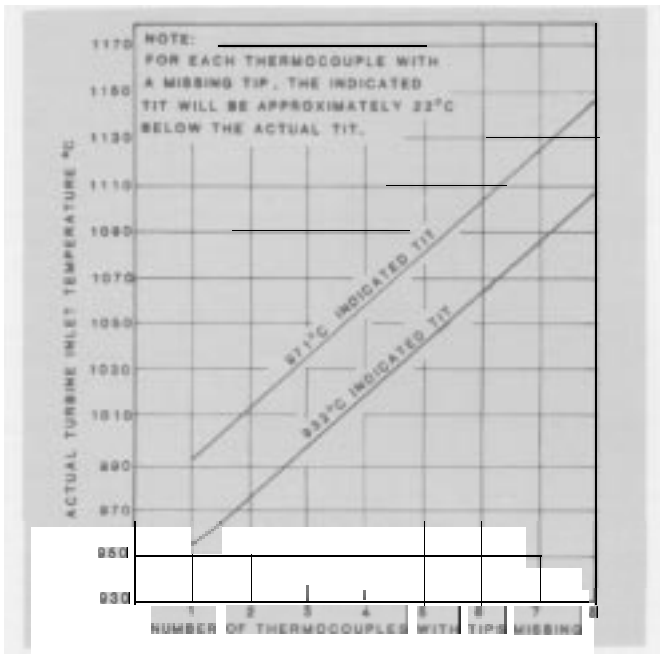
To gain an appreciation of just how serious the impact of lost thermocouple probe tips can be, let us assume that we are operating a T56-A-7 engine that is performing properly except that three of its thermocouples have missing probe tips. Remember that each thermo-

Figure 8. Indicated and actual TIT in a 501 -D22/T56-A-7 engine with one or more thermocouple probe tips missing.

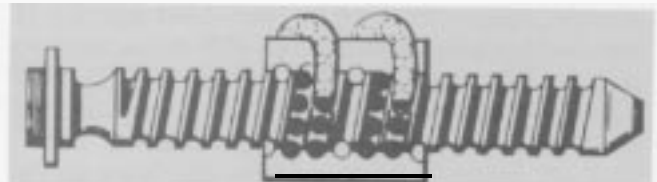
In order to ensure proper extension and retraction of the C-130 main landing gear, the ballscrews should be inspected frequently for cleanliness, condition, and adequate lubrication. Most reported cases of binding gear have been corrected by cleaning and lubricating the ballscrews in conjunction with cleaning the tracks. If an inspection discloses rough areas on the ball thread, there may be problems inside the ball nut. Foreign matter such as dirt or grit may be present inside the nut, and the recirculating balls inside the nut may be damaged (Figure 2).

Figure 2. Cross-sectional view of ball nut (typical).

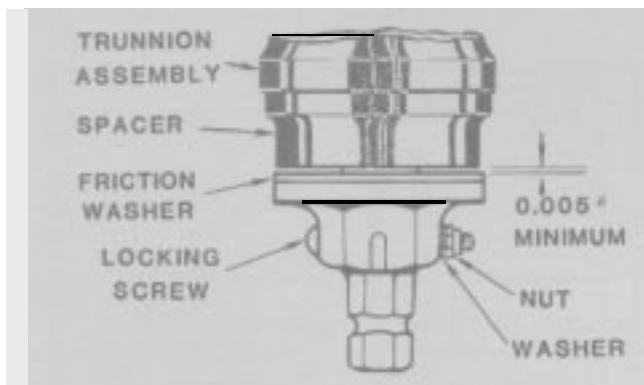
Insufficient clearance between the main landing gear friction washer and the spacer located next to the trunnion assembly will prevent gear retraction. The minimum clearance between the washer and the spacer is 0.005 inch. If the clearance is 0.005 inch and the locking bolt hole in the ballscrew is not aligned with a locking slot, the adjusting nut should be backed off (counterclockwise) to the nearest slot on the nut that will align with this bolt hole. A new locking screw, washer, and self-locking nut should be installed (Figure 3). The nut on the locking screw should be tightened to a torque value of 12 to 15 inch-pounds.

Figure 3. Lower portion of ballscrew assembly, showing friction washer to spacer clearance and locking screw.
