SERVICE NEWS

A Service Publication of Lockheed Aeronautical Systems Company

Mark II GPWS

Vol.1 7, No.3, July-September 1990

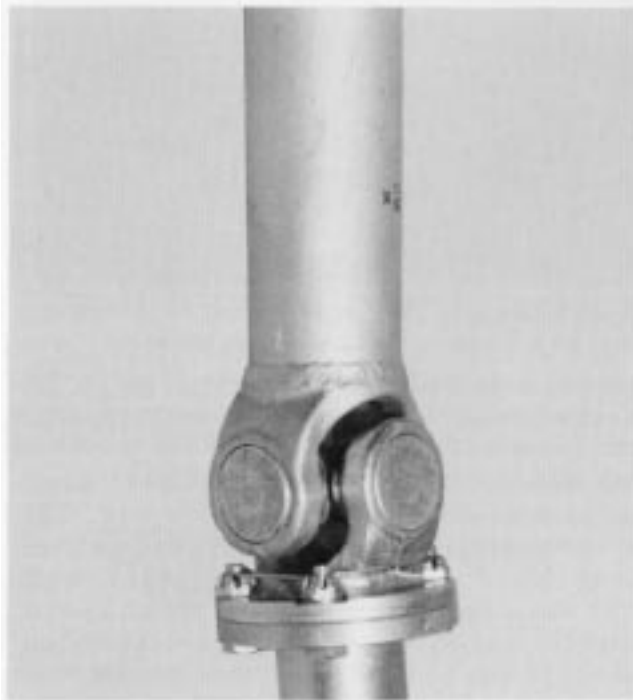
MLG torque shaft lower universal joint, typical of airplanes built prior to LAC 5162. Note the bolted coupling.

Aircraft built prior to Lockheed serial number LAC 5162 were equipped with PN 8372-MI, PN 8372, PN 69757943, or similar MLG vertical torque shafts. In these designs, the universal joint companion flanges are connected

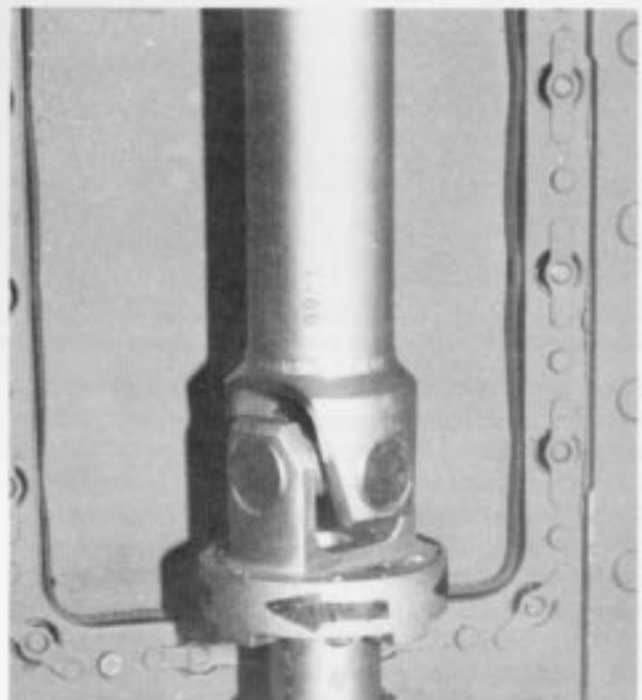
LAC 5162 end subsequent Hercules aircraft are equipped with quick-disconnect couplings at these locations.

by four bolts. LAC 5162 and subsequent aircraft use PN 8372442 at these locations. The vertical torque shaft lower companion flanges in this case are connected by a single, knurled, quick-disconnect coupling.
