Akron Airdock PCB Exterior Remediation Strategy

June 22, 2007

Lockheed Martin Corporation
1210 Massillon Road
Akron, Ohio 44315

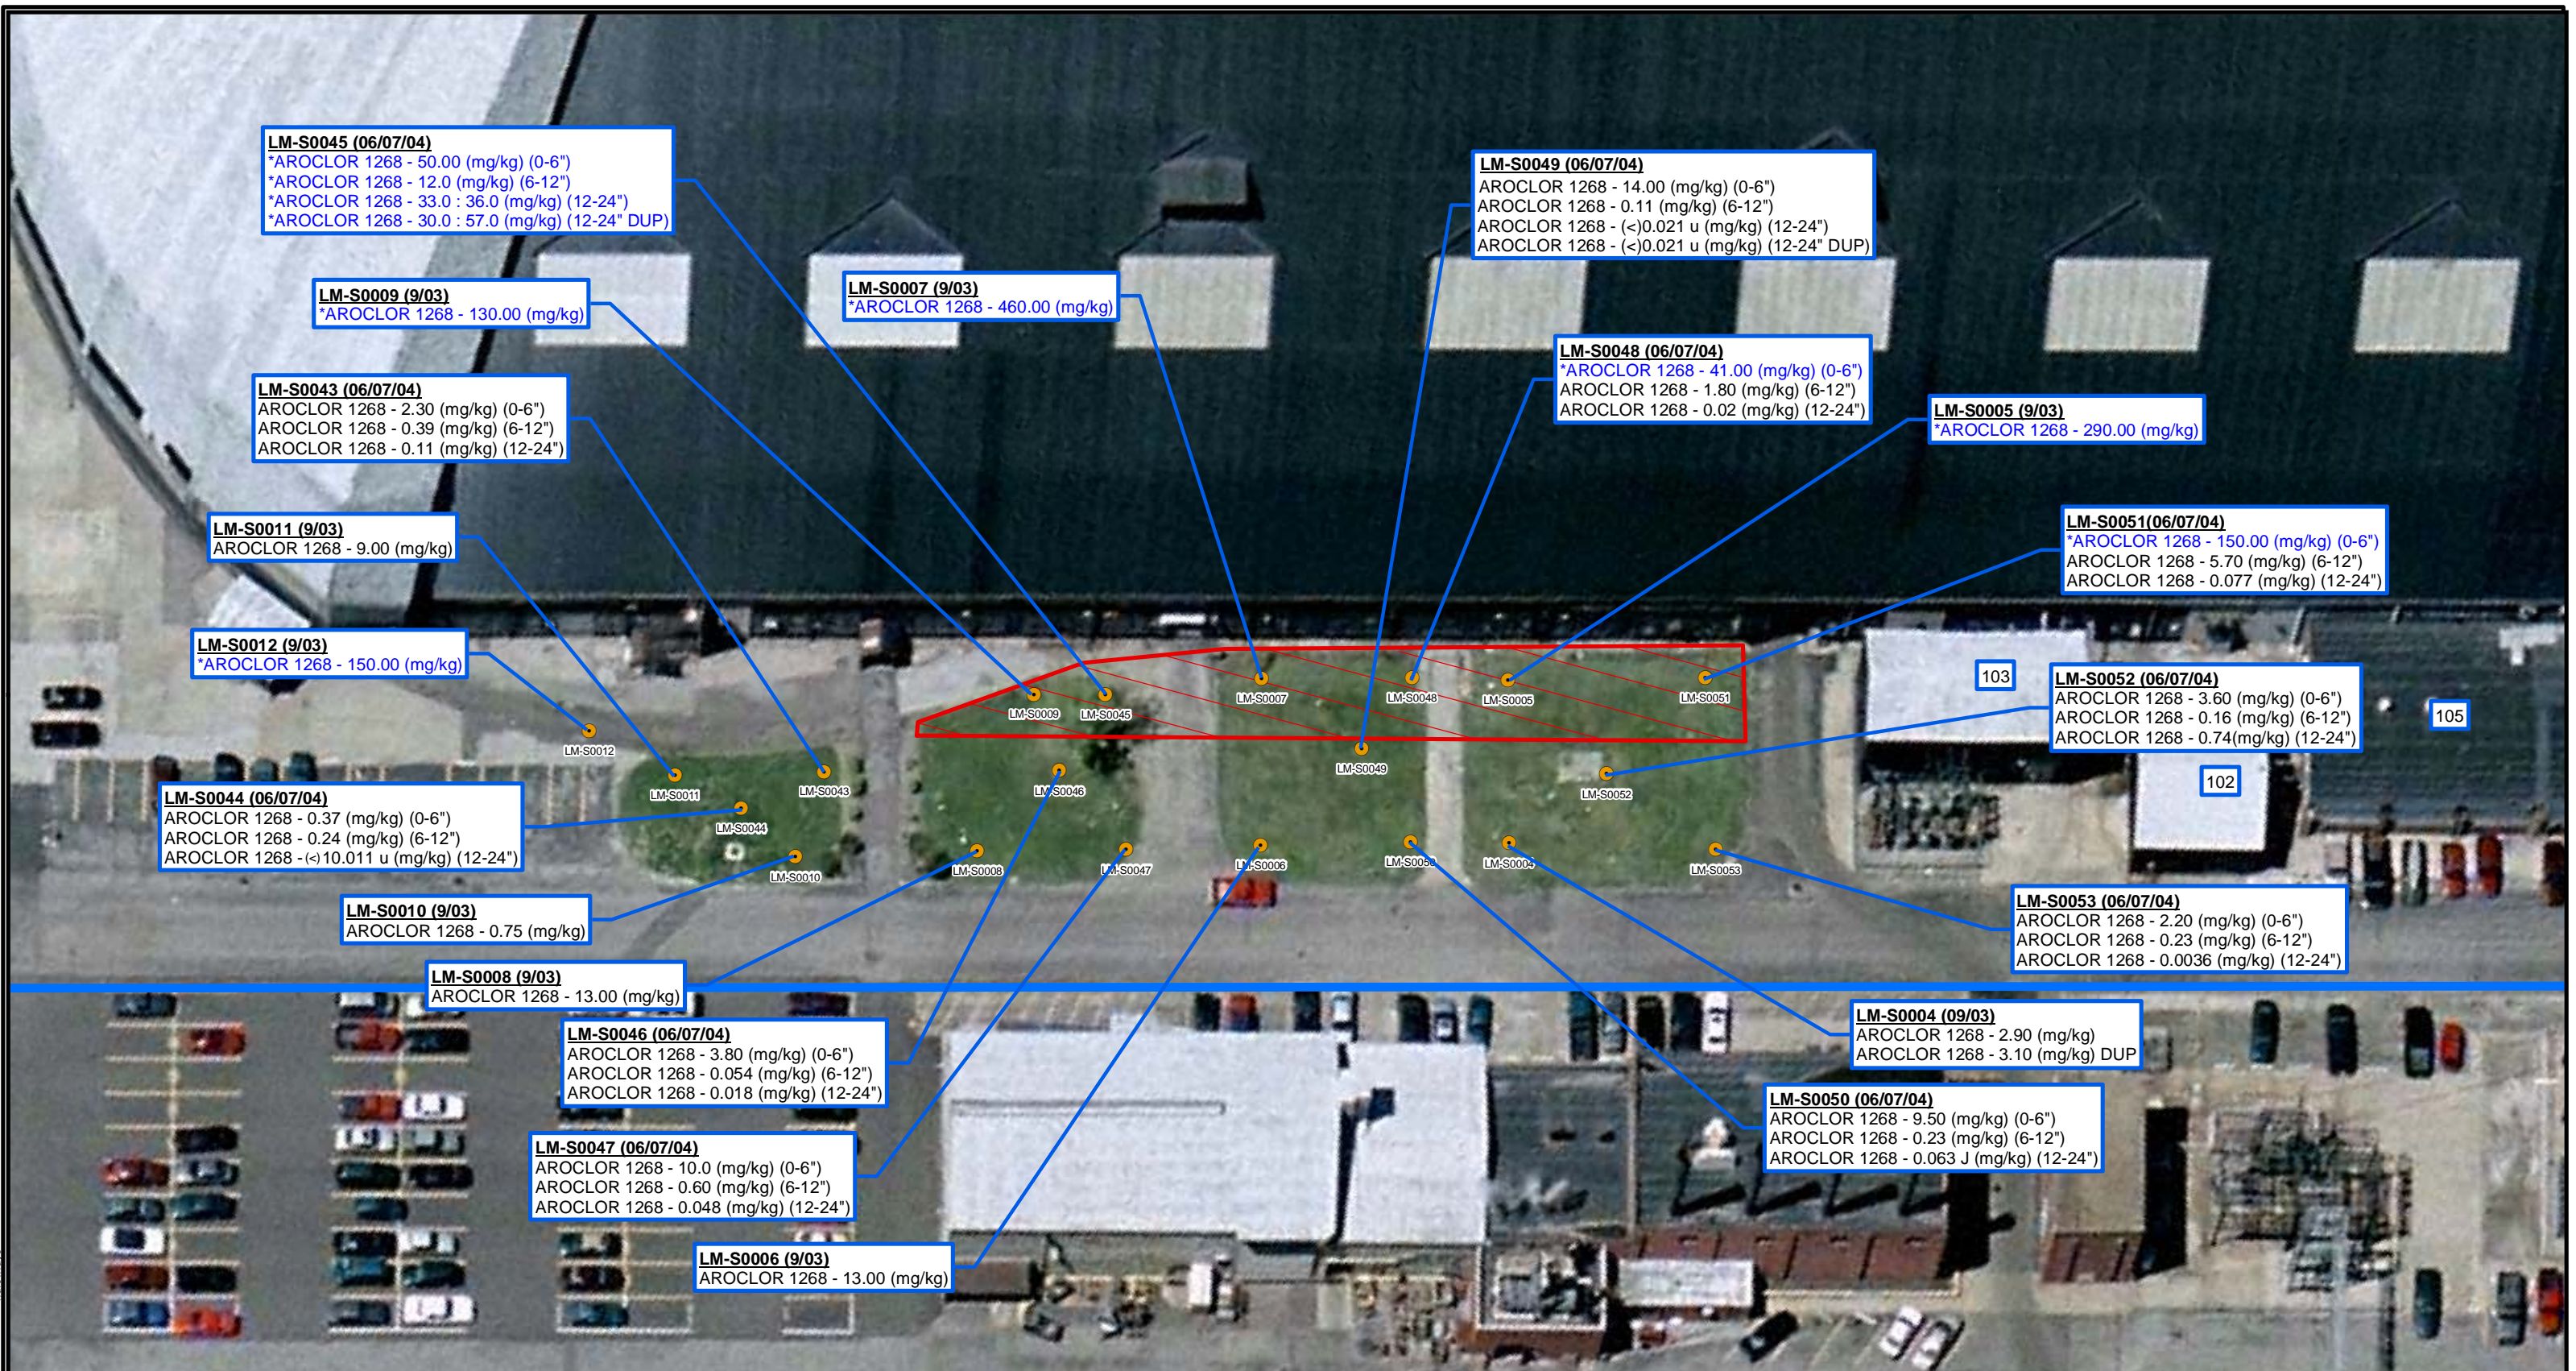
A soil removal action will occur in the grassy area directly outside the southeastern area of the Airdock (Figure 3) and from an isolated area below pavement on the northwest corner of the Airdock (designated with the box labeled F1 on Figure 2). Soil samples have been collected from 20 locations at different depth intervals and analyzed for PCBs, including Aroclor 1268. The sampling and analysis data show that PCB concentrations in soil decline rapidly with depth and distance away from the building, a pattern consistent with the non-mobility of the chemical.

LM-S0045 (06/07/04)
 *AROCLOR 1268 - 50.00 (mg/kg) (0-6")
 *AROCLOR 1268 - 12.0 (mg/kg) (6-12")
 *AROCLOR 1268 - 33.0 : 36.0 (mg/kg) (12-24")
 *AROCLOR 1268 - 30.0 : 57.0 (mg/kg) (12-24" DUP)

LM-S0049 (06/07/04)
 AROCLOR 1268 - 14.00 (mg/kg) (0-6")
 AROCLOR 1268 - 0.11 (mg/kg) (6-12")
 AROCLOR 1268 - (<)0.021 u (mg/kg) (12-24")
 AROCLOR 1268 - (<)0.021 u (mg/kg) (12-24" DUP)

The property-specific risk assessment (Tetra Tech 2007) demonstrates that removal of soil with PCBs from the 250- by 25-foot area and from isolated hot spot SC-8 will meet risk and hazard goals under the VAP, and consequently meet a risk-based cleanup approach under §761.61(c). Confirmatory soil samples will be collected from the excavated areas upon completion of the soil removal action in the Southeast Area and SC-8 Hot Spot area to confirm that the average PCB levels in soil meet the risk and hazard goals. Details of the risk analysis will be submitted in the risk-based approval request submitted to EPA during the third quarter of 2007.

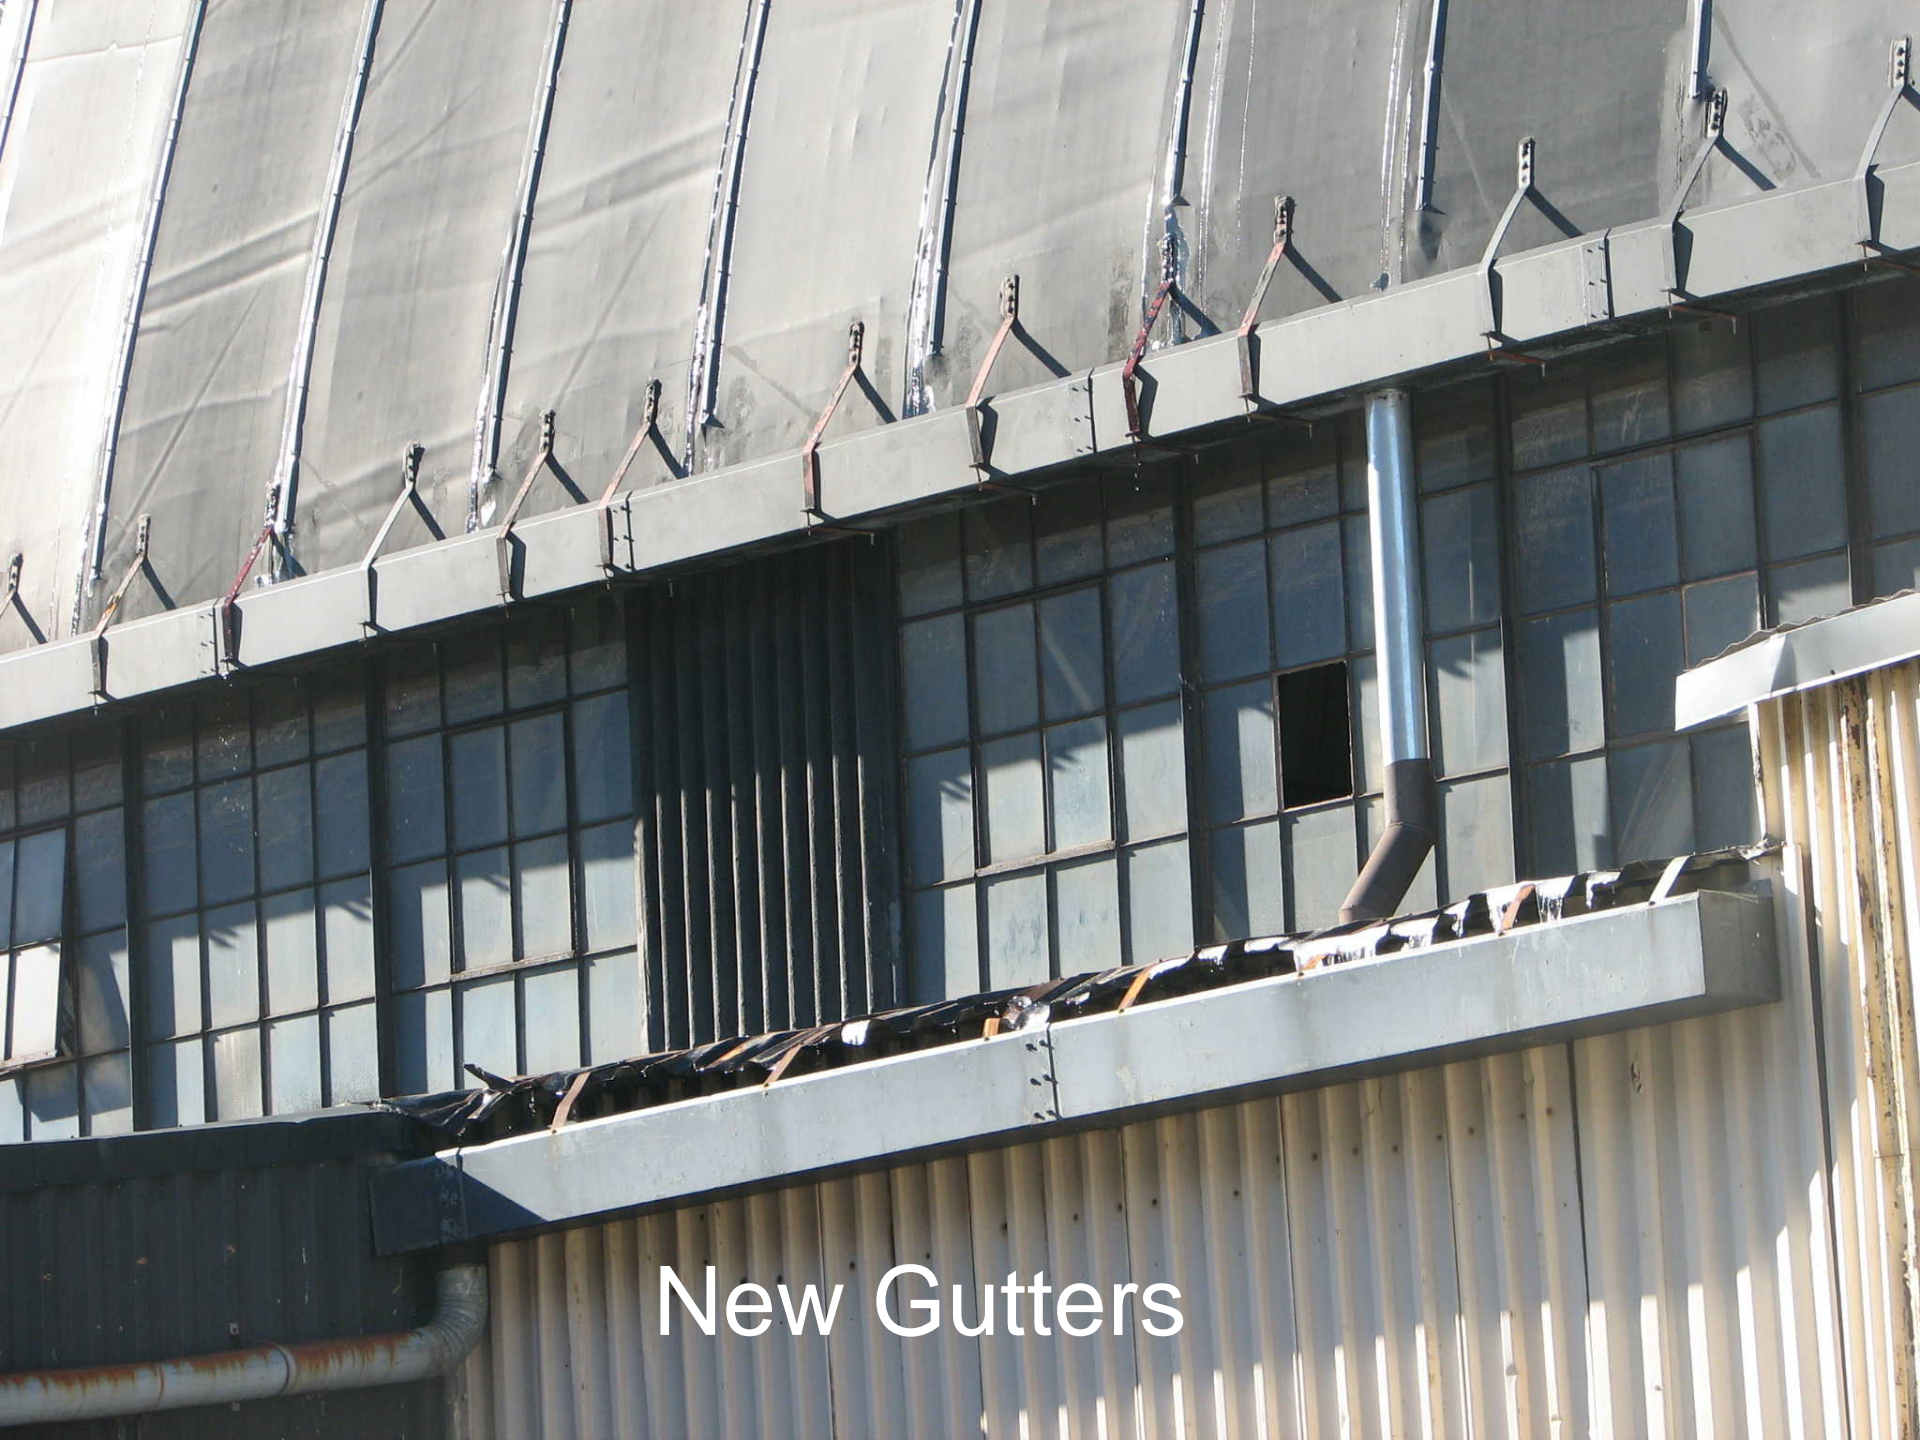
New Gutters

The Airdock gutters and downspouts needed repair to prevent rainwater from washing down the vertical siding and windows. Replacement of the west side and east side gutter and downspout systems was completed in 2005. All removed gutters, downspouts, and associated debris were disposed of as PCB waste in accordance with 40 CFR 761.61(b).

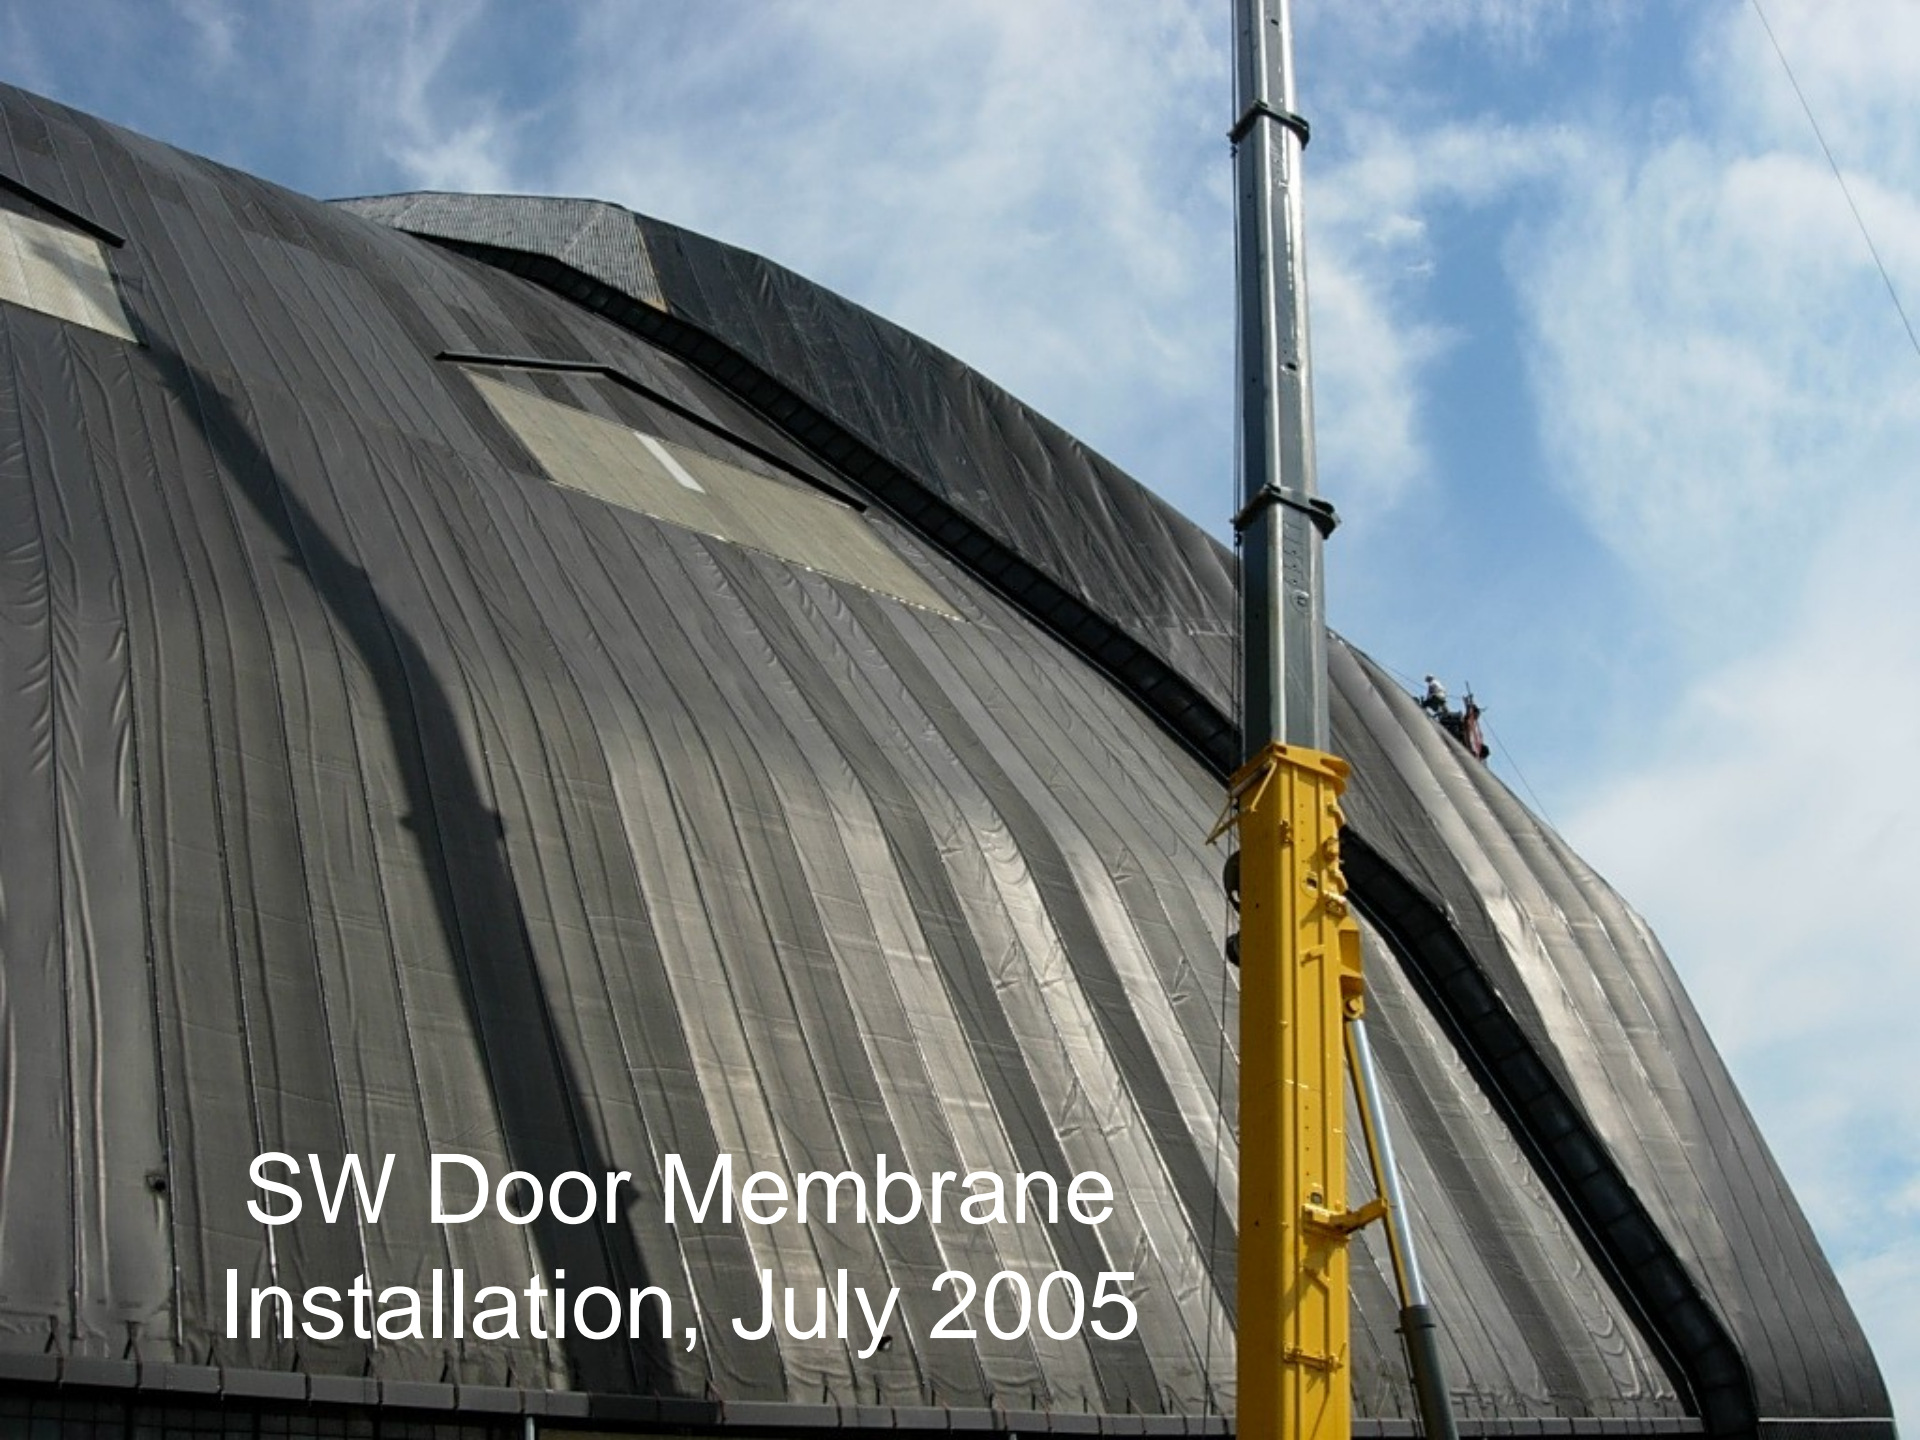
SW Door Membrane
Installation, July 2005

Except for the four doors covered with foam since 1985, the roof has been encapsulated with a rolled rubber membrane, completed in 2005. In 2005, the rolled rubber membrane material was applied over the four doors, including the rear-facing lip of each door. A portion of the northeast door rear lip was damaged in 2006; repairs to this area are being completed during the second quarter of 2007.

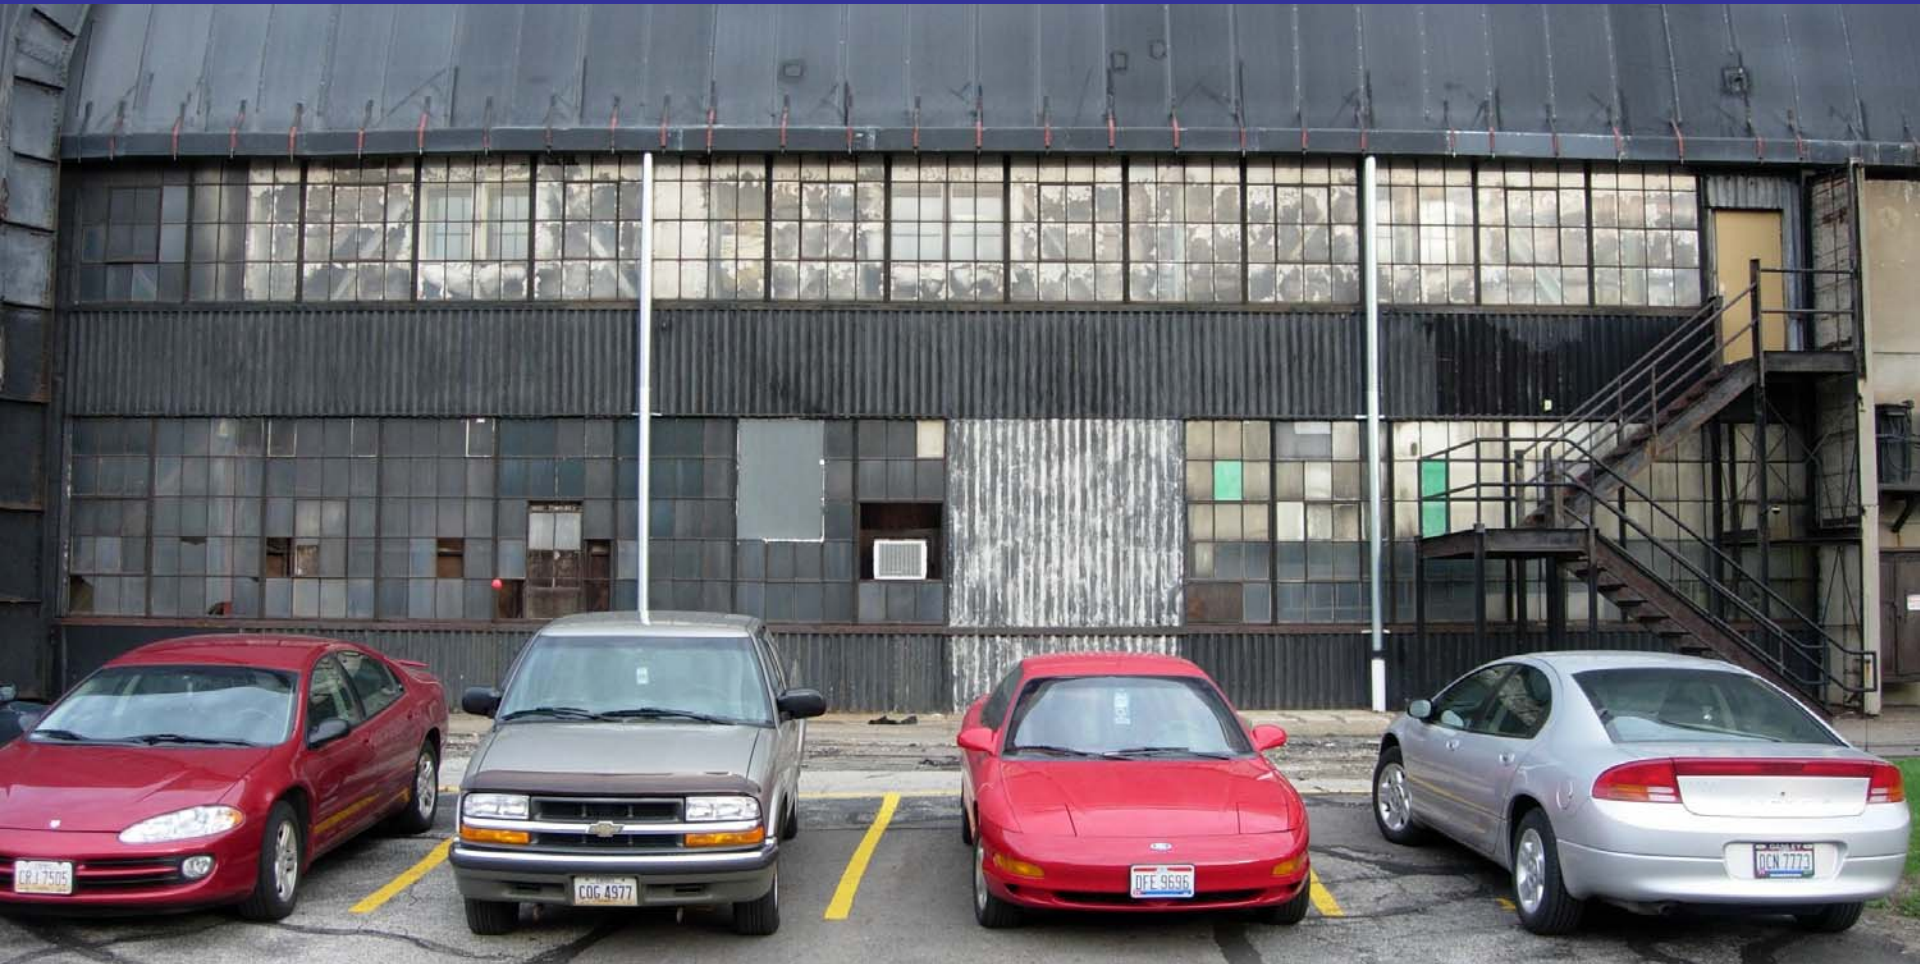
1E-2E, April 2004

The RPM material consists of five components: steel sheet metal, asphalt, asbestos felt, bitumen (impregnated with a fire-retardant, Aroclor 1268), and aluminum paint. Exfoliation of the RPM coating over time apparently resulted from the following factors: asphalt and steel with mismatched coefficients of thermal expansion, significant asphalt oxidation, dryness from more than 75 years of aging, and seasonal temperature fluctuations.

Original Siding

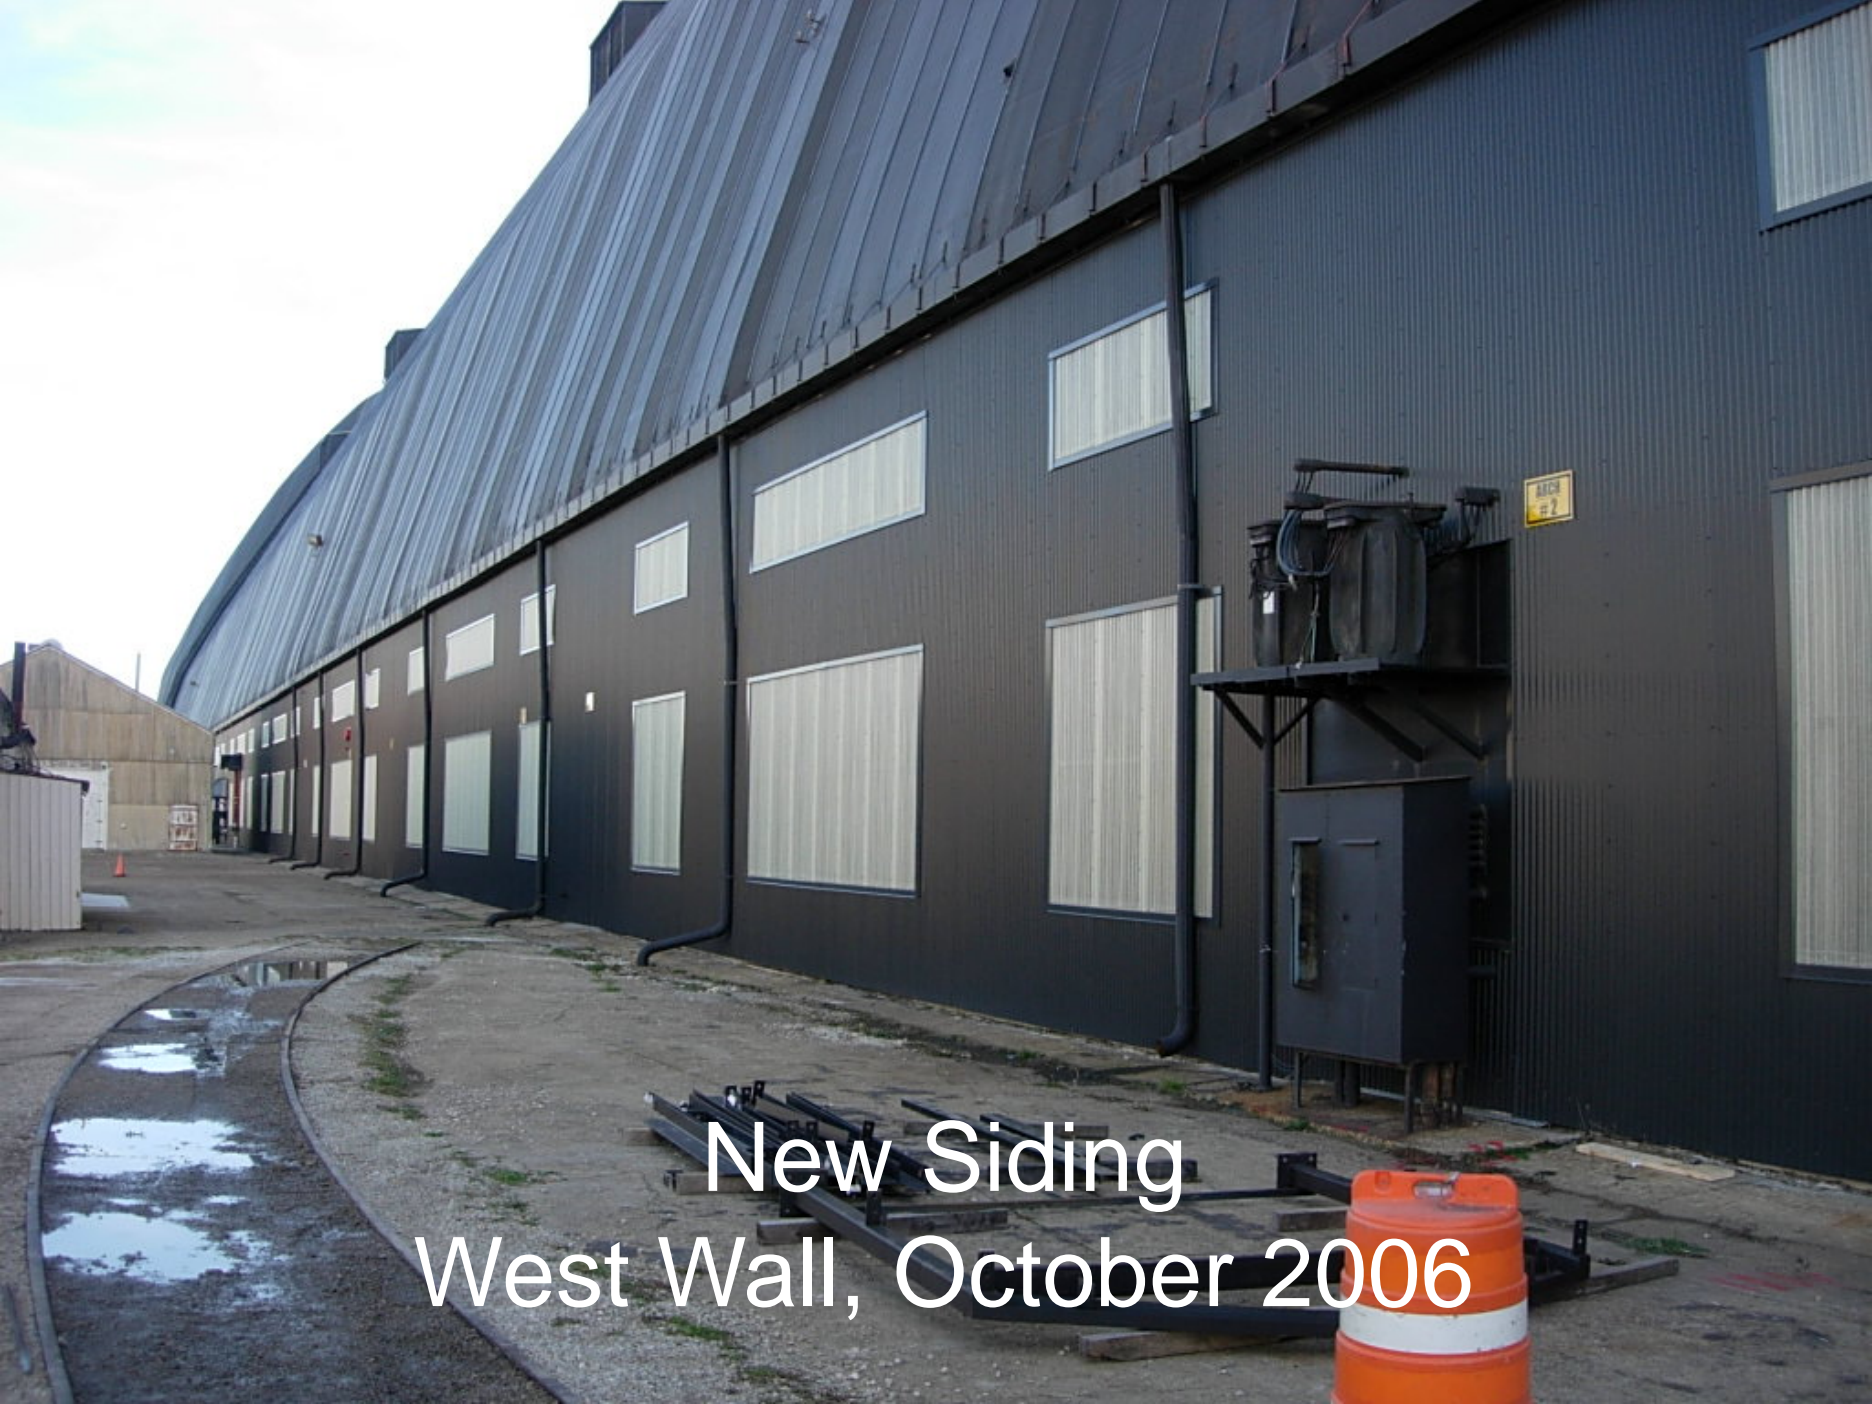
New Siding
West Wall, October 2006

The Airdock roof membrane ends at the gutter approximately 24 feet above the ground. The bottom 24 feet of the Airdock exterior is vertical and consists of windows, doors, siding, and associated structures and equipment. On the Airdock doors, the rubber roof membrane ends just above the vertical translucent panels. Between 2005 and 2006, all of the Airdock's vertical siding panels were replaced below the gutter on the arched segments, including all translucent panels and exposed siding on the doors. Also replaced (because these materials were RPM) were the siding and roofing material for two of the four door motor buildings and the electrical substation building. The new siding is corrugated painted aluminum with translucent fiberglass reinforced plastic (FRP) panels.

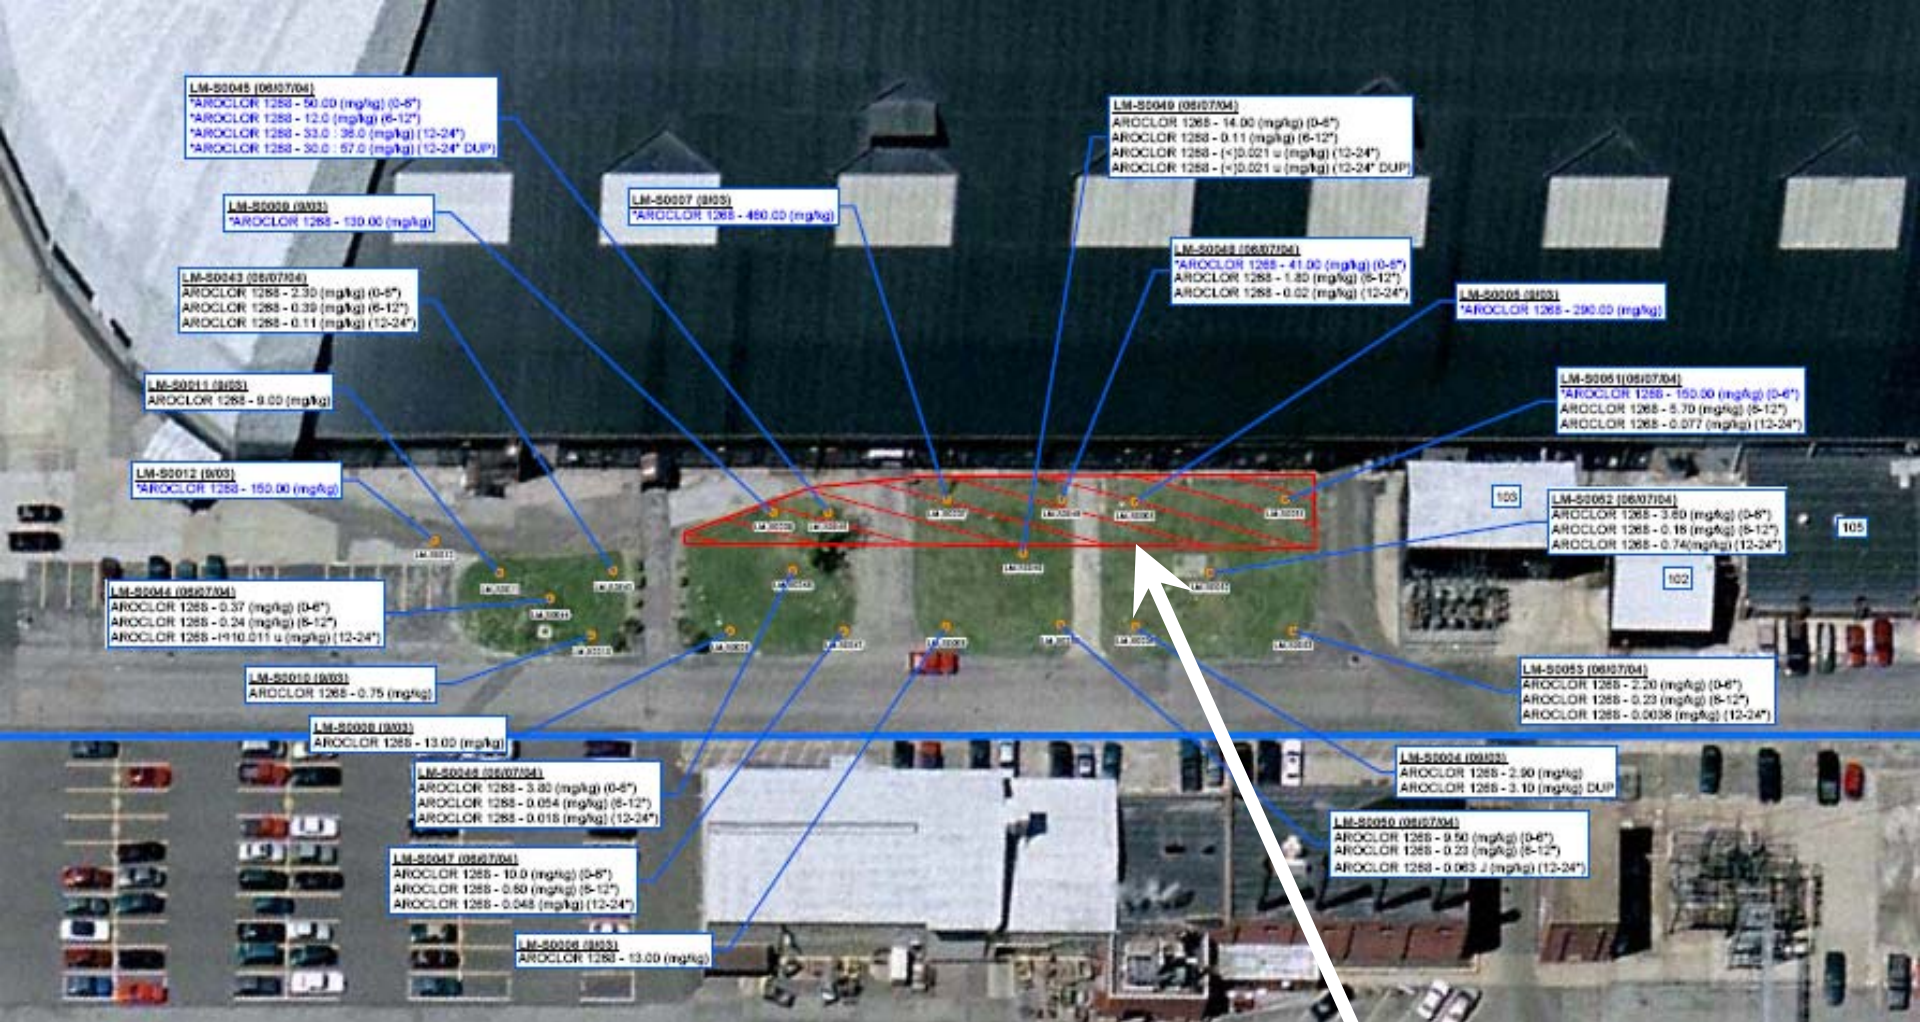
Soil Excavation Area

Pavement Cleaning Area

- *Removing soil on SE of the Airdock*
- *Cleaning pavement surrounding the Airdock*

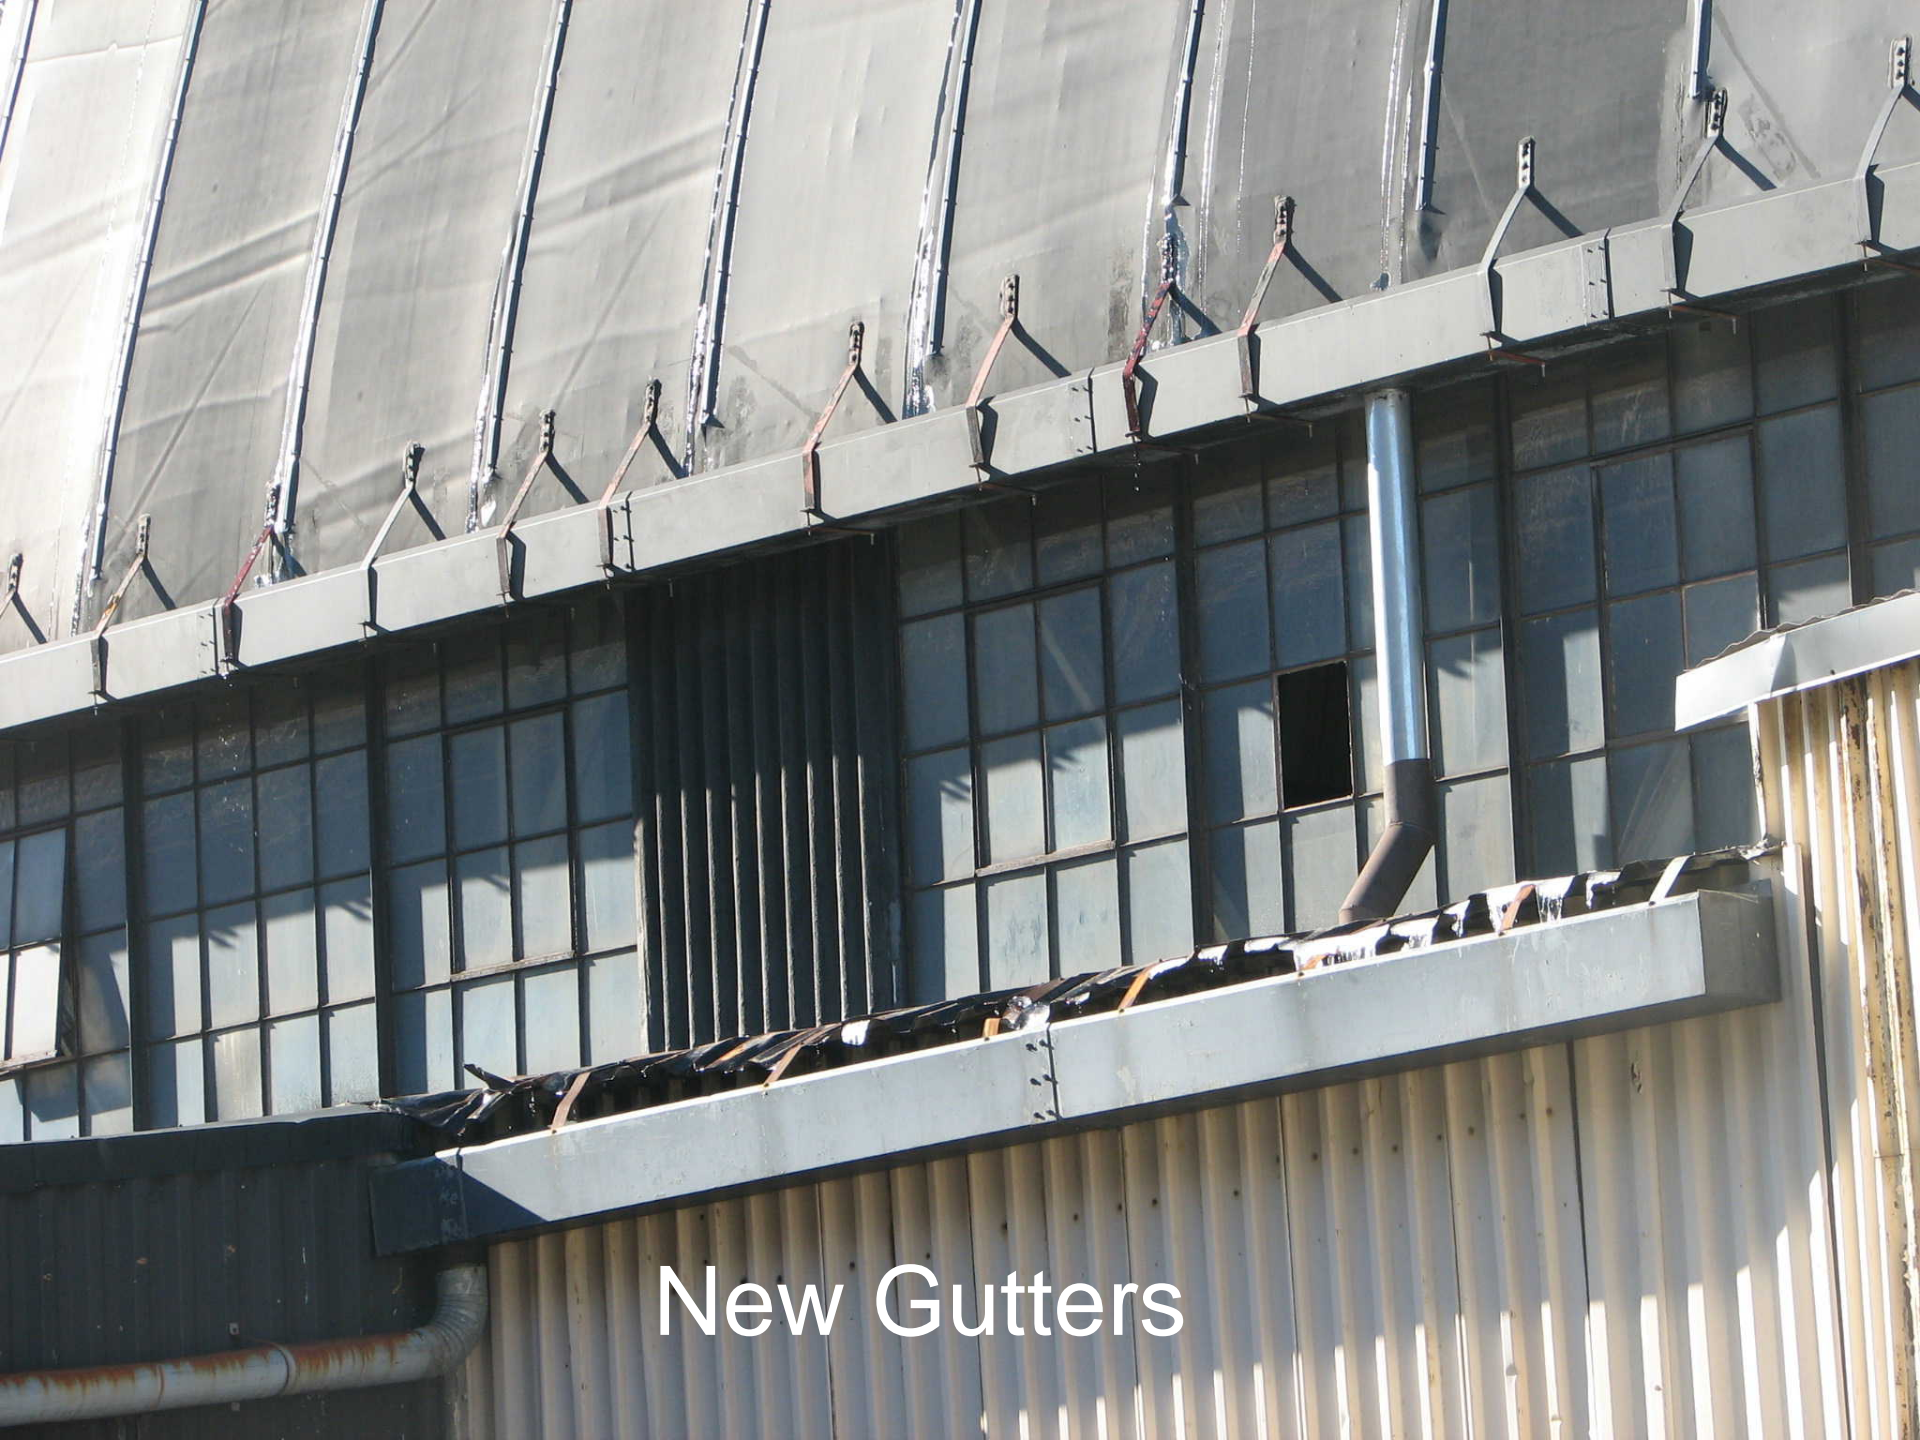
New Gutters

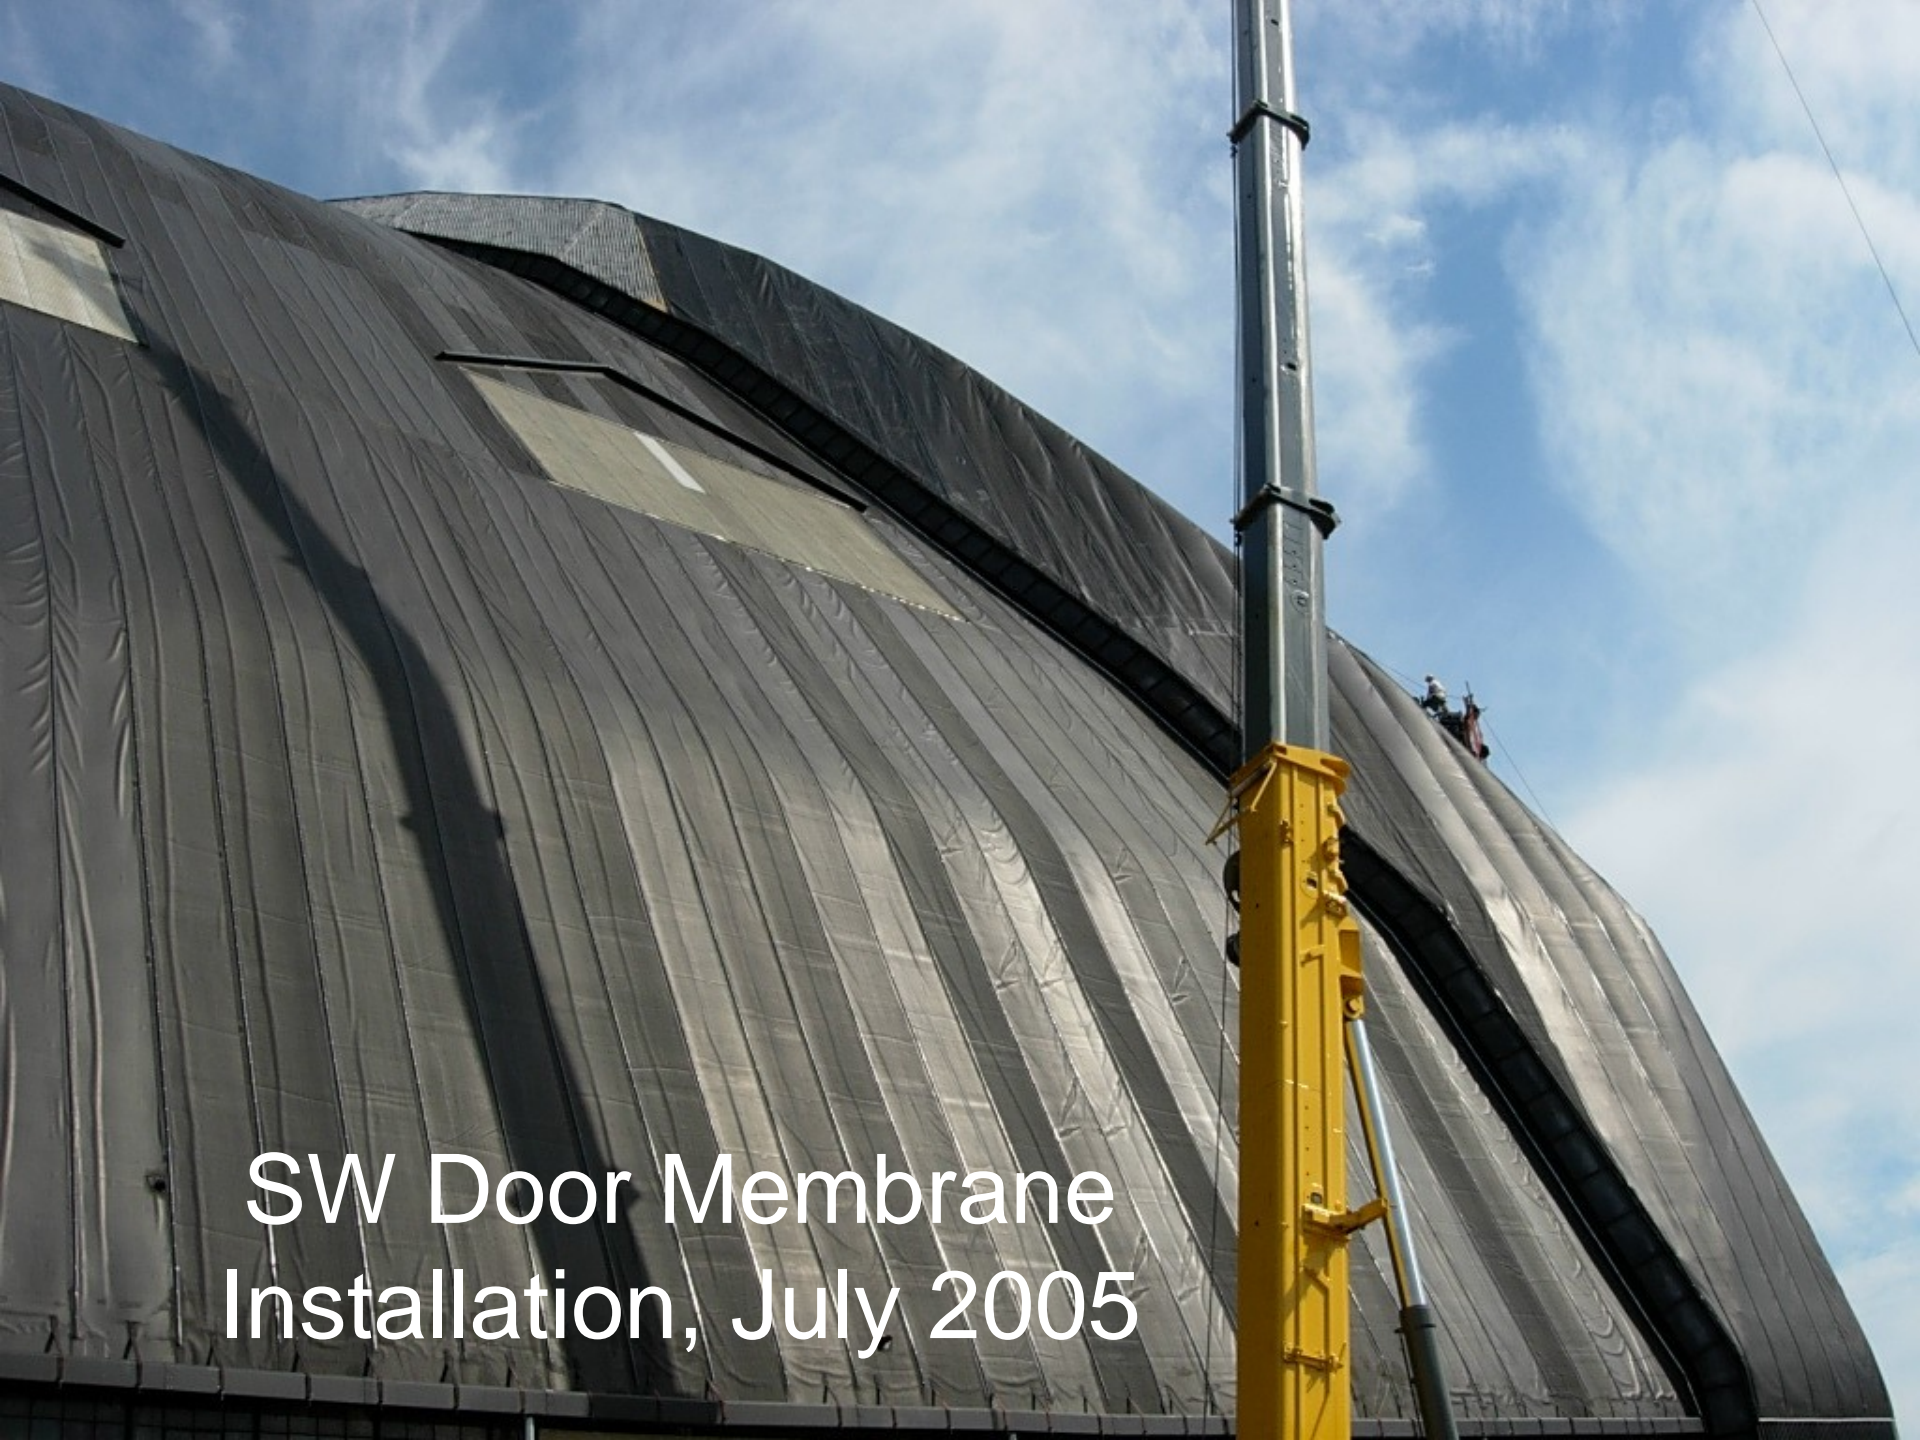
SW Door Membrane
Installation, July 2005
