Akron Airdock PCB Exterior Remediation Strategy

June 22, 2007

Lockheed Martin Corporation
1210 Massillon Road
Akron, Ohio 44315

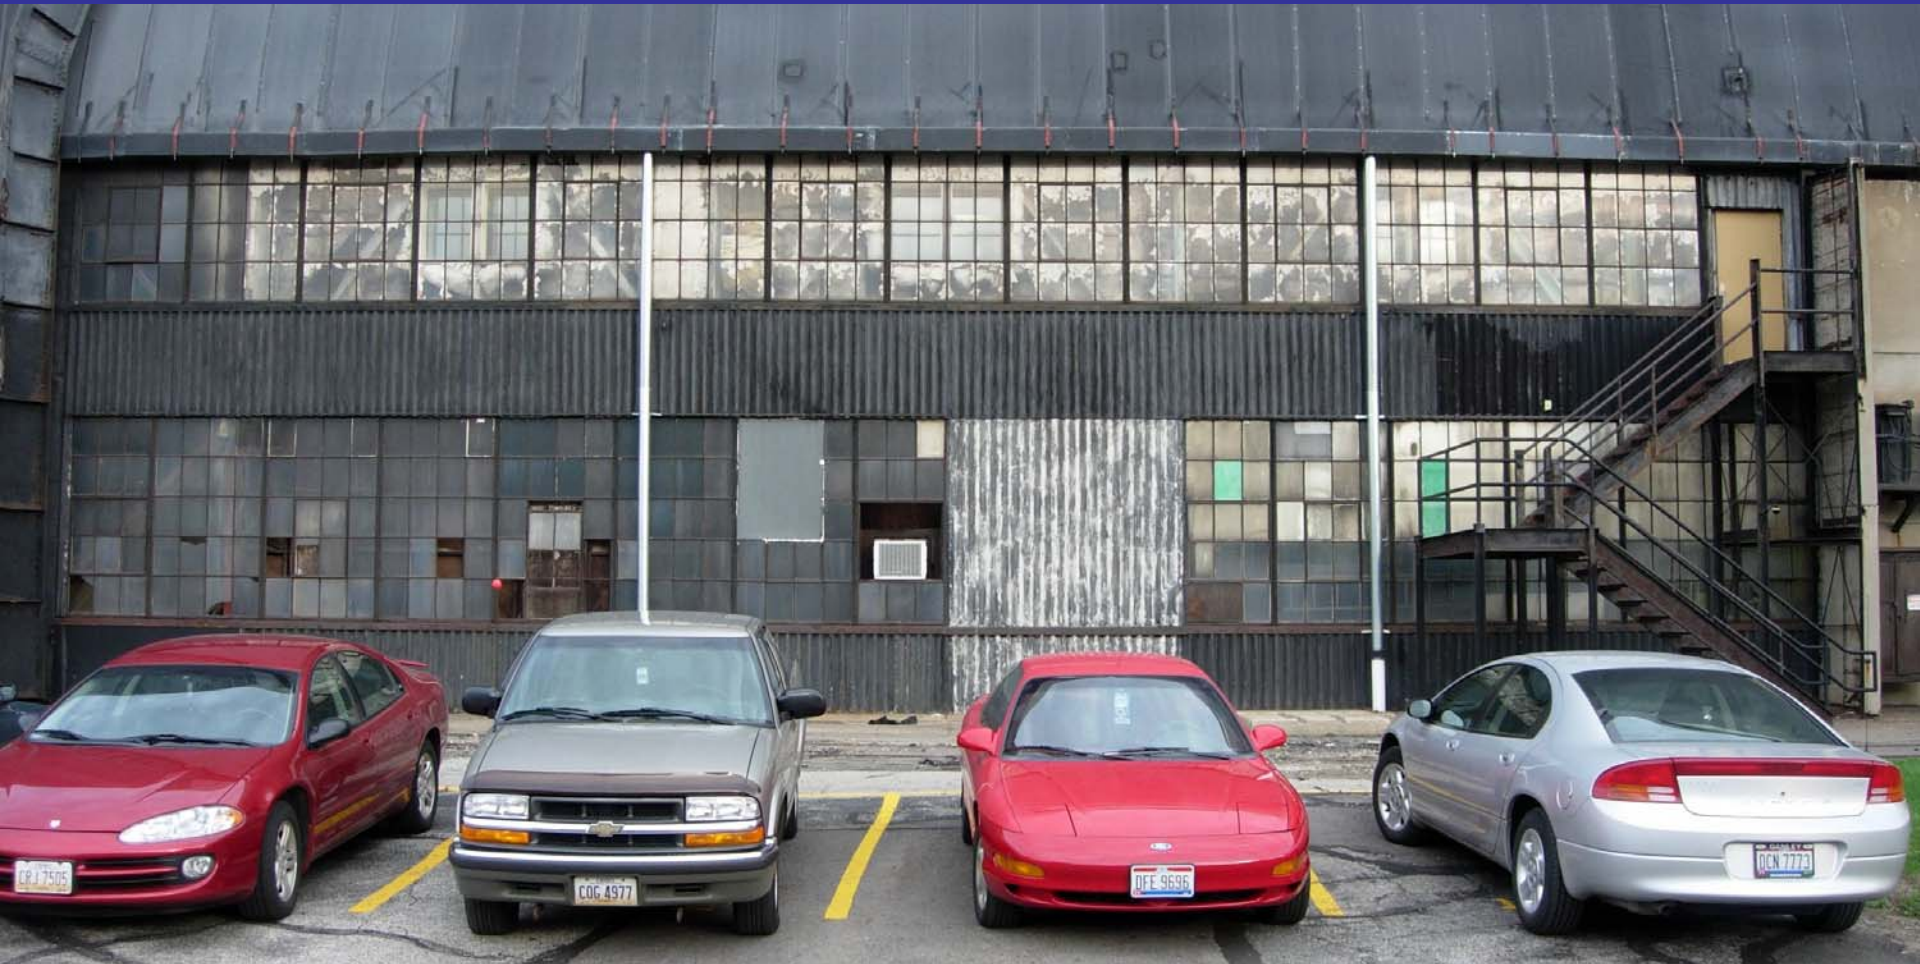
1E-2E, April 2004

The RPM material consists of five components: steel sheet metal, asphalt, asbestos felt, bitumen (impregnated with a fire-retardant, Aroclor 1268), and aluminum paint. Exfoliation of the RPM coating over time apparently resulted from the following factors: asphalt and steel with mismatched coefficients of thermal expansion, significant asphalt oxidation, dryness from more than 75 years of aging, and seasonal temperature fluctuations.

Original Siding

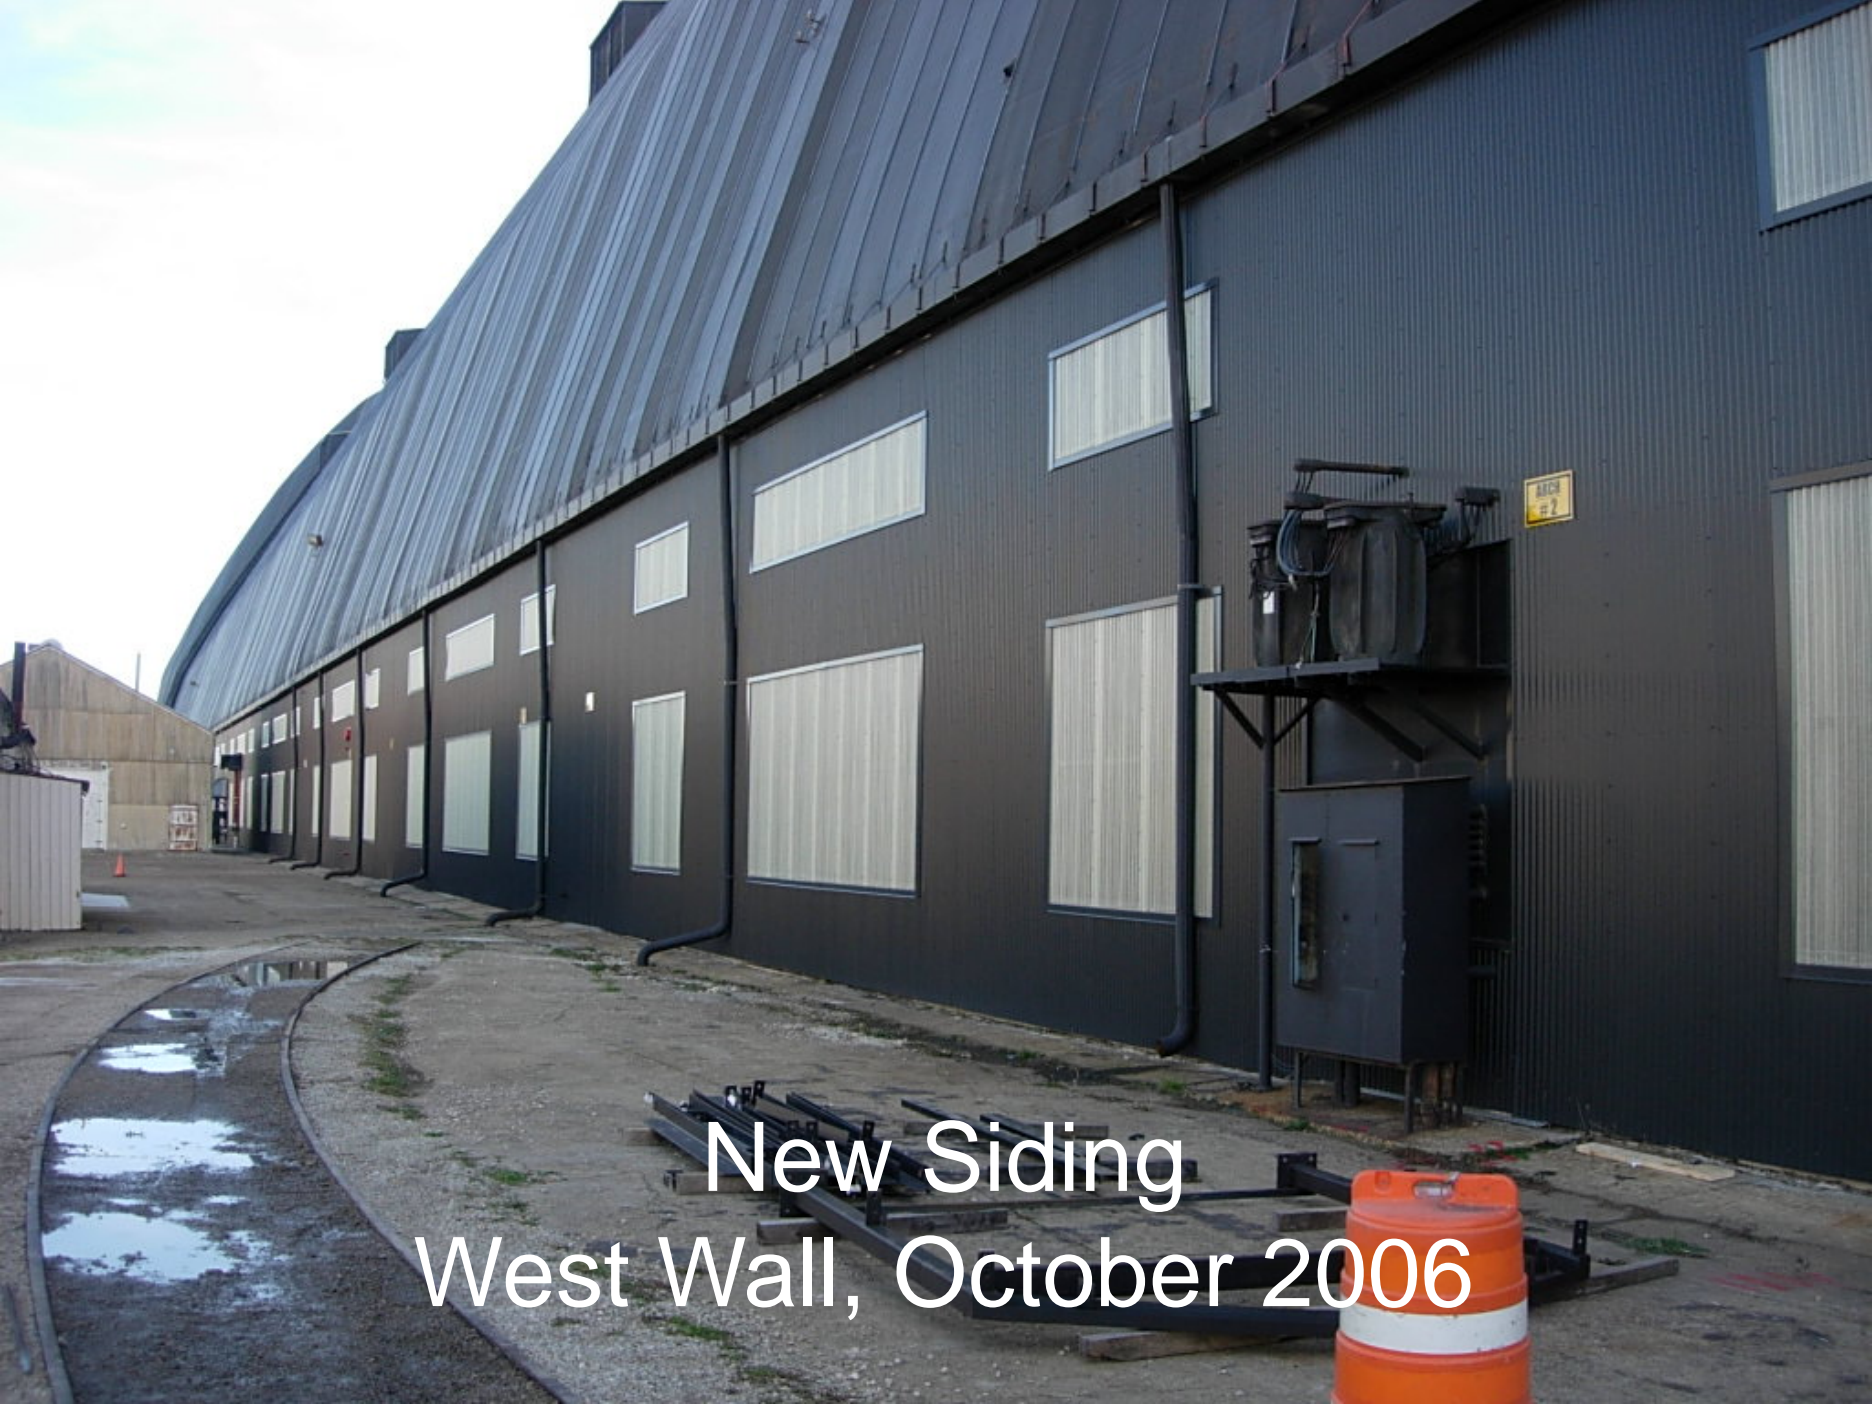
New Siding
West Wall, October 2006

The Airdock roof membrane ends at the gutter approximately 24 feet above the ground. The bottom 24 feet of the Airdock exterior is vertical and consists of windows, doors, siding, and associated structures and equipment. On the Airdock doors, the rubber roof membrane ends just above the vertical translucent panels. Between 2005 and 2006, all of the Airdock's vertical siding panels were replaced below the gutter on the arched segments, including all translucent panels and exposed siding on the doors. Also replaced (because these materials were RPM) were the siding and roofing material for two of the four door motor buildings and the electrical substation building. The new siding is corrugated painted aluminum with translucent fiberglass reinforced plastic (FRP) panels.

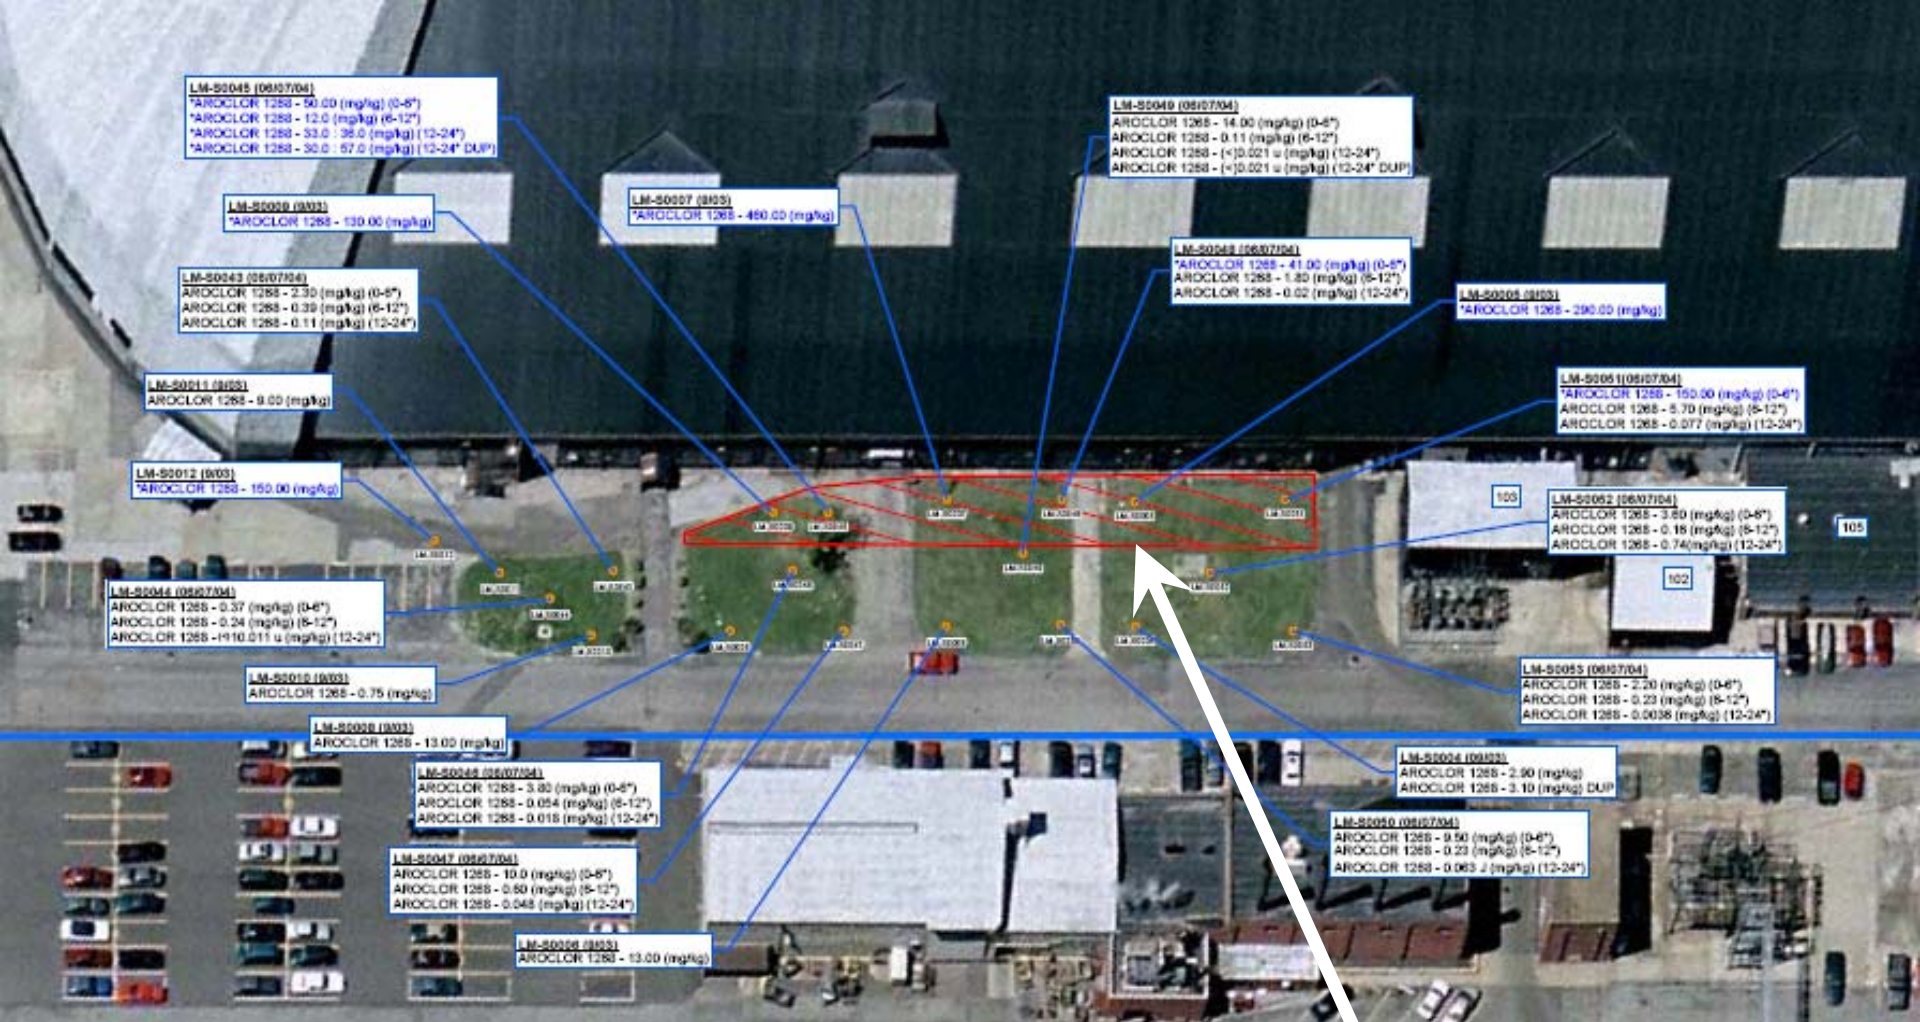
Soil Excavation Area

Pavement Cleaning Area

- *Removing soil on SE of the Airdock*
- *Cleaning pavement surrounding the Airdock*
