Exterior Cleanup Approach

Exterior Progress 2003 to 2007

2008 Plans and Progress to Date

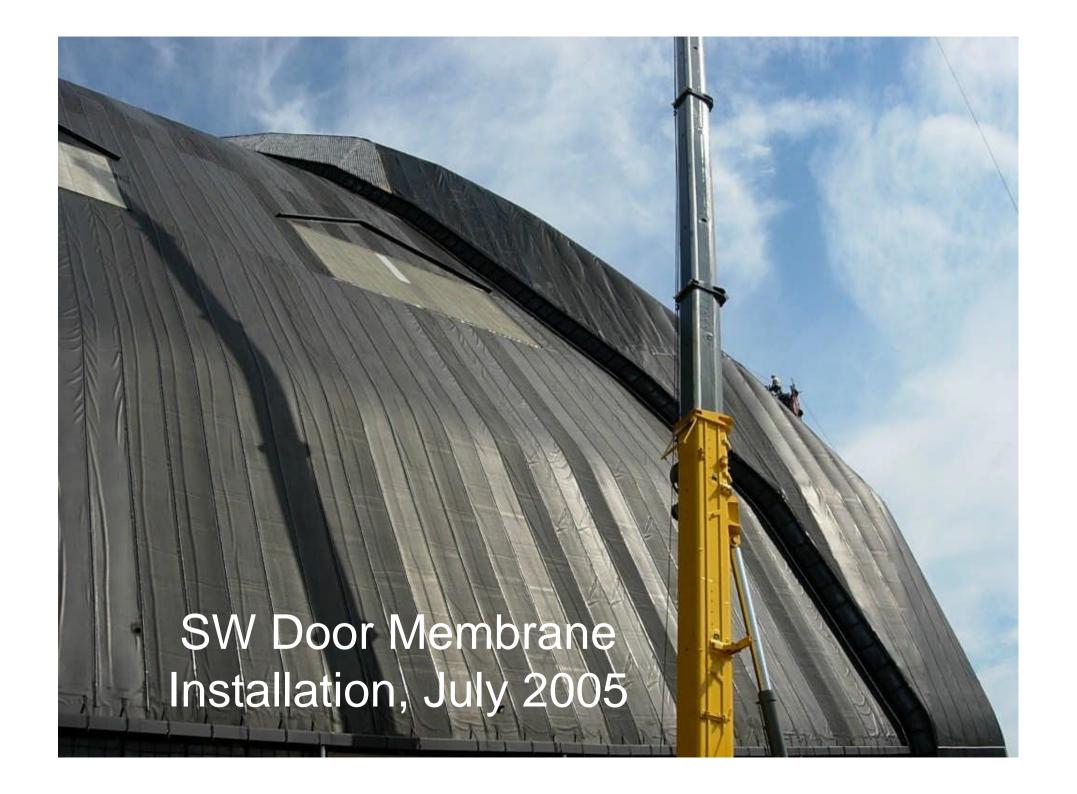
Original Siding

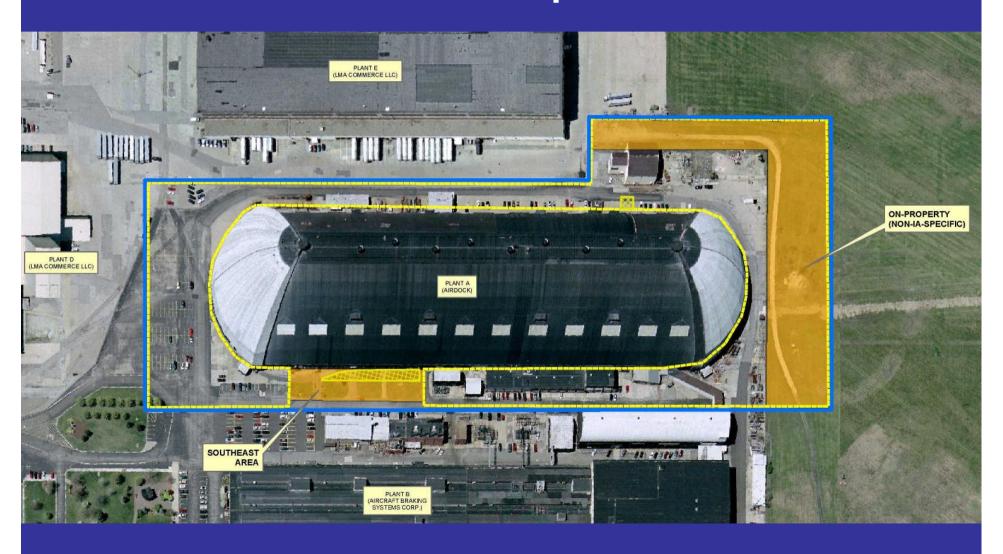
Soil Cleanup Areas

- On-Property Soil SE area: 4.9 ppm
- On-Property Soil North area: 1.5 ppm
- Off-Property Soil <1 ppm

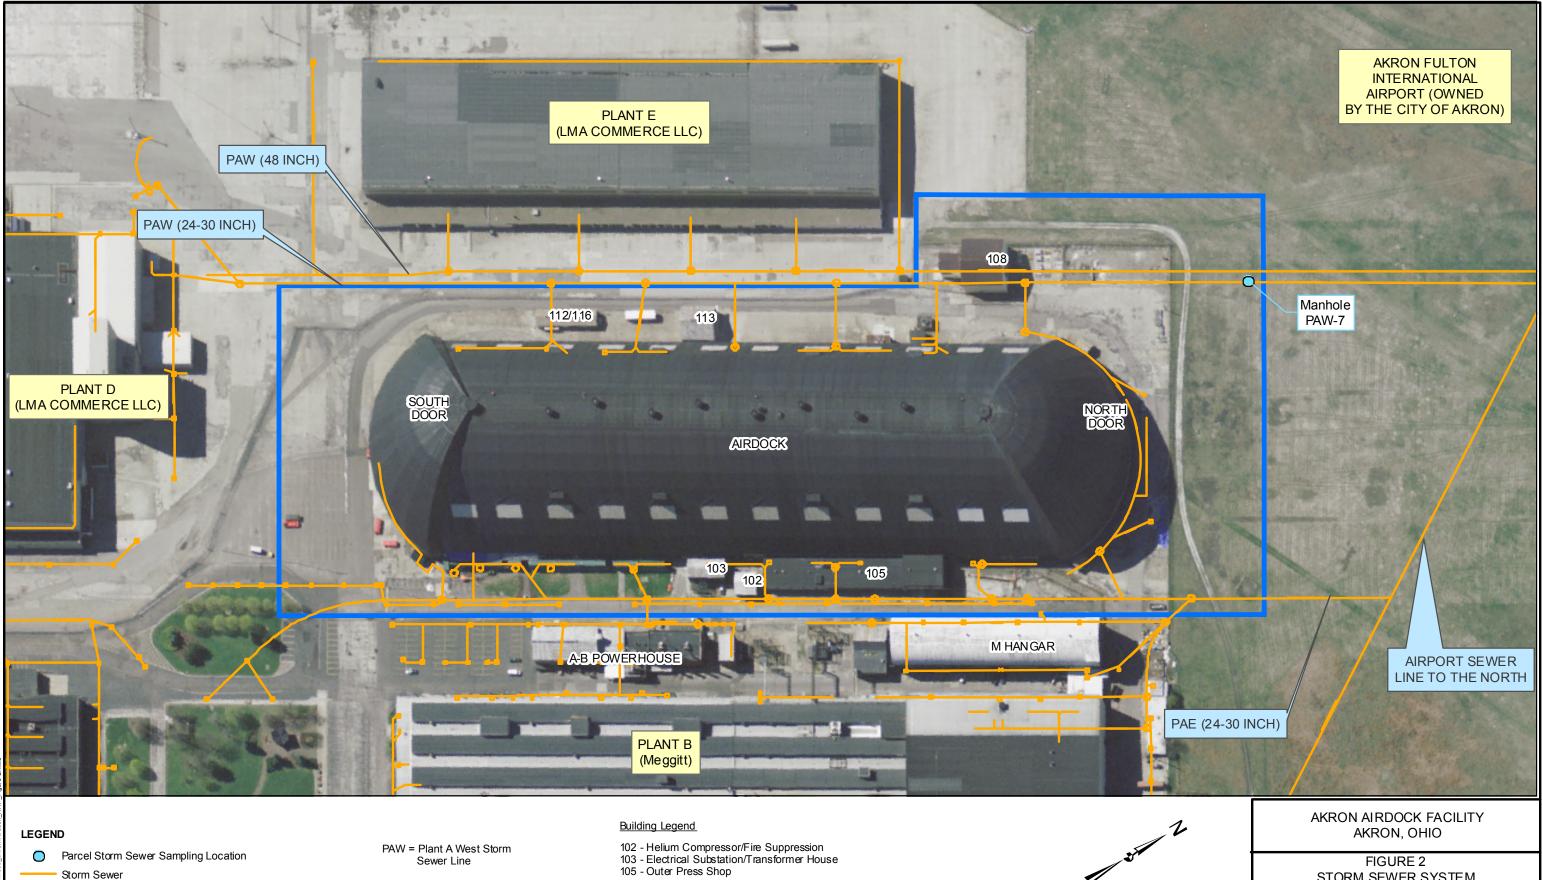
FIGURE 2 STORM SEWER SYSTEM WITH SAMPLING LOCATION

Parcel Storm Sewer Sampling Location
