Airdock Soil Excavation

Project Report
Akron, Ohio

October 14, 2008

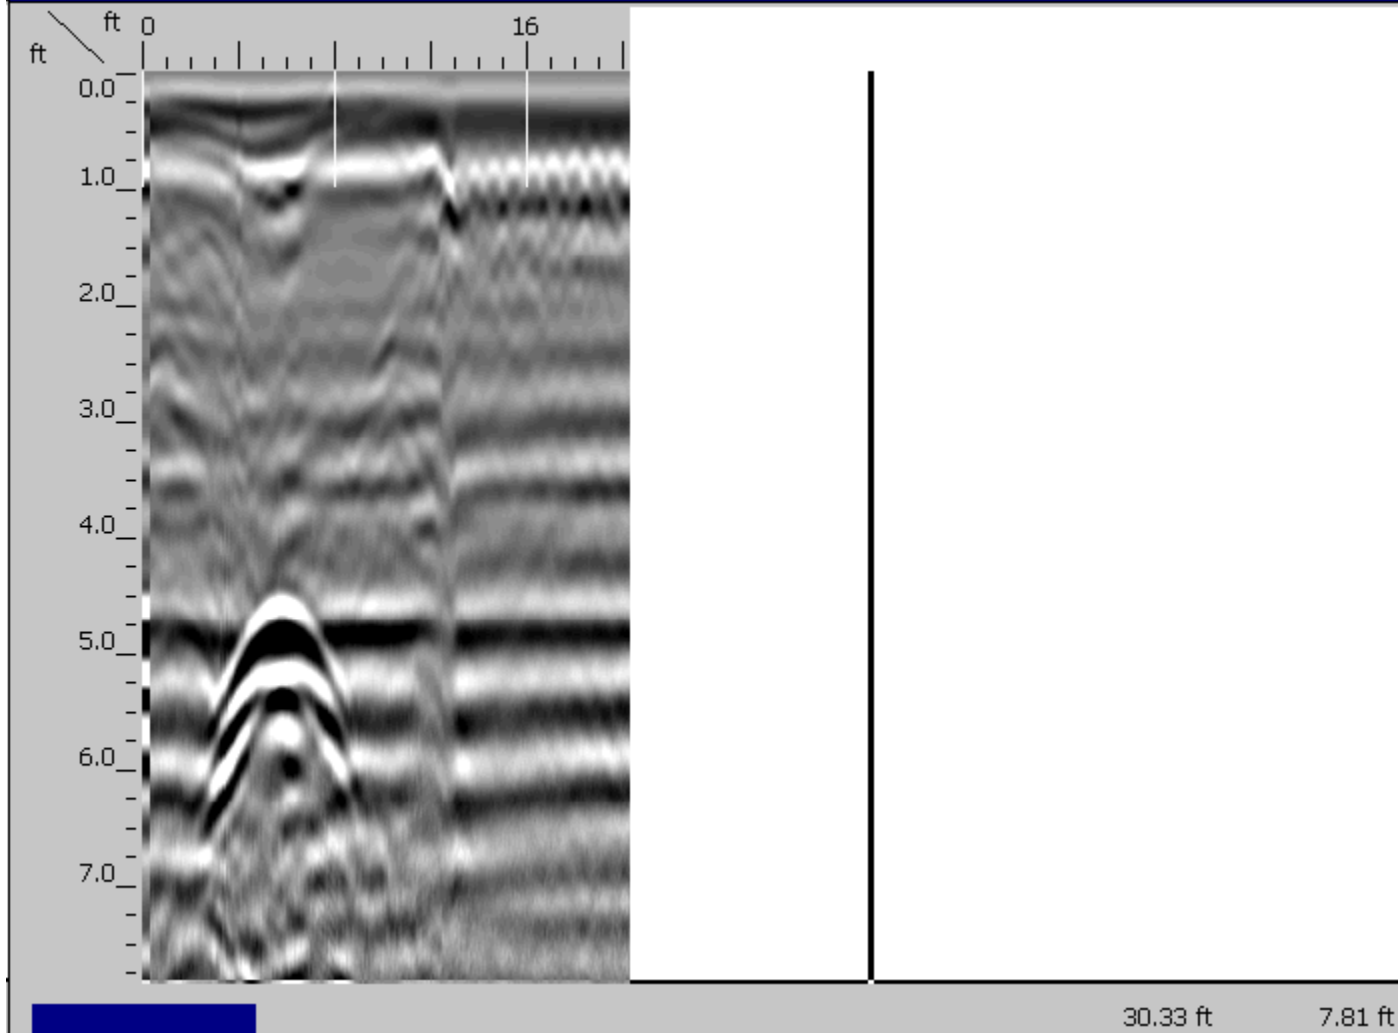
The above data shows the UST that was found onsite at a depth of 4.5'.

- A buried concrete structure measuring approximately 3 feet square and approximately 1 foot bgs was indicated 16.8 feet from the Airdock in Area B-2. An excavation was made to evaluate this structure revealing a cover over a pipe.
- At approximately 4.5 feet bgs a structure resembling an underground storage tank and measuring approximately 10 feet in width was located approximately 3 feet away from the Airdock (Area C-1). Additional excavation was made at this area to uncover the structure and it was determined to be a water pipe.

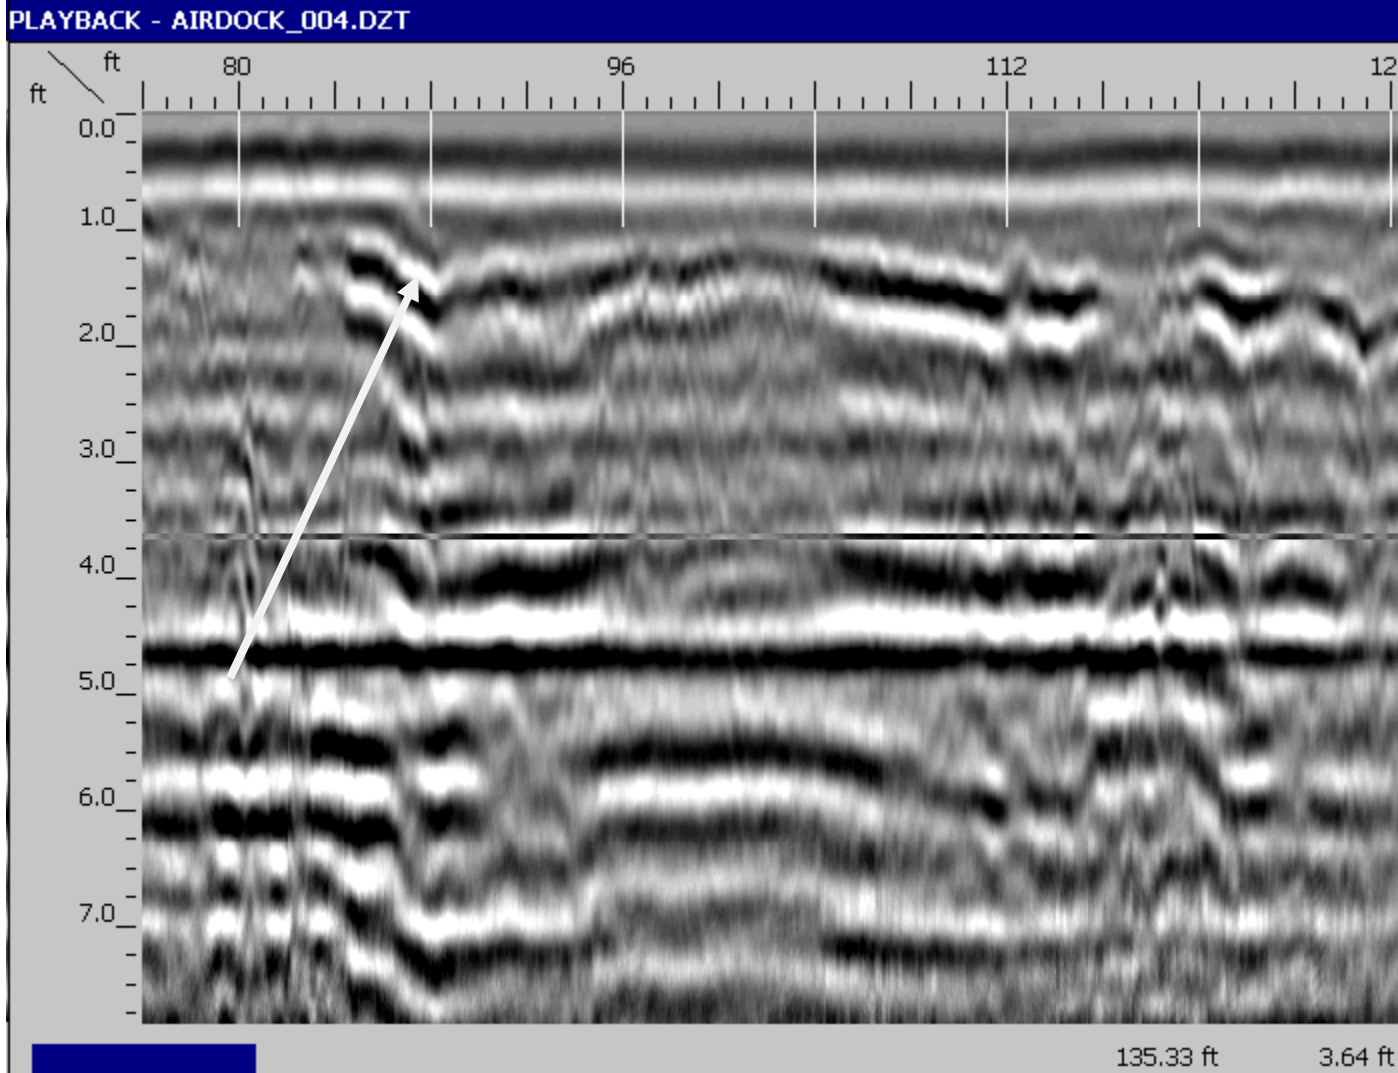
The above data is a scan over the top of the possible duct bank. The arrow is pointing to the horizontal band at approximately 1' deep that represents what is thought to be buried concrete.

- The RD-4000 located a power signal (approximately 4 to 6 feet below ground surface (bgs)) running southwest from the Airdock and intersecting with a line running parallel with the building (north and south). This power signal was not strong, which led GPRS to believe that this line is a low voltage buried electrical line or possibly a tracer tone on a water line.
- A structure was located which appeared to be buried concrete and was thought to be the top of a duct bank or a utility corridor or tunnel (located approximately 6 to 8 feet from the Airdock in Areas A and B). The top of this buried concrete was approximately 1 foot bgs and power was not detected in this area.

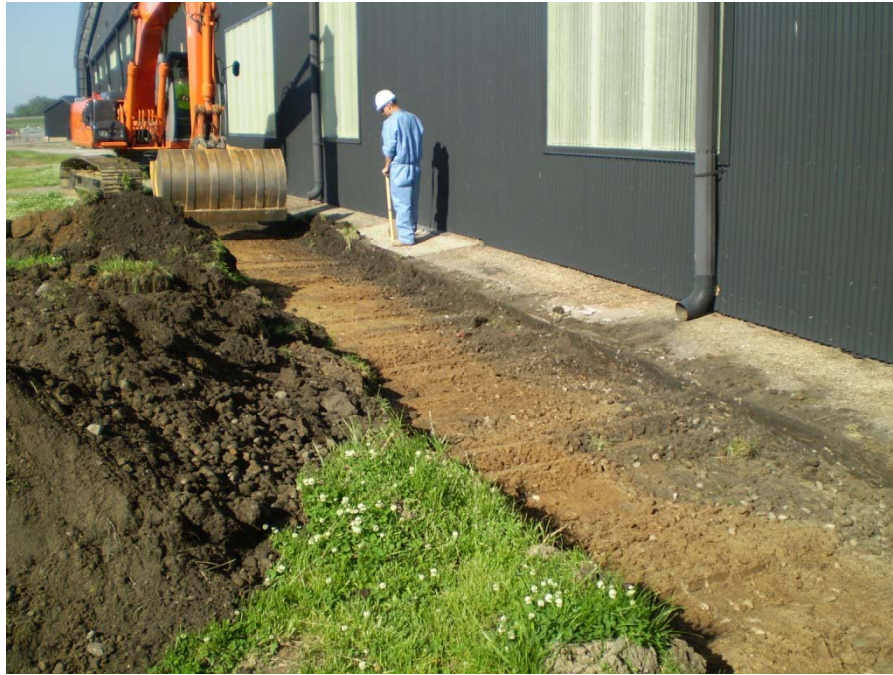
Photo # 1: Facing south the photo depicts excavation activities continuing from the northern section to the southern section.

Soil excavation activities were conducted from June 9, 2008 until June 12, 2008 and photos of the project are provided in Attachment 3. Work activities were initiated on the northern section of the Southeast Area and progressed to the southern section of the Southeast Area. As soil was excavated, it was directly loaded into 20 and 30 yard roll-off dumpsters provided by Lockheed Martin. Transportation and disposal of the roll-off dumpsters was arranged by Lockheed Martin. As a result of the soil excavation activities, a total of eighteen (18) dumpsters (301 tons) were generated. During soil excavation activities, soils were not excavated from beneath roads, parking lots, parking areas, or sidewalks. Excavation next to sidewalks and curbs were completed in a manner that minimized potential damage to curbs and adjacent roadways.

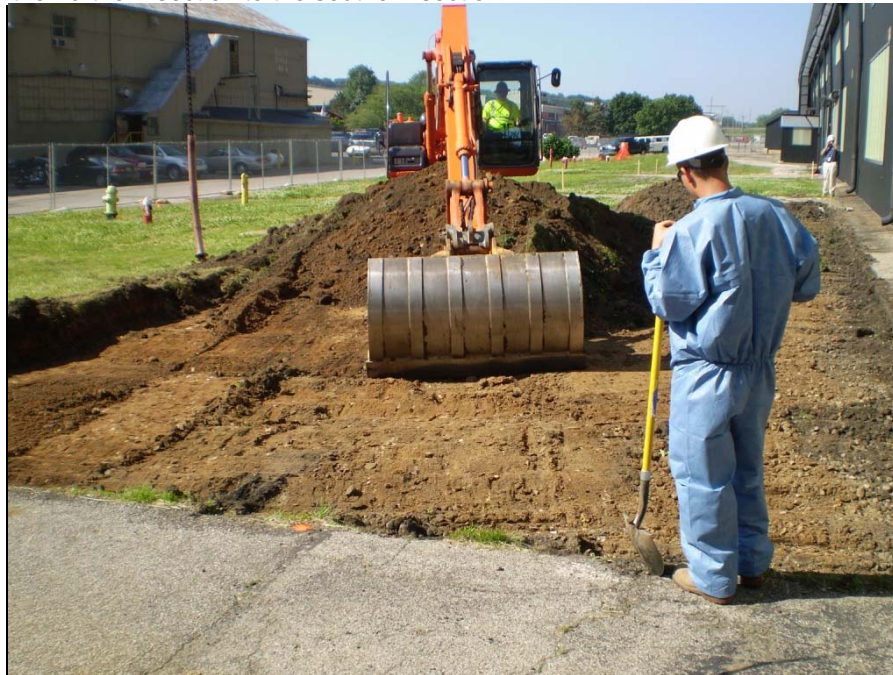
Photo # 2: Facing south-Continuation of excavation activities in the Southeast Area.

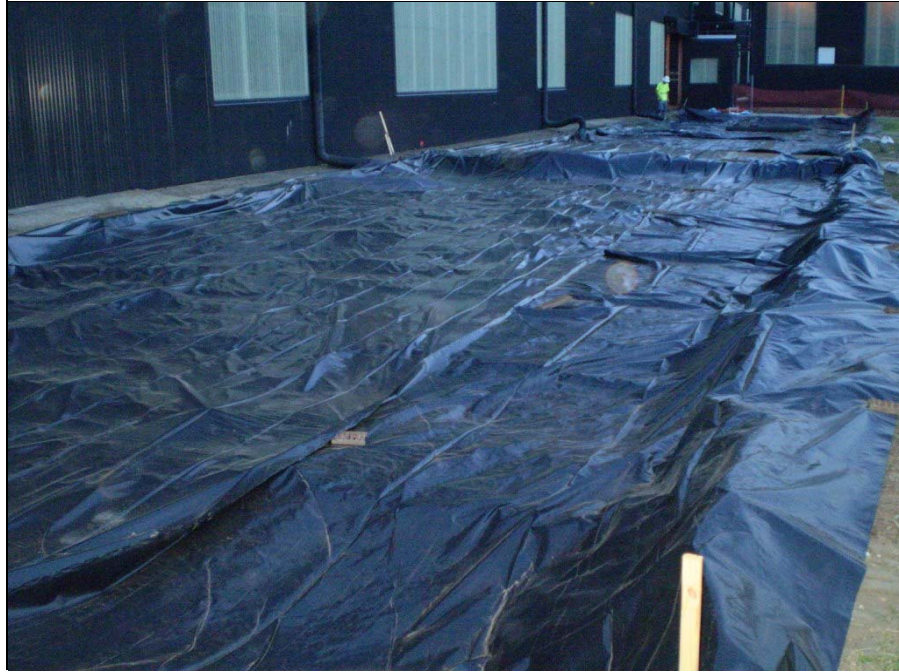
Photo # 3: Facing north, excavation covered awaiting sample results.

To demonstrate compliance with the target cleanup level of 25 ppm, all individual sample results from the verification samples collected from the base of the excavation were required to be less than 25 ppm before backfilling could begin.

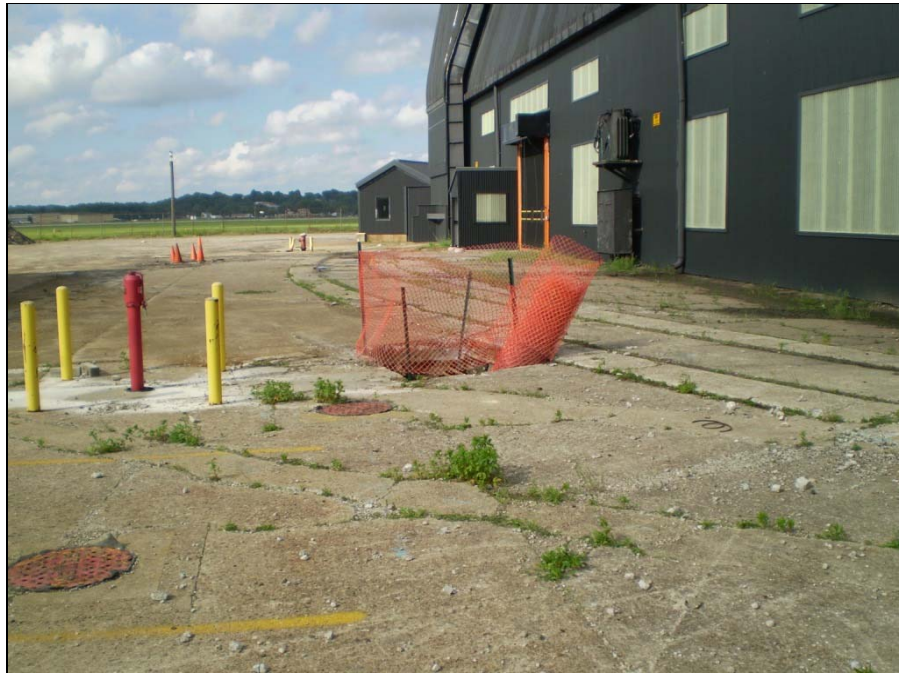
Photo # 4: Photo on northwest side of Airdock depicts the SC8 Area.

At the SC8 area, approximately 6-inches of concrete pavement covering the excavation area was removed. Following the concrete removal, soil was removed to a depth of two feet BGS and confirmation sampling was conducted from the bottom of the excavation as described in the following section.

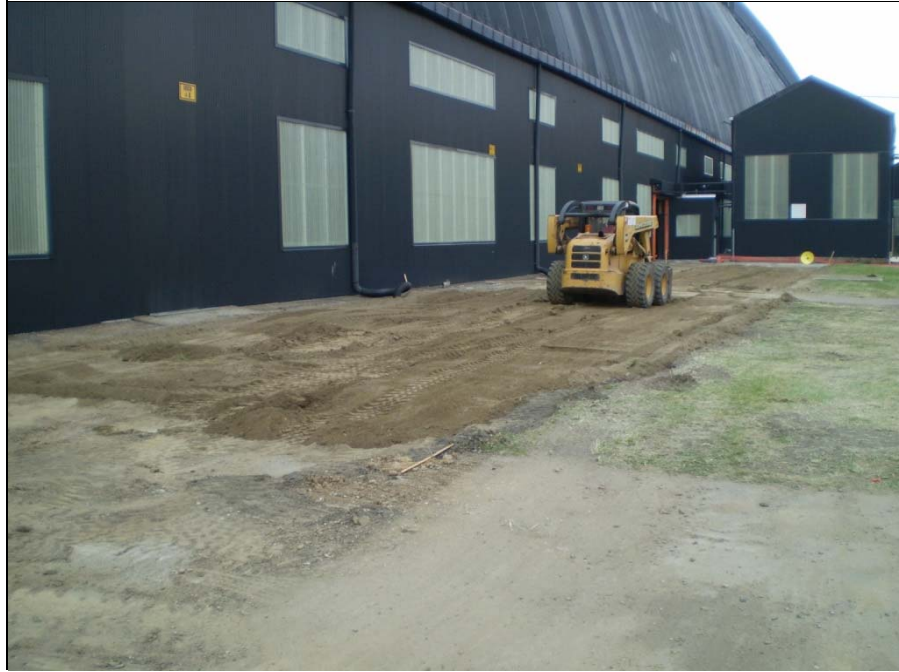
Photo # 5: Backfill in the Southeast area is being spread and compacted.

Following receipt of acceptable post-excavation confirmation sample results of less than 25 ppm, the excavated areas were backfilled to the pre-existing grades to re-establish the pre-existing grade. Soil backfill was provided by R.C. Materials L.L.C. located in Wadsworth, Ohio. Backfilling activities were conducted from June 11, 2008 until June 12, 2008 and resulted in a total of 272 tons of backfill soil being utilized. Backfill soil was placed in the excavation area and compacted using the excavation equipment.

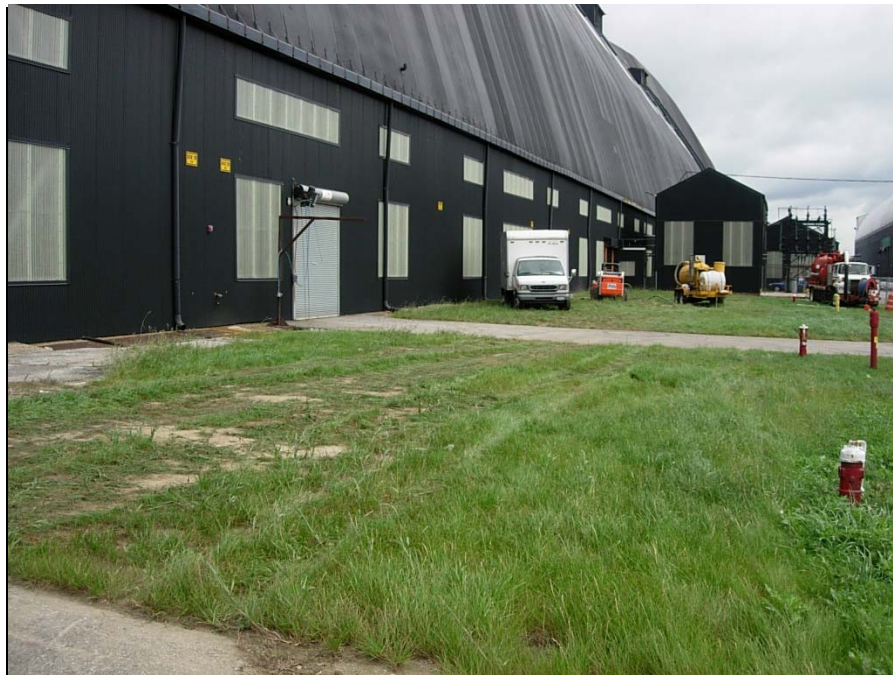
Photo # 6: Southeast area after grass established, September, 2008.

At the conclusion of backfilling activities, the area was hydro-seeded by Pro Tree Landscape Company located in Cuyahoga Falls, Ohio on June 13, 2008.
