Re: *Section 404 Nationwide Permit Application,  
Haley's Ditch Restoration Project  
North of East Archwood Avenue and south of Triplett Boulevard,  
Akron, Summit County, Ohio 44306*

**INDIVIDUAL 404 PERMIT APPLICATION**

<b>12. PROJECT NAME OR TITLE (see instructions)</b> Haley's Ditch Remediation	<b>14. PROJECT STREET ADDRESS</b> No associated street address; the project area is located in Akron, Ohio (Appendix A: Map 1) is bordered to the north by East Archwood Avenue and to the south by Triplett Boulevard; South Seiberling Street and Landon Street are located east of the project area (Appendix A: Maps 2 and 3).
<b>13. NAME OF WATERBODY, IF KNOWN (if applicable)</b> Haley's Ditch and adjacent wetland habitat	
<b>15. LOCATION OF PROJECT</b> <u>Summit</u> <u>Ohio</u> COUNTY STATE	<b>16. OTHER LOCATION DESCRIPTIONS, IF KNOWN (see instructions)</b> Lat: 81° 28' 21.38" Long: 41° 02' 42.51"

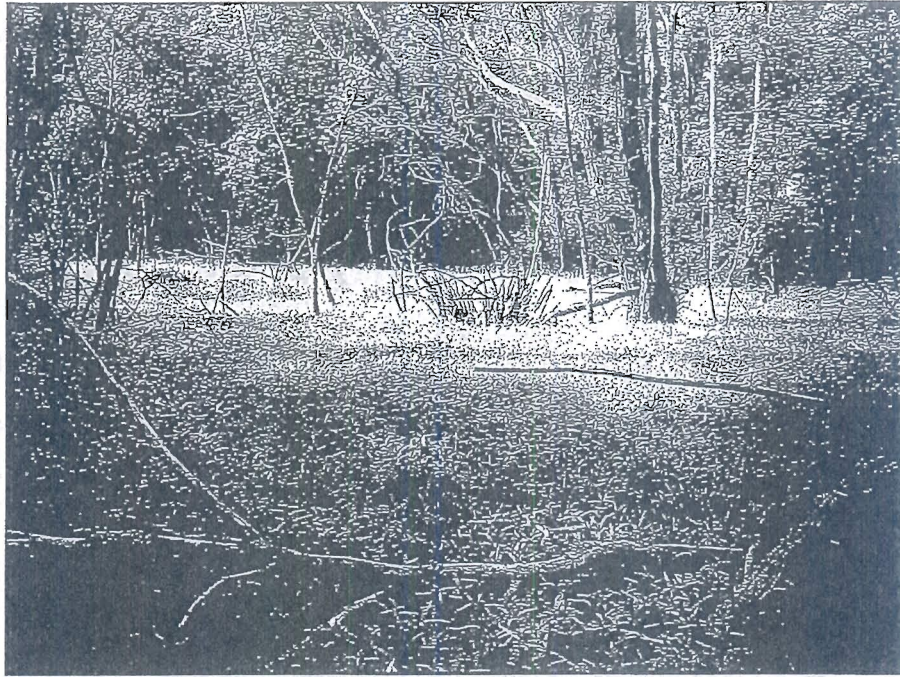
**Photograph 1 (6-25-08)** Wetland A is a lowland woods and wet meadow.

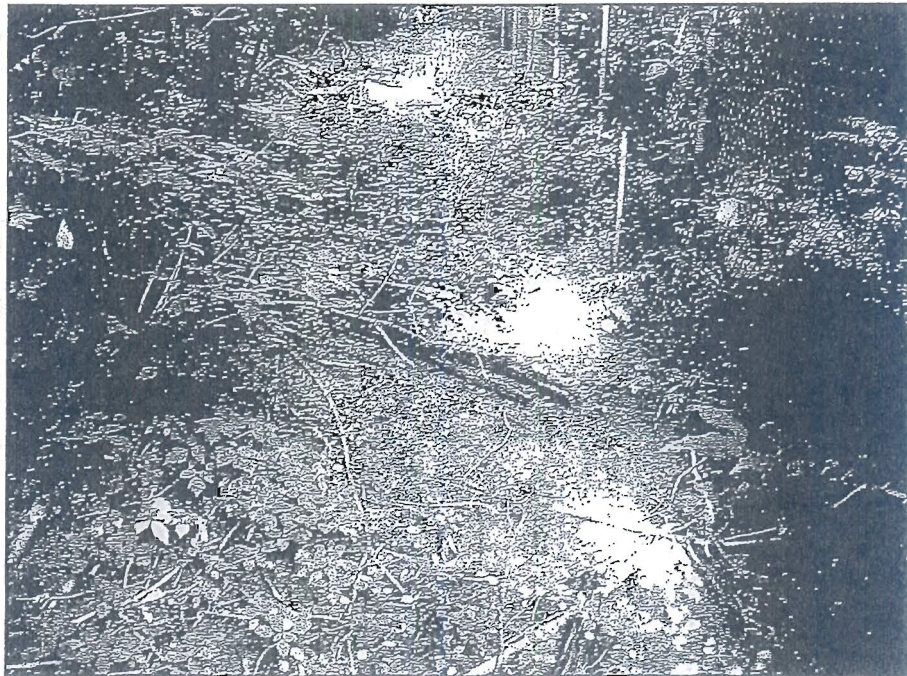
**Photograph 2 (6-25-08)** Wetland B is a lowland woods.

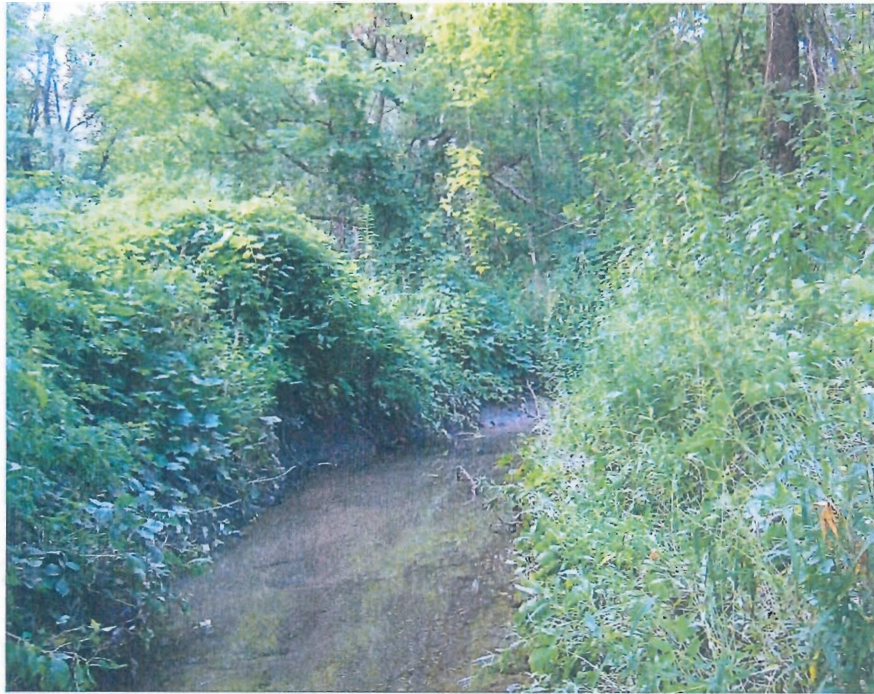
**Photo 3.** Haley's Ditch flowing northwards through the site.

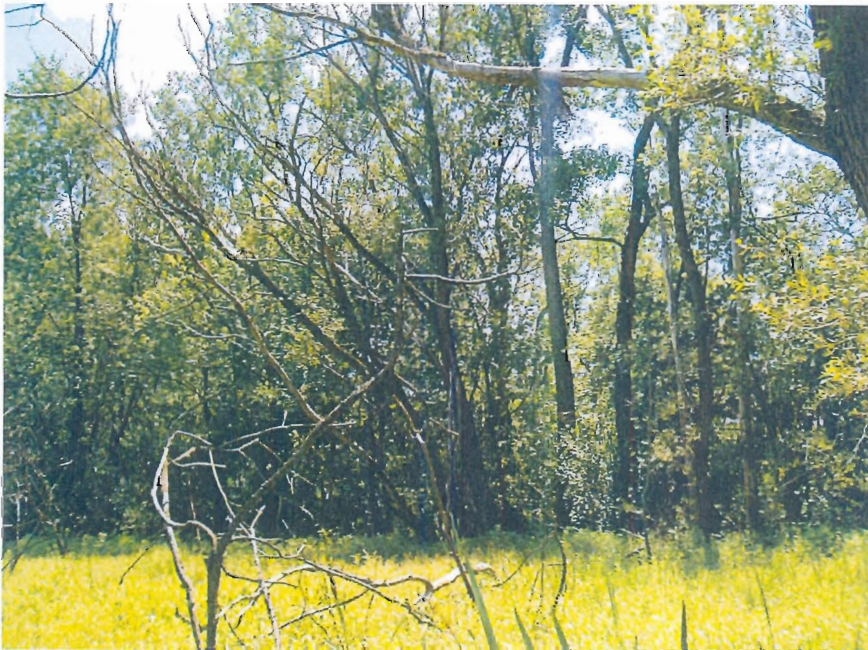
**Photo 4.** View of Wetland A and successional forest habitat surrounding the wetland.

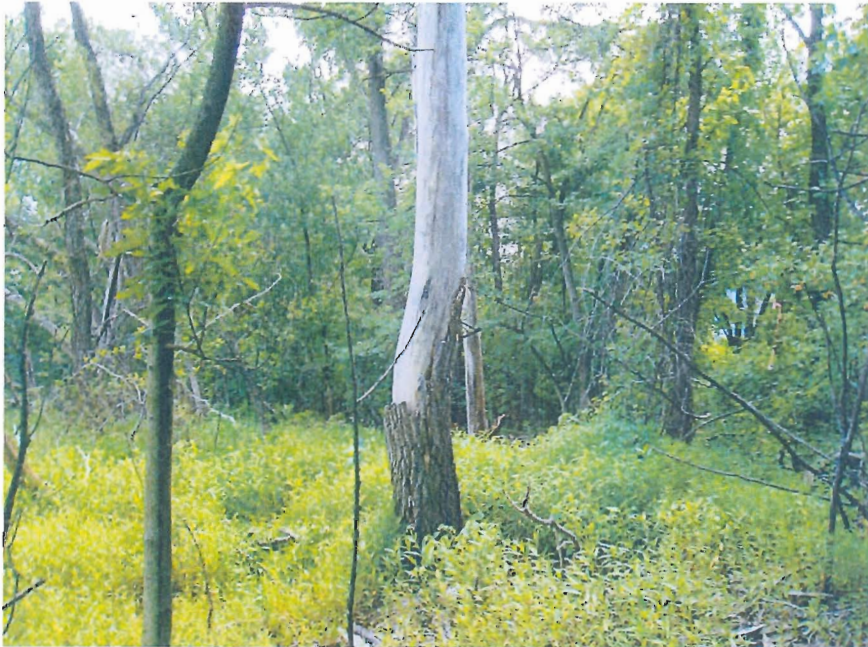
**Photo 8.** Potential Indiana Bat roosting tree habitat.

Potential Indiana Bat maternity and roost tree habitat was identified throughout the successional forest, scrub shrub and herbaceous wetland habitat portions of the study area (Appendix C: Photos 8 and 9). However, no Indiana Bats were observed during the mist net survey, only one Big Brown Bat (*Eptesicus fuscus*) was observed. Please refer to the Indiana Bat Survey Report conducted by EnviroScience, Inc. in July 2008.

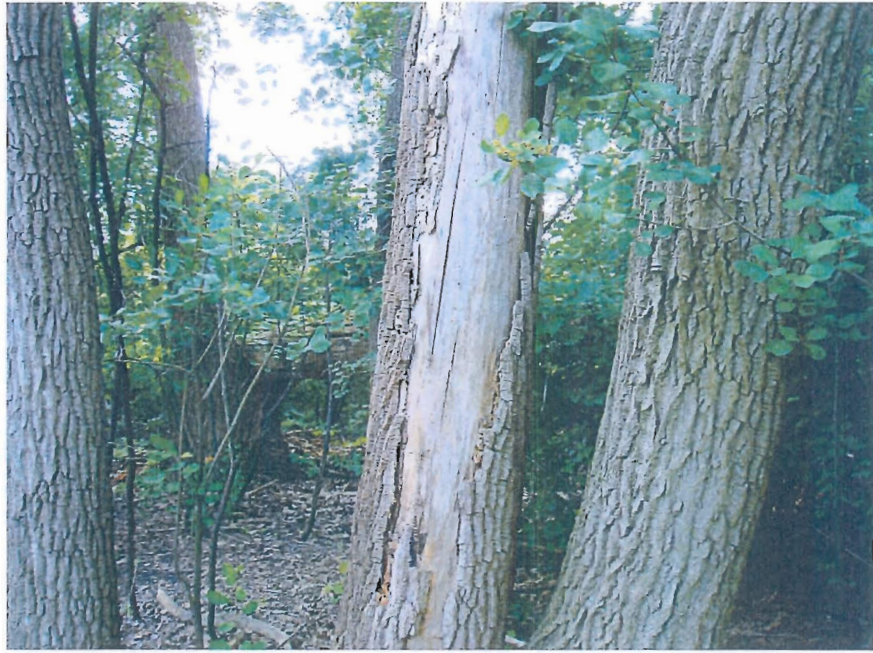
**Photo 9.** Potential Indiana Bat roosting tree habitat.

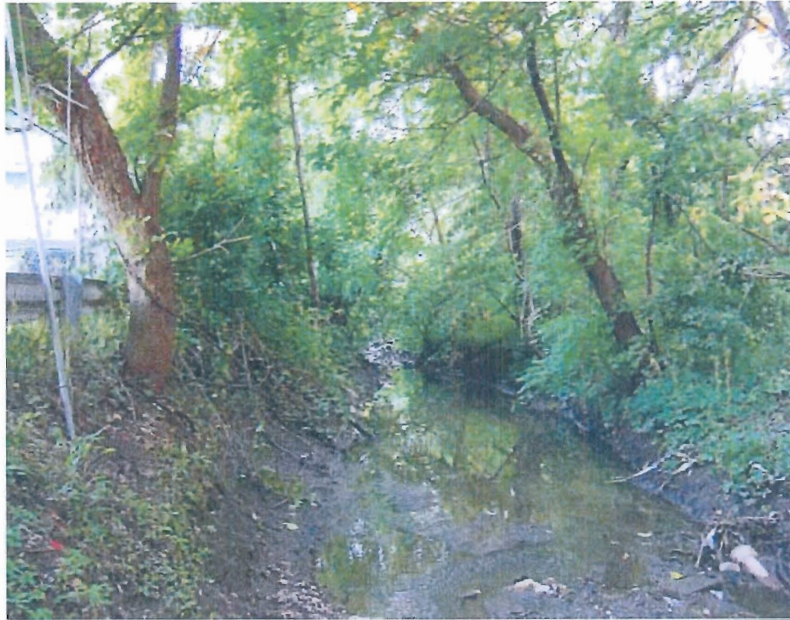
**Photo 5.** View of Net Site 1 looking upstream and showing edge of parking lot to left.

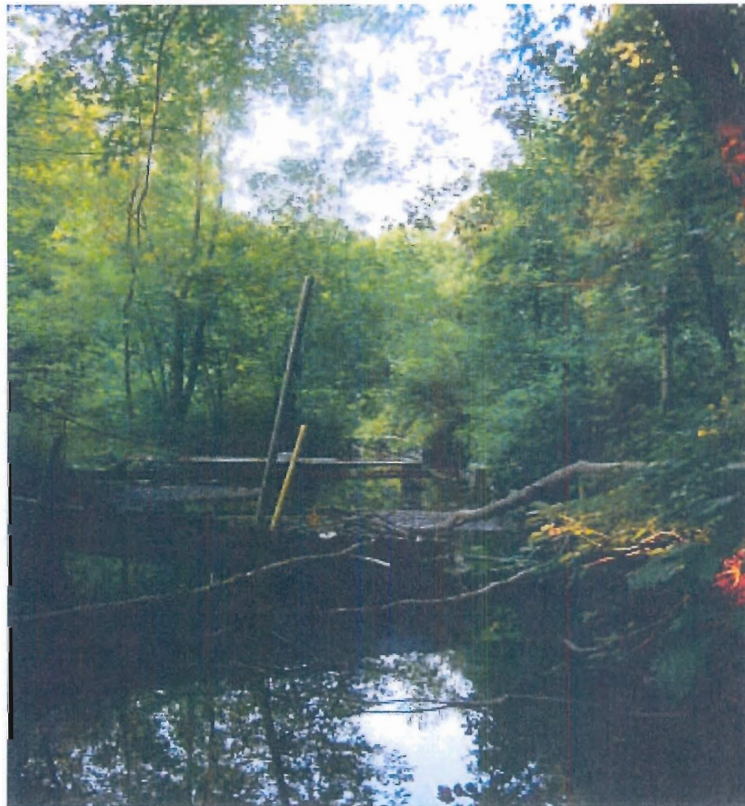
**Photo 6.** Net Site 2 looking down stream from walkway over ditch.

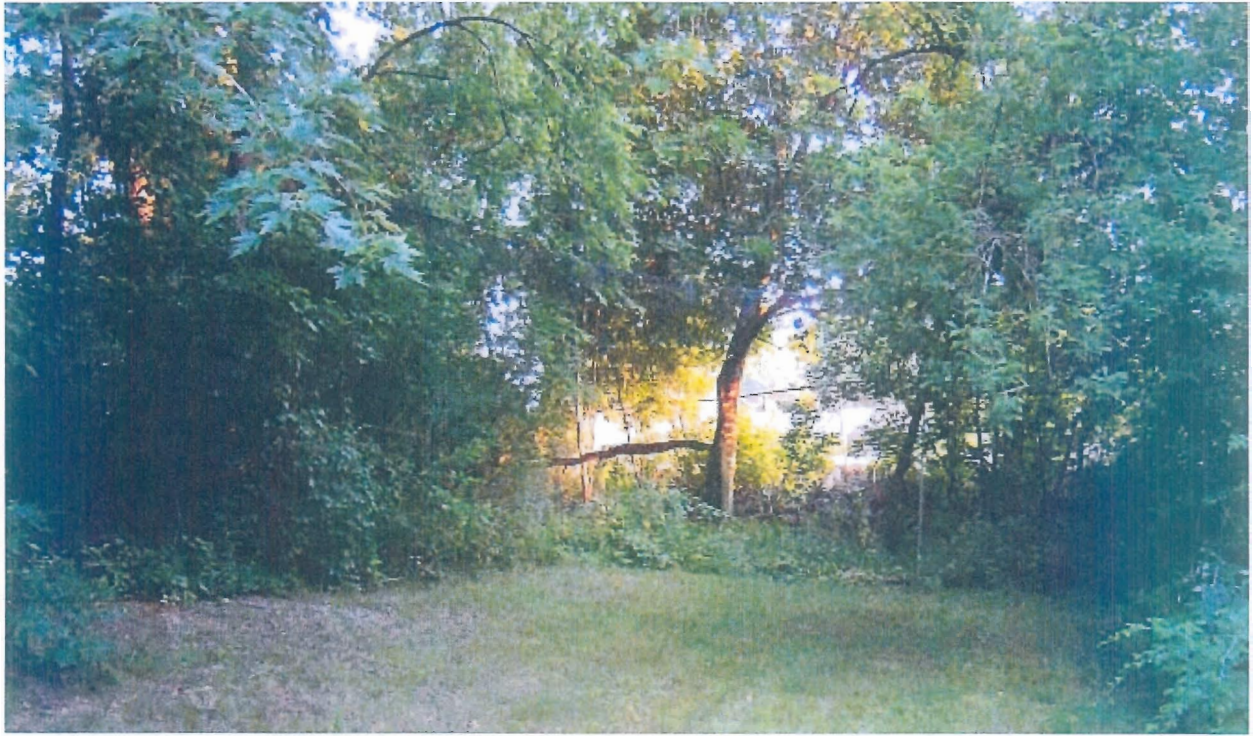
**Photo 7.** Net Site 2, net in wooded mowed area.
