Wetlands Delineation Report

5.85 Acres Haley's Ditch Remediation Area

Akron Airdock Facility, Lockheed Martin Corporation Akron, Ohio

July, 2008

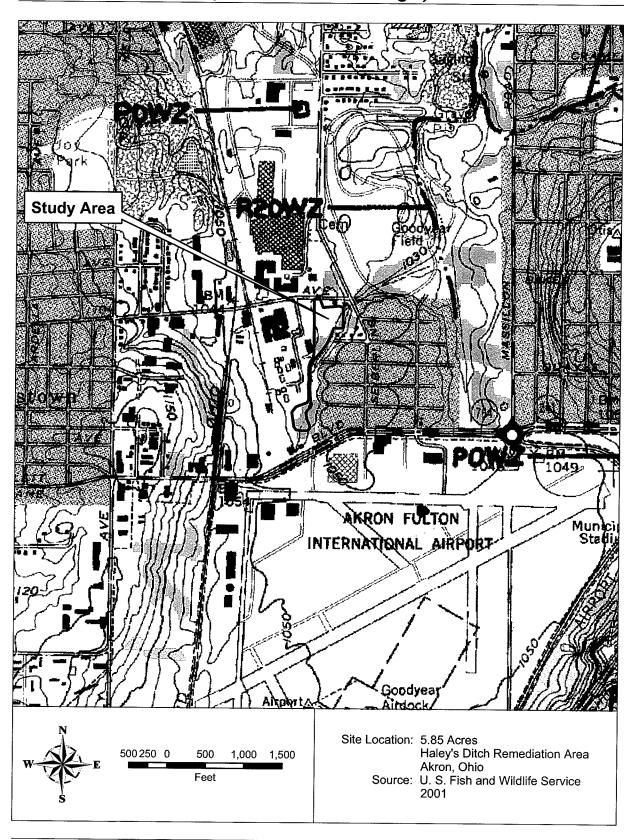
Appendix D Location of Study Area on National Wetlands Inventory Map (Akron East Quadrangle)

The National Wetlands Inventory (NWI) map (Akron East quadrangle) is in Appendix D. No wetlands are mapped for the site.

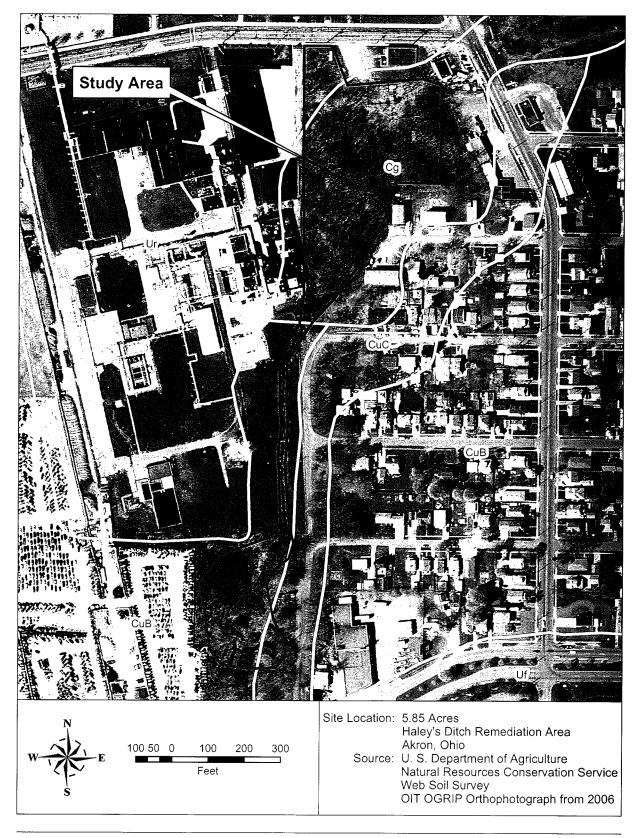
Appendix E Soils Information for Study Area

A map showing soil types from the U. S. Department of Agriculture Natural Resources Conservation Service Web Soil Survey (2007) is found in Appendix E. See Table 1 for a list of soil types mapped for the site.

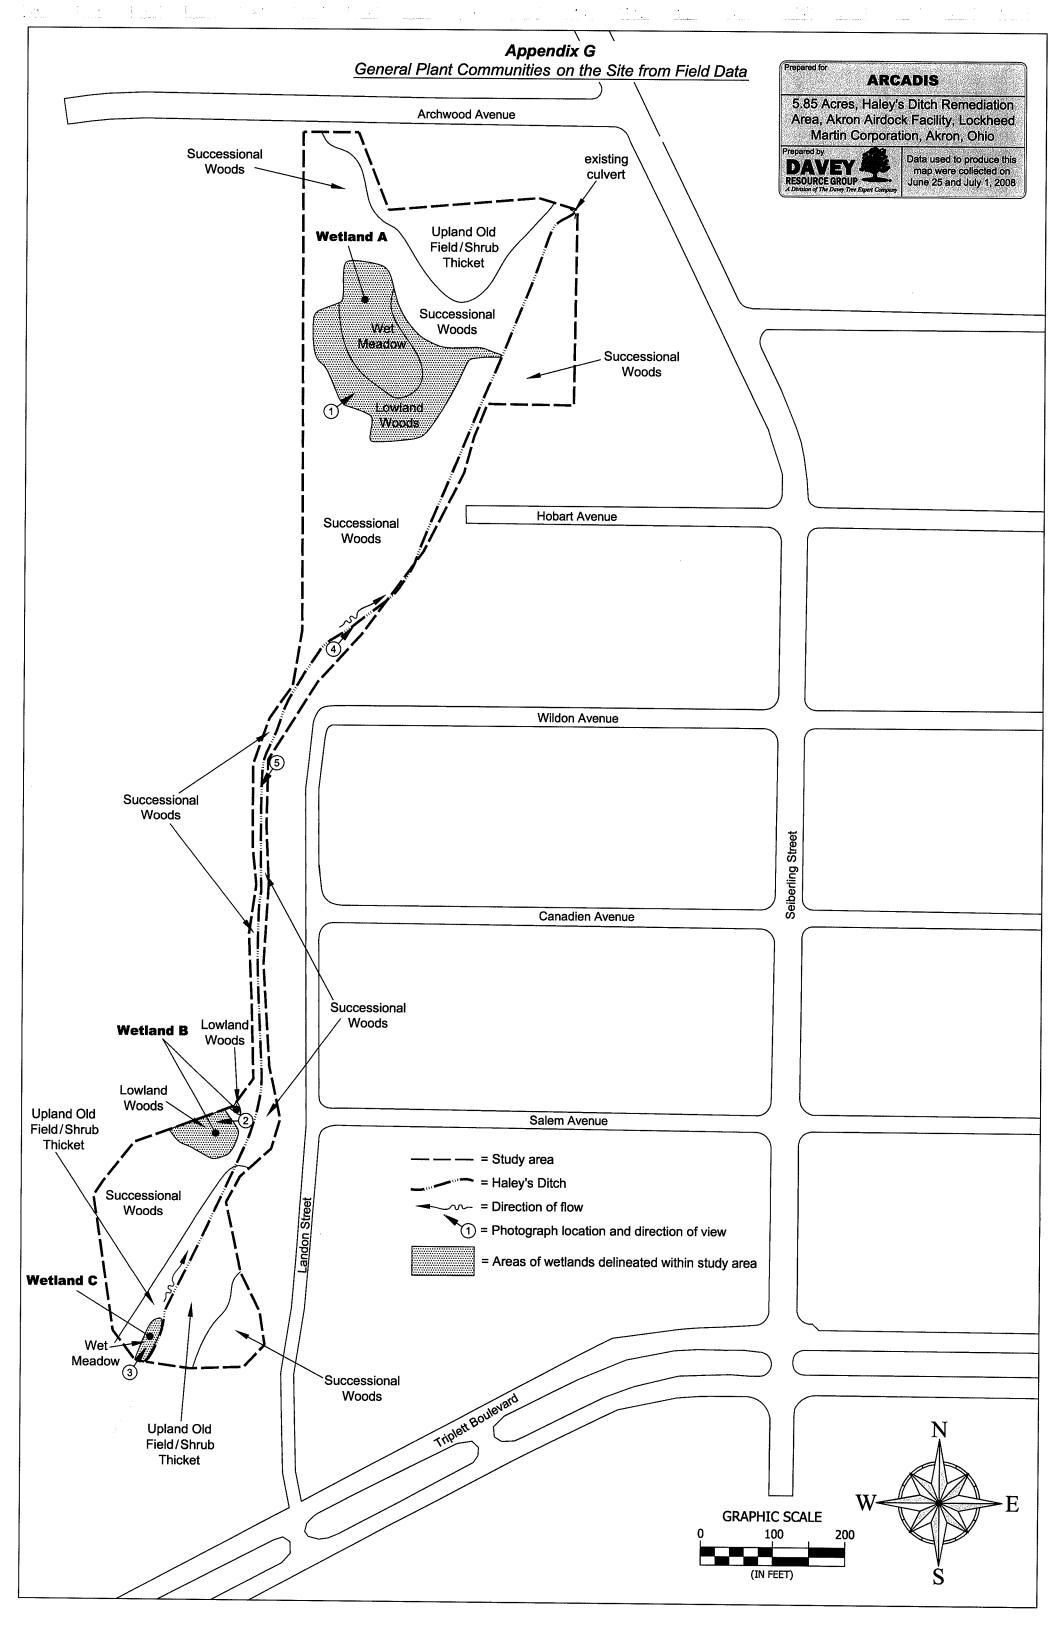
Appendix G General Plant Communities on the Site from Field Data

A map showing the locations of vegetative communities present on the property is in Appendix G. The site contains successional woods, upland old fields and shrub thickets, wet meadows, and lowland woods. Species identifications are based on Braun (1989), Newcomb (1977), and Weishaupt (1971). Reed (1988) was consulted to assign wetlands indicator statuses to plant species.

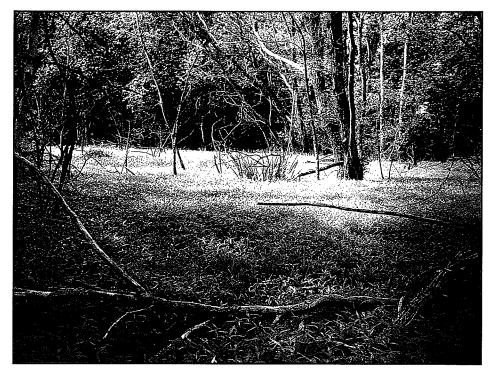
Photograph 1 (6-25-08) Wetland A is a lowland woods and wet meadow.

Wet Meadows. All of Wetland C and portions of Wetland A are wet meadows (Photographs 1 and 3, Appendix H). Common species include *Impatiens capensis* (spotted touch-me-not, FACW), *Leersia oryzoides* (rice cutgrass, OBL), and *Polygonum pennsylvanicum* (Pennsylvania smartweed, FACW).

Lowland Woods. All of Wetland B and portions of Wetland A are lowland woods (Photographs 1 and 2, Appendix H). These areas contain *Acer saccharinum* (silver maple, FACW), *Impatiens capensis* (spotted touch-me-not, FACW), *Lysimachia nummularia* (creeping Jennie, FACW-), *Populus deltoides* (eastern cotton-wood, FAC), and *Viburnum recognitum* (northern arrow-wood, FAC).

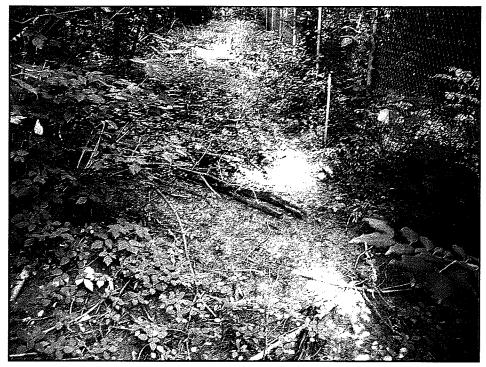
Photograph 2 (6-25-08) Wetland B is a lowland woods.

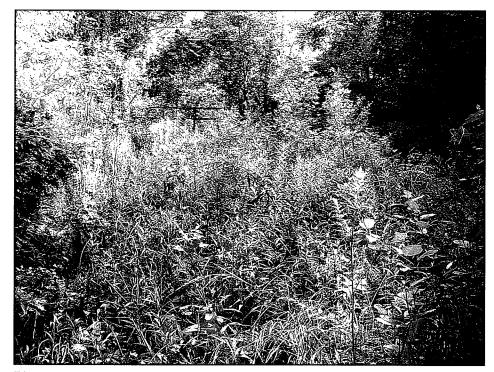
Photograph 3 (6-25-08) Wetland C is a wet meadow.

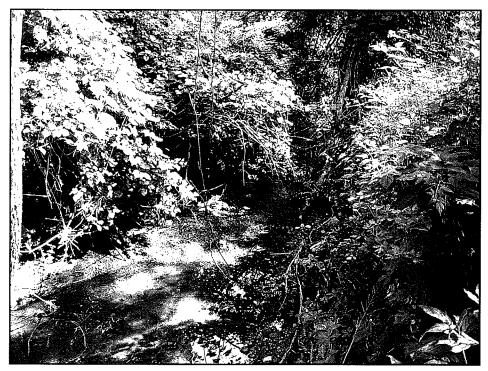
Photograph 4 (6-25-08) Haley's Ditch, the northern portion of the site, is surrounded by successional woods.

Haley's Ditch flows north through the study area, entering a culvert at the north end of the site (Photographs 4 and 5, Appendix H). Haley's Ditch continues flowing north through the Goodyear Tire and Rubber Company property, eventually entering Springfield Lake Outlet, which in turn enters the Little Cuyahoga River, a tributary to the Cuyahoga River. The Cuyahoga River has a watershed area of 809 square miles and debouches into Lake Erie in the City of Cleveland.

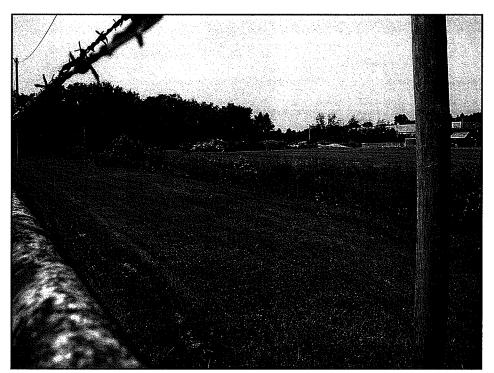
Photograph 5 (6-25-08) Haley's Ditch in the central portion of the site is surrounded by a narrow area of upland old field.

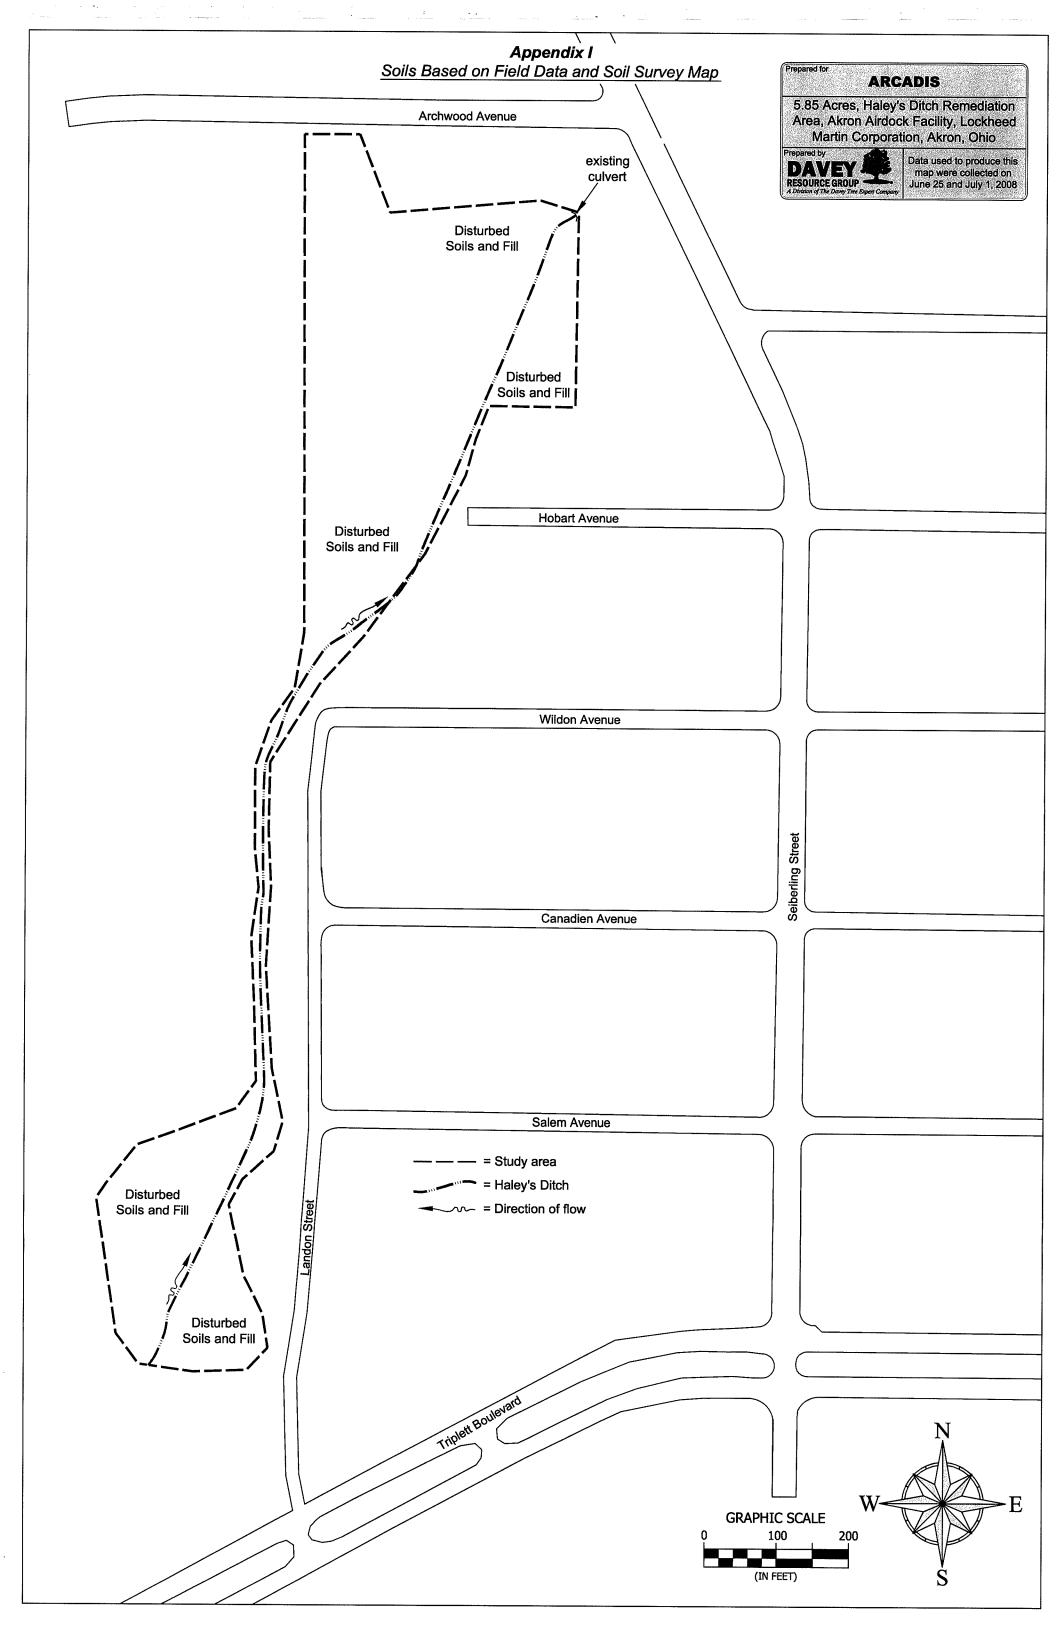
Appendix I Soils Based on Field Data and Soil Survey Map

The soils on the site are disturbed. There are areas of fill as well as soils that have been disturbed from years of stream dredging and channelization. A large area of soils mapped as Carlisle muck in the northern portion of the site could not be located in the field. A map showing the general locations of soil types as shown on the soil survey and identified in the field is included in Appendix I.

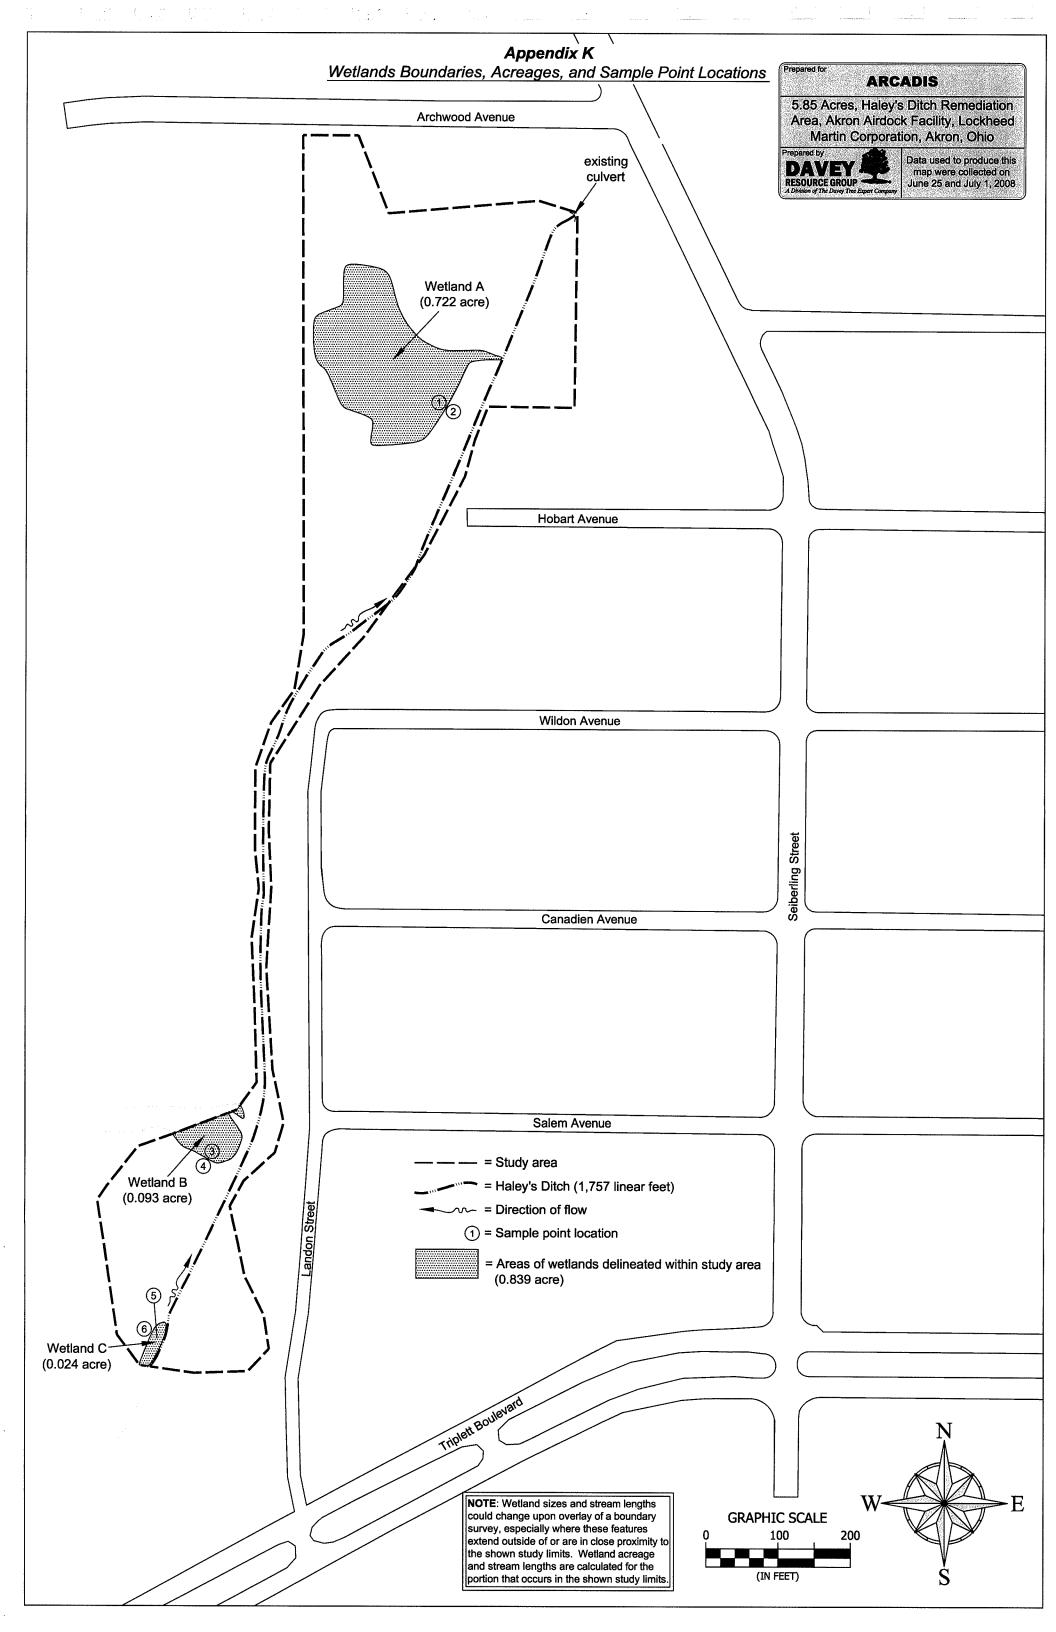
Appendix K Wetlands Boundaries, Acreages, and Sample Point Locations

A map showing the location and size of the jurisdictional wetlands and aquatic features identified on the property, along with the locations of sample points, is shown in Appendix K. Three wetlands totaling 0.839 acre are found within the study area (Table 2). In addition to the wetlands, Haley's Ditch has a length of 1,757 linear feet.
