Airdock Exterior Remediation Plan and Schedule

Airdock Remediation Plan and Schedule

Airdock 2003 – 2004 Exterior Sampling Summary

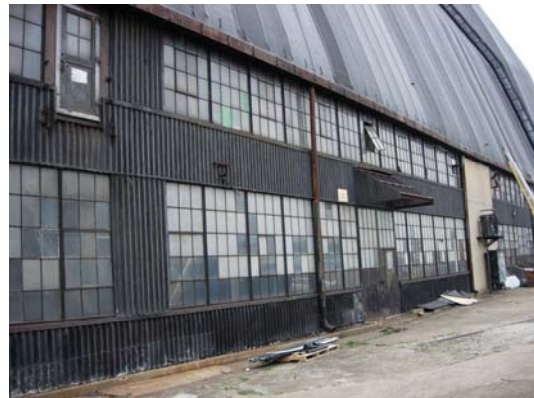
Typical Airdock vertical siding

The Airdock roof membrane ends at the gutter approximately twenty-four feet above the ground. The bottom twenty four feet of the Airdock exterior is vertical and consists of windows, doors, siding and associated structures and equipment. On the Airdock doors the rubber roof membrane ends just above the translucent panels. The plan is to replace the entire vertical siding below the gutter on the arched segments, and all translucent panels and exposed siding on the doors. In addition to the siding on the Airdock, the siding and roofing material for the four door motor buildings, the

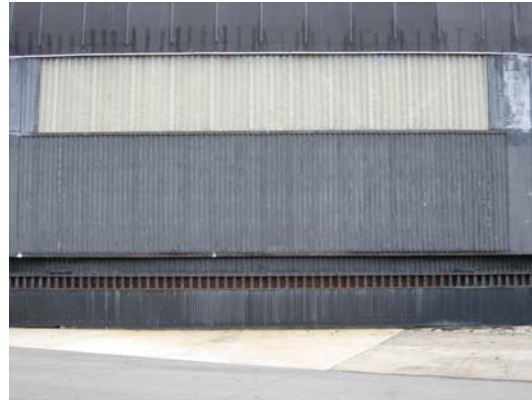
Typical Airdock door siding

helium compressor (fire pump house) building and the electrical substation building will be replaced because these materials also are RPM. The new siding will be corrugated painted metal and the translucent panels will be replaced with the same material.
