Lockheed

SERVICE NEWS

VOL. 10, NO. 1, JANUARY—MARCH 1983

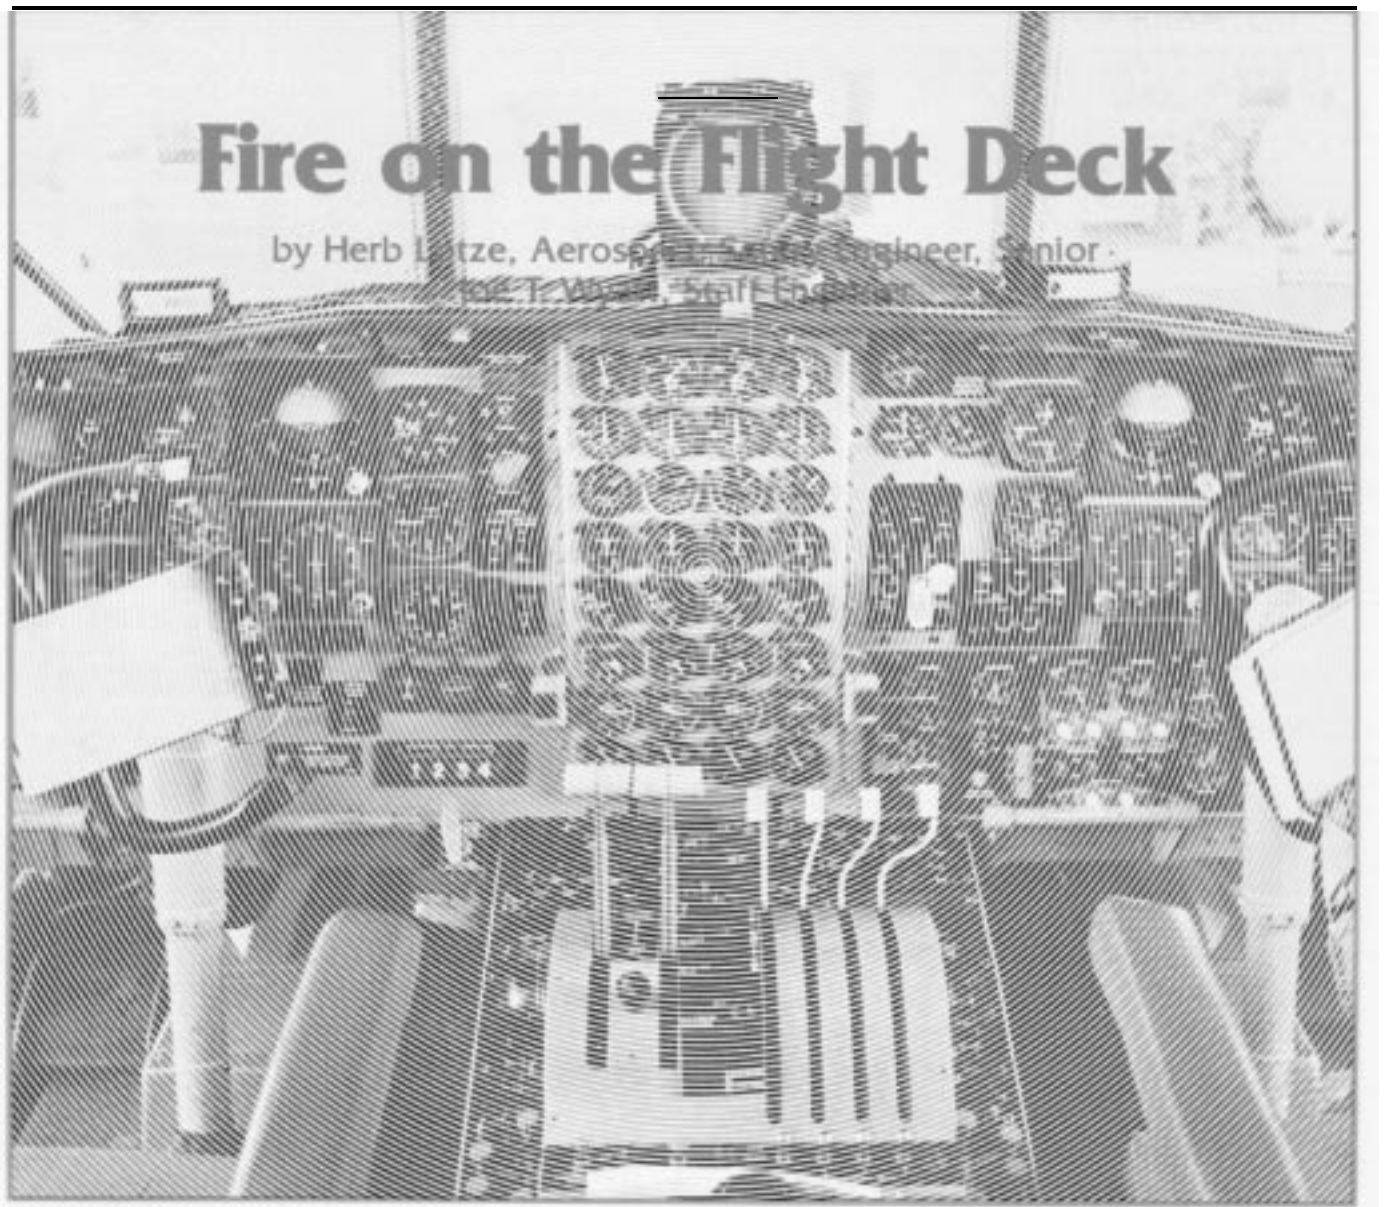
Figure 1. The aftermath. A well-intended effort to solve a minor problem ultimately yielded this scene of destruction.

creased in intensity as the aircraft was stopped and crew members made an emergency evacuation. Fire and crash equipment operators on the scene were able to save the airplane, but the flight station area sustained heavy damage (Figure 1).

Engineering review is currently in process to block unwanted access to Hercules aircraft power distribution areas, but hardware alone cannot provide total protection against the consequences of innovative "solutions" to transient problems that fail to take all possible risk factors into account.

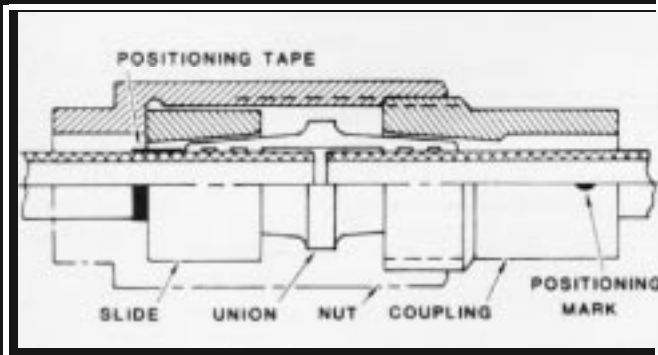
Figure 1. "H" fitting components in position for the swaging action.

A cross section of the "H" fitting assembly is illustrated in Figure 1, which shows the positions of the parts before installation is complete. Figure 2 shows the union swaged permanently to the ends of the tubing.

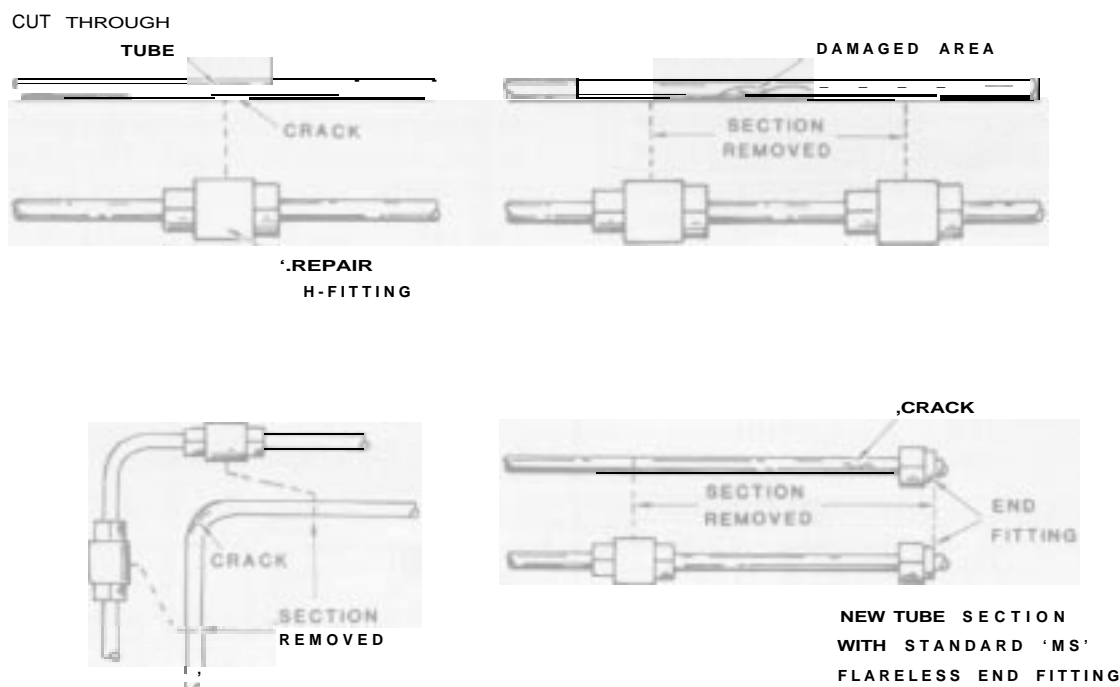
Figure 3. Typical “H” fitting repair installations.

A small defect will require a simple square cut through the tubing at the point of damage, allowing the fitting assembly to be slipped into position over the free ends. A single repair fitting will cover a relatively small area, as specified in the instructions for that tube and fitting size. Longer or curved sections to be replaced will require an “H” fitting at each end. Figure 3 illustrates some of the situations that occur and the approach in repairing each one.
