SERVICE NEWS

Troubleshooting APQ-122 Radar
The Amazing Hercules

Vol. 5, No. 2, April-June 1978

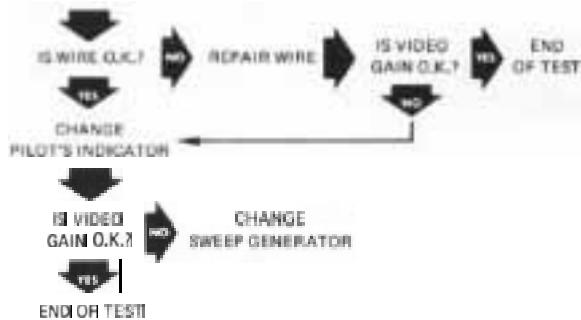
TROUBLESHOOTING CHART 14

Problem: Pilot has no control of video gain.

CHECK VIDEO GAIN
WIRE FROM SWEEP
GENERATOR (15J2-Z1)
TO PILOT'S INDICATOR
-1W1-Z1

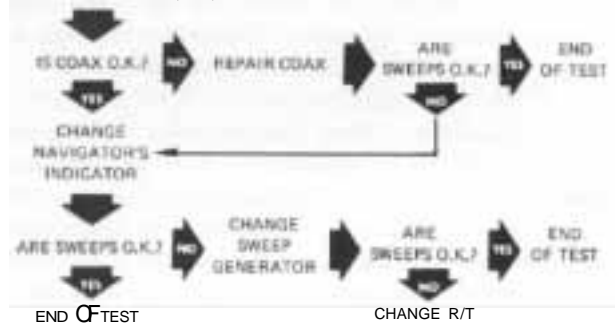
TROUBLESHOOTING CHART 23

Problem: LOSS of sweep on both indicators.

CHECK COAX FROM R/T (7J31 TO NAVIGATOR'S INDICATOR (17J4) AND FROM NAVIGATOR'S INDICATOR (17J5) TO SWEEP GENERATOR (15J4)

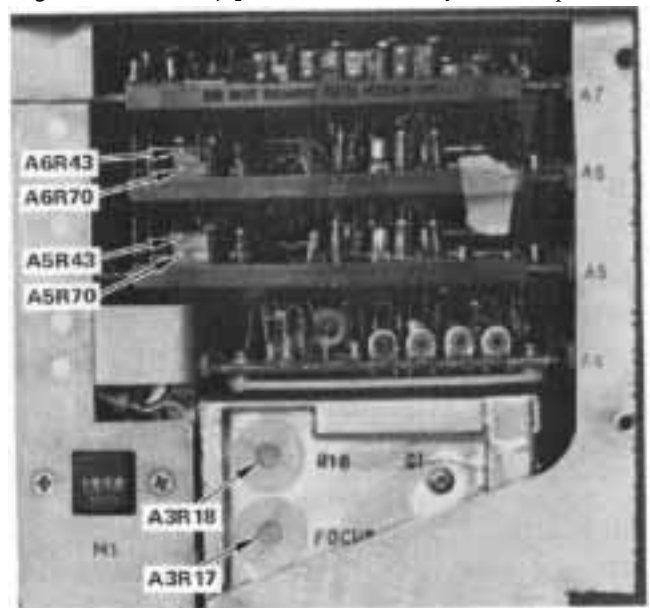
Figure 1. Location of pilot's indicator adjustment points.

Gain Adjustment - When changing either the pilot's indicator or the sweep generator, it may be necessary to match the two units by adjusting potentiometer A3R18 (Figure 1). To make this adjustment, turn the sweep intensity control on the front panel of the pilot's indicator fully clockwise and the video gain control fully counterclockwise. Adjust potentiometer A3R18 until the sweep is just visible, then readjust until the sweep barely disappears. If this adjustment is not successful, change the indicator.

Focus Adjustment - Set the range marks for optimum viewing, then adjust potentiometer A3R17 (Figure 1) for the required focus on the face of the display. If the focus does not optimize, change the indicator.

3. Set the relative bearing control on the antenna control panel to zero.
4. Adjust potentiometer A5R43 (Figure 1) to position the vertex at the center of the display (cosine adjust).

5. Rotate the relative bearing control on the antenna control panel to 90°.
6. Adjust potentiometer A6R43 (Figure 1) to position the vertex at the center of the display (sine adjust).

7. Rotate the relative bearing control on the antenna control panel to zero degrees.
8. Adjust potentiometer A5R70 (Figure 1) until the entire fifth range mark appears at the edge of the display.

10. Rotate the relative bearing control on the antenna control panel to 90°.
11. Adjust potentiometer A6R70 (Figure 1) until the entire fifth range mark appears at the edge of the display.

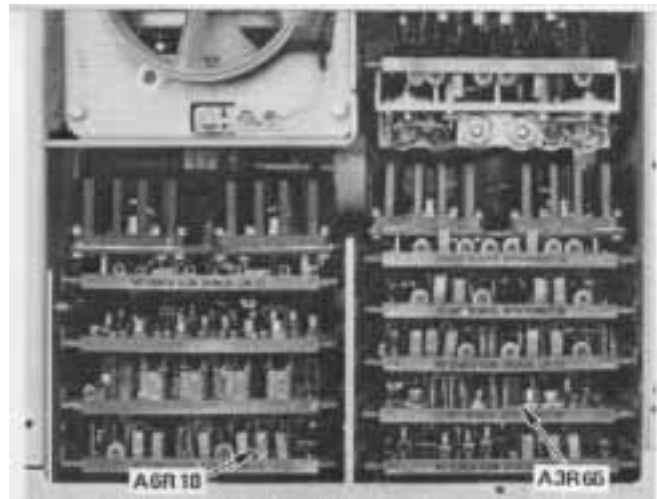
Figure 2. A dash 3 navigator's indicator with cover removed for access to adjustment points. NOTE: Cursor alignment for the dash 3 indicator must be accomplished on the bench while the dash 1 and dash 2 indicators can be adjusted on the airplane. On the dash 1 and dash 2 indicators there will be a potentiometer, A3R65, in the position noted on the photo, which is used to adjust for cursor position.

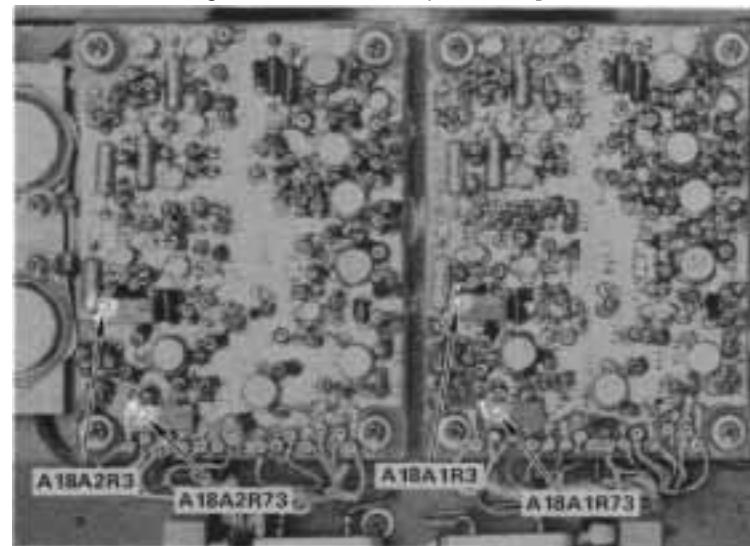
Figure 3. Location of navigator's indicator adjustment points.

3. Adjust the relative bearing control on the antenna control panel to 0°.
4. Adjust potentiometer A1 8A1 R3 (Figure 3) to center the vertex of the vertical sweep (cosine adjustment).
5. On the antenna control panel rotate the relative bearing control to 90°.
6. Adjust potentiometer A1 8A2R3 (Figure 3) to center the vertex of the horizontal sweep (sine adjustment).
7. On the antenna control panel rotate the relative bearing control to 0°, and adjust potentiometer A18A1R73 (Figure 3) until the entire fifth range mark appears at the edge of the display.

8. Rotate the relative bearing control on the antenna control panel to 180', and check that the fifth range mark appears at the same relative position at the bottom of the display. It may be necessary to adjust potentiometers A18A1R3 and A18A1R73 (Figure 3) to fine adjust the sweep in the vertical plane.

9. On the antenna control panel, rotate the relative bearing control to 90', and adjust potentiometer A18A2R73 (Figure 3) until the entire fifth range mark appears at the edge of the display.

10. On the antenna control panel, rotate the relative bearing control to 180', and check that the fifth range mark appears at the same relative position on the left edge of the display. It may be necessary to adjust potentiometers A18A2R3 and A18A2R73 (Figure 3) to fine-adjust the sweep in the horizontal plane.
