VOL. 15, NO. 2, APRIL-JUNE 1988

# *SERVICE* *NEWS*

# TROUBLESHOOTING ENGINE OIL LOSS

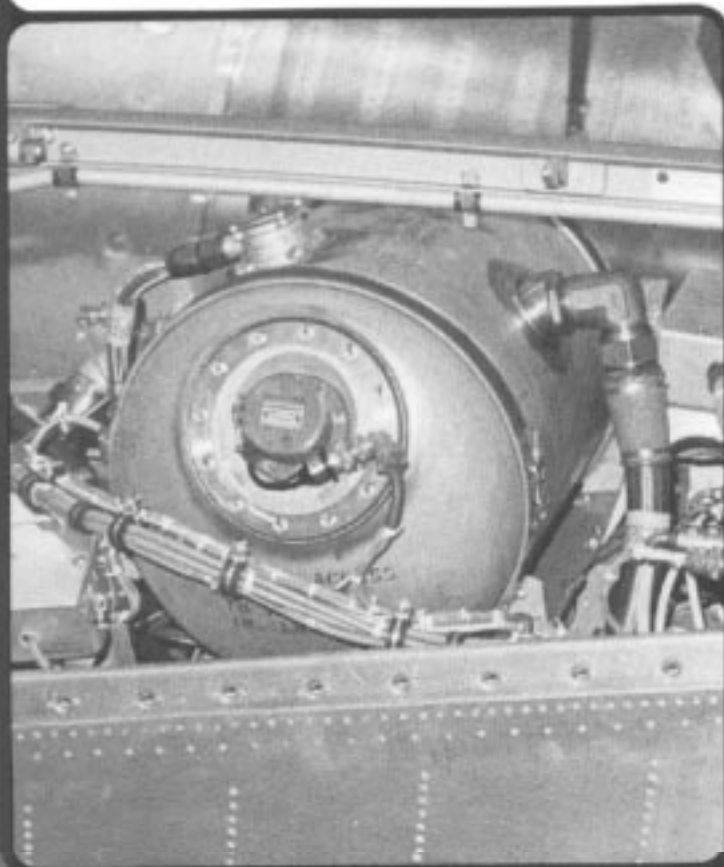
## Scavenge Oil Leakage

Some areas deserve special attention. A number of occurrences of scavenge oil leakage at the external oil pump outlet tube of the power section accessory drive housing have been reported, and these have generally involved the PN 6784121 aluminum alloy union fitting that is threaded into the magnesium accessory case at that location.

Experience has shown that this fitting is highly susceptible to damage from the application of too much torque during installation. Even slight overtorquing of the union in the accessory case may strip the threads in the magnesium casting and result in oil leakage.

If the correct torquing techniques are used, it is unlikely that the threads in the accessory case will ever be stripped. But should it nonetheless become necessary to repair a leak at this location because of damaged threads, it is possible to correct the problem by following the instructions and specifications in the Allison *Commercial Engine Bulletin 72-1525* or T.O. 2J-T56-43, Figure 6-140A, page 6-158C, Change 42.

Note that this repair is best accomplished at overhaul because it is difficult to gain access to the area where the union is located while the engine is installed on the aircraft.

The repair procedure consists of reworking the bore as necessary to allow it to accept a PN 6879168 union fitting. This fitting is slightly larger in diameter than the part it replaces and has more threads. This extra thread engagement will reduce the tendency for the accessory case to become damaged. It is advisable, however, to exercise the same care in torquing the new union as is specified for the original.

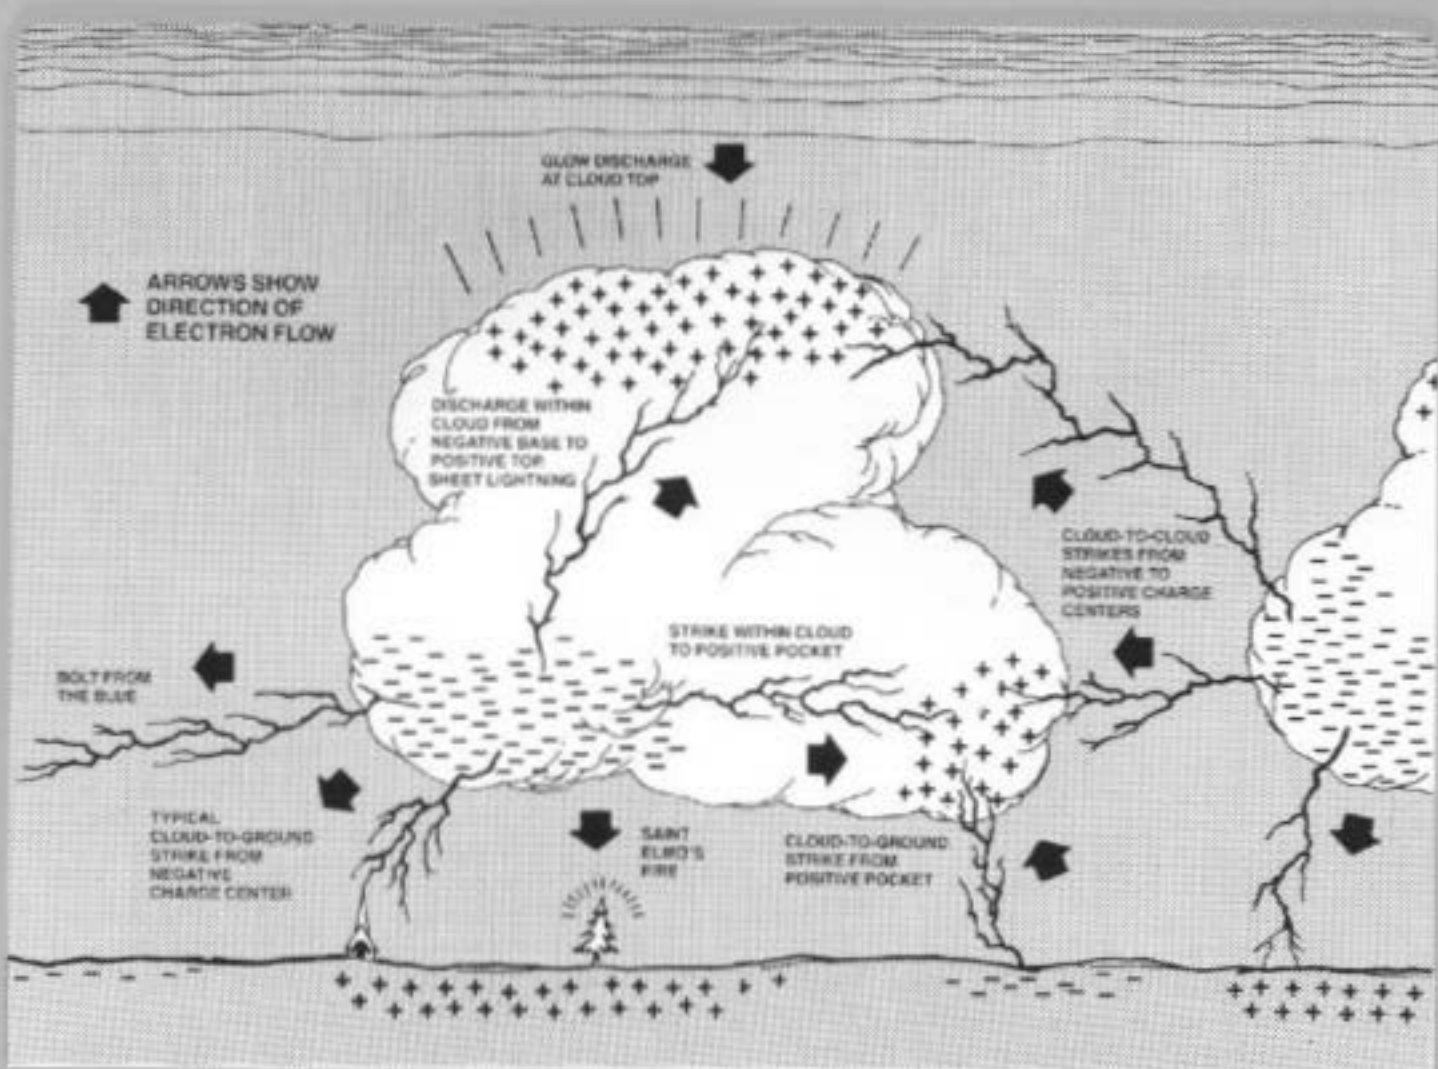
Small pits, marks, or holes melted in the skin may occur in the area of the lightning attachment points. In areas such as trailing edges, where the flash can hang on for a

longer period, there is the possibility of a hole being melted. There may also be some crimping or deformation of metal skin caused by the intense magnetic fields generated by strike currents.
