***T56 Oil System
Maintenance***

Lockheed SERVICE NEWS

Vol. 18, No. 3, July-September 1981

A Guide to Oil Loss Prevention

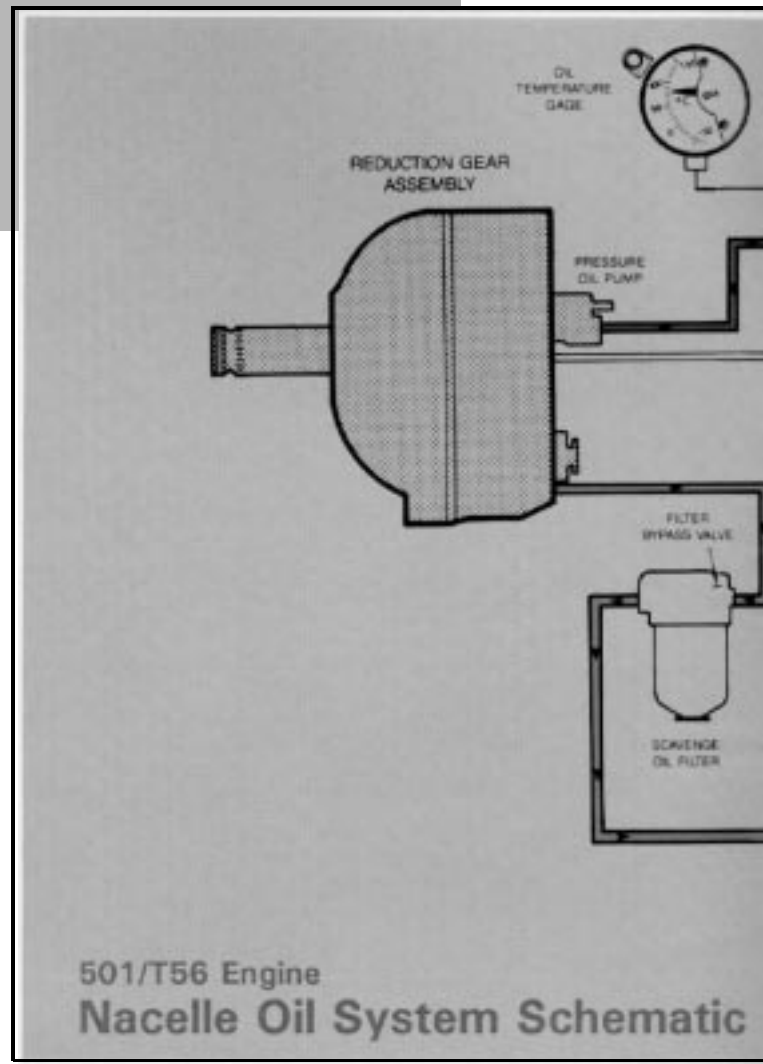
Figure 1.

The overall 501/T56 engine lubrication system consists of two essentially independent systems (Fig. 1). They are the pressure lubrication system and the dry-sump scavenge recovery system. These two systems, commonly known as the "pressure side" and the "scavenge side," actually have only one thing in common, and

There are three components in the oil system that are directly affected by altitude (Fig. 1). The oil tank pressurization valve is a spring-loaded valve that controls the amount of pressure in the oil tank. The spring tension on the valve may become too weak and possibly cause a change in oil tank pressure, or the valve could stick open or closed and cause problems. As a practical matter, there is not too much that can go wrong with this valve because of its simplicity. Replacing it does not often correct an oil dumping problem. It is a factor which should be considered, however.

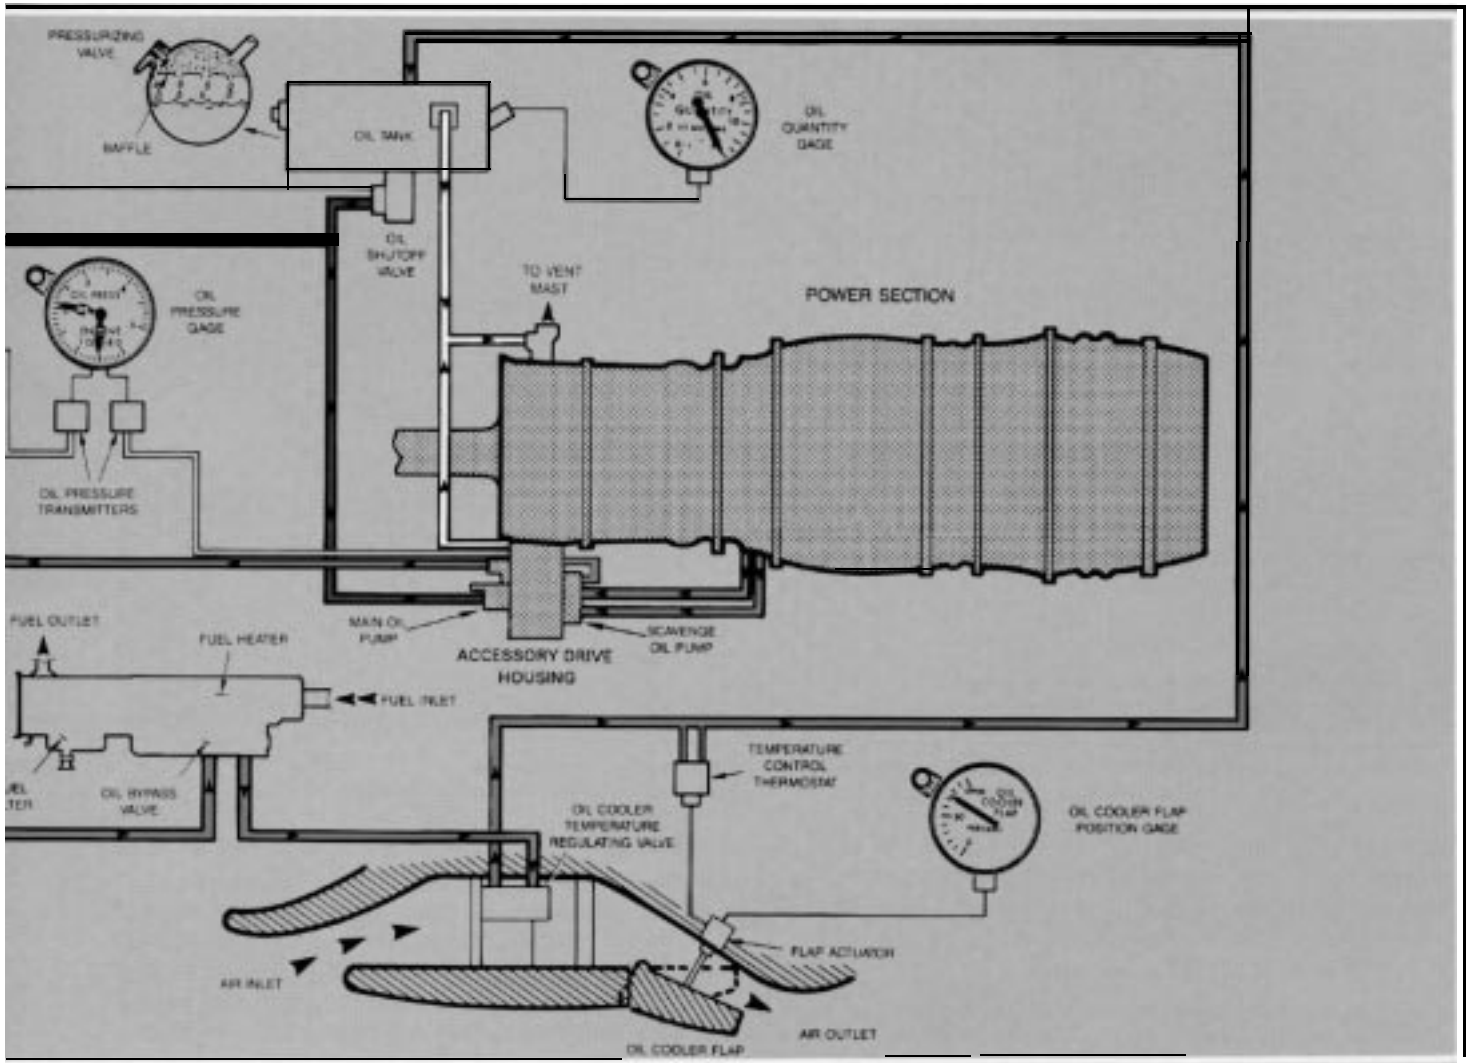
The most common cause of static leakage, also called gravitational flooding, is an improperly functioning oil retention check valve. This may occur either in the power section oil filter assembly or in the reduction gearbox oil pump assembly (Fig. 2).

Figure 2. Improperly functioning oil retention check valves are a common cause of static oil leakage.

the oil retention check valves. Sometimes there will be evidence of oil dripping out of the bottom compressor bleed valves, and sometimes there will be oil in the tail pipe or intake. On the other hand, there may be no external indication of oil leakage at all.

When a static leak is suspected, perform the following confirmation check. Verify that the oil quantity gage of the affected engine shows at least four gallons present to provide lubrication, and then motor the engine briefly.
