# SERVICE NEWS

VOL. 10, NO. 2, APRIL—JUNE 1983

*Engine-Driven Hydraulic Pumps*

# Engine-Driven Hydraulic Pumps:

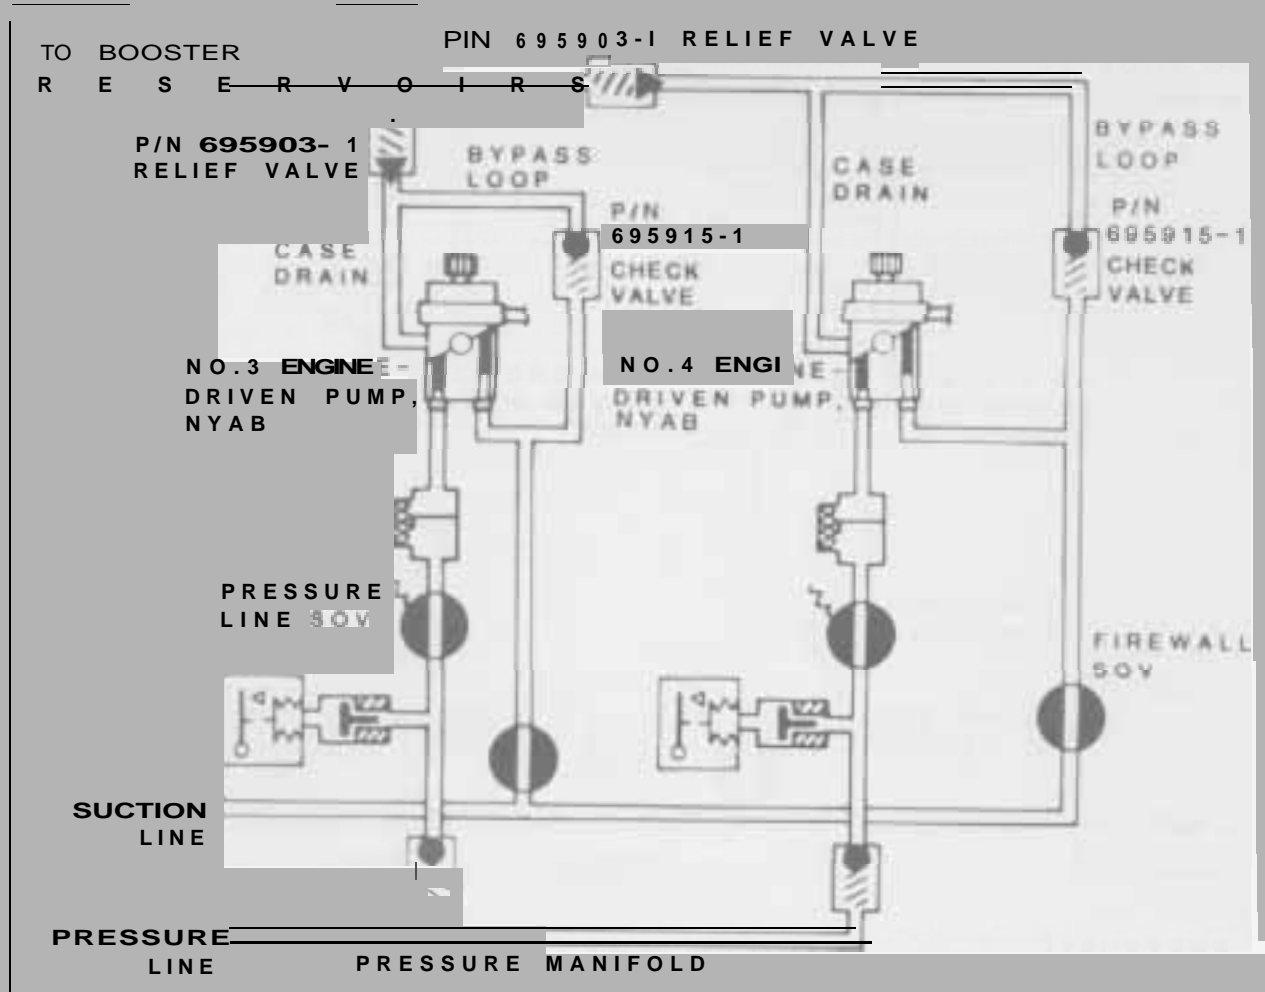
Figure 1. Baseline hydraulic configuration on Hercules aircraft LAC 3501 to LAC 4181.

with P/N 66WBD300 New York Air Brake Company engine-driven hydraulic pumps. The New York Air Brake (NYAB) pump requires a bypass loop connecting the case drain line and the suction line (Figure 1). The bypass loop is required because the design of the pump is such that it receives its lubrication from the hydraulic fluid in the suction line. This causes no difficulty unless one of the engine-driven pump switches on the copilot's instrument panel is placed to OFF or the fire emergency handle for an engine is pulled. When this happens, the normal source of lubricating fluid for the affected pump is no longer available even though the need for lubrication is still present.

pump was incorporated in the system's plumbing for the specific purpose of maintaining lubrication to the pump when the firewall and pressure line shutoff valves are closed. The bypass loop routes case drain fluid back into the suction line and thereby provides the necessary lubrication. A P/N 695903-1 relief valve in the case drain line set to open at 22 psi ensures that hydraulic fluid will be forced into the bypass loop whenever loss of pressure in the suction line caused by the closing of the firewall shutoff valve allows the P/N 695915-1 check valve to open.

This plumbing configuration is the only one of those found on Hercules aircraft that will keep the NYAB engine-driven hydraulic pump lubricated and within its temperature design limit when it is operating and the firewall and pressure line shutoff valves are closed.

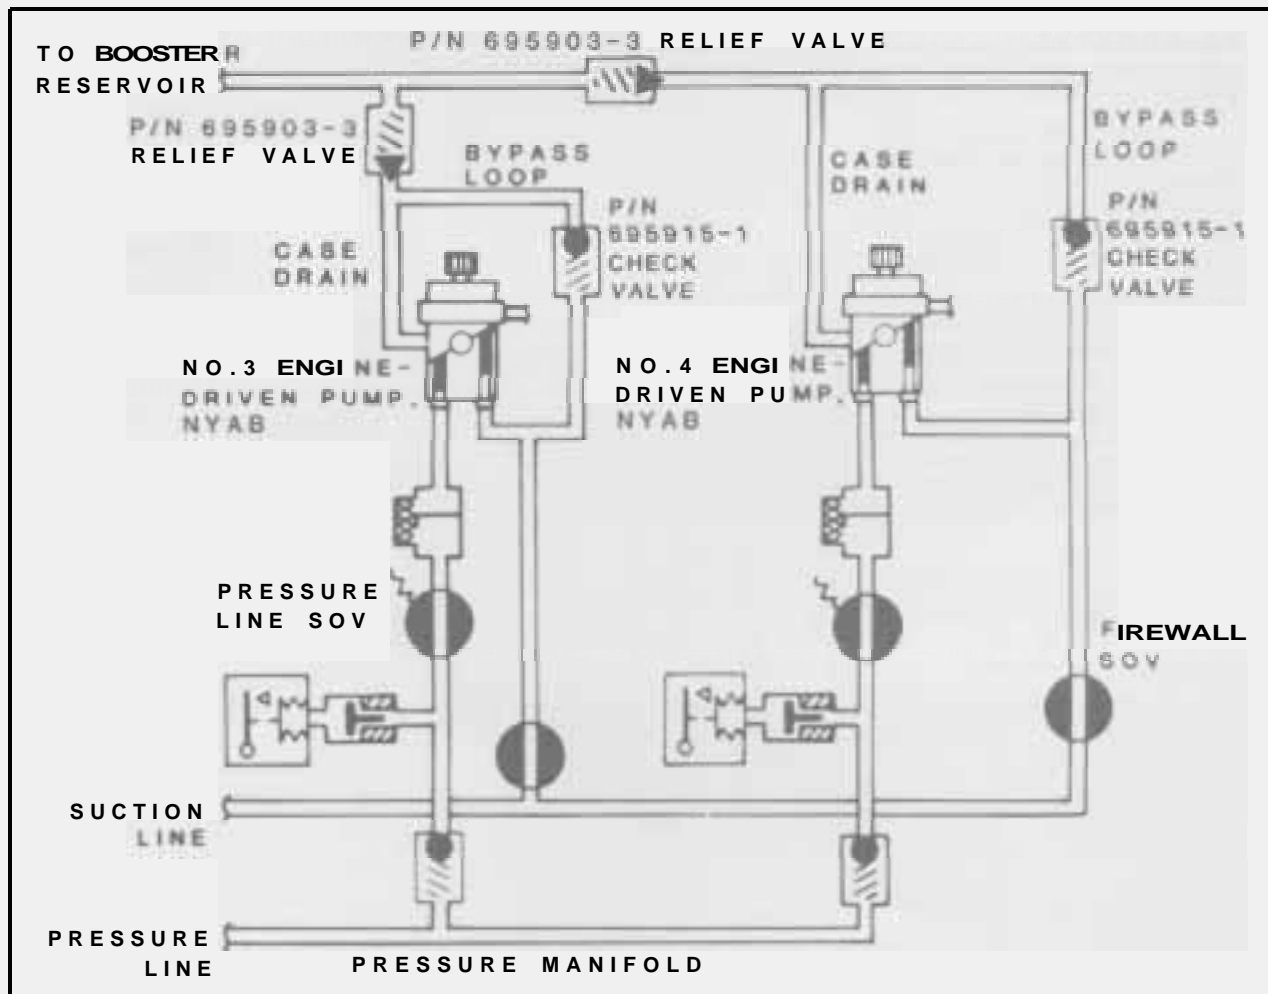
Figure 2. The baseline configuration of LAC 4182 to LAC 4429; note relief valve change.

There was one minor change to the NYAB plumbing at Lockheed serial number LAC 4182. The 695903-1 relief valve was replaced by an improved relief valve, P/N 695903-3 (Figure 2). The change in relief valves did not affect the pump itself.

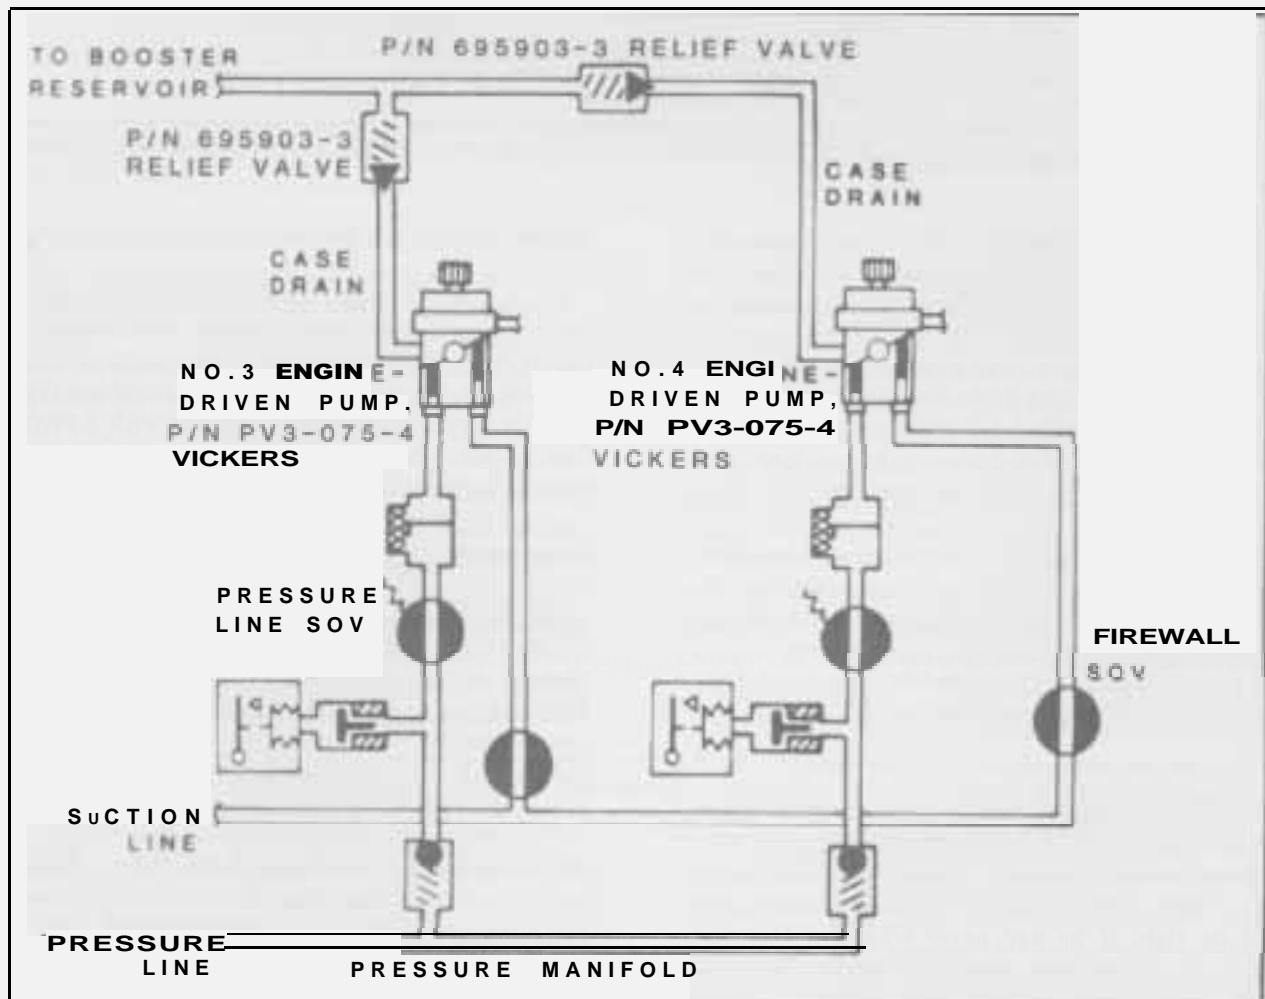
Figure 3. At LAC 4430, Vickers pumps were introduced and the bypass loops deleted.

The P/N PV3-075-4 Vickers engine-driven hydraulic pump is an in-line pump whose design is such that it uses the fluid that has been forced into the case drain line for internal lubrication. Tests showed that with the firewall and pressure line shutoff valves closed, the use of a bypass loop caused the Vickers pump to generate an operating temperature that exceeded the permissible value. The bypass loop was therefore deleted from the plumbing configuration (Figure 3). The new arrangement allowed the Vickers pump to remain within safe temperature limits under all operating conditions.

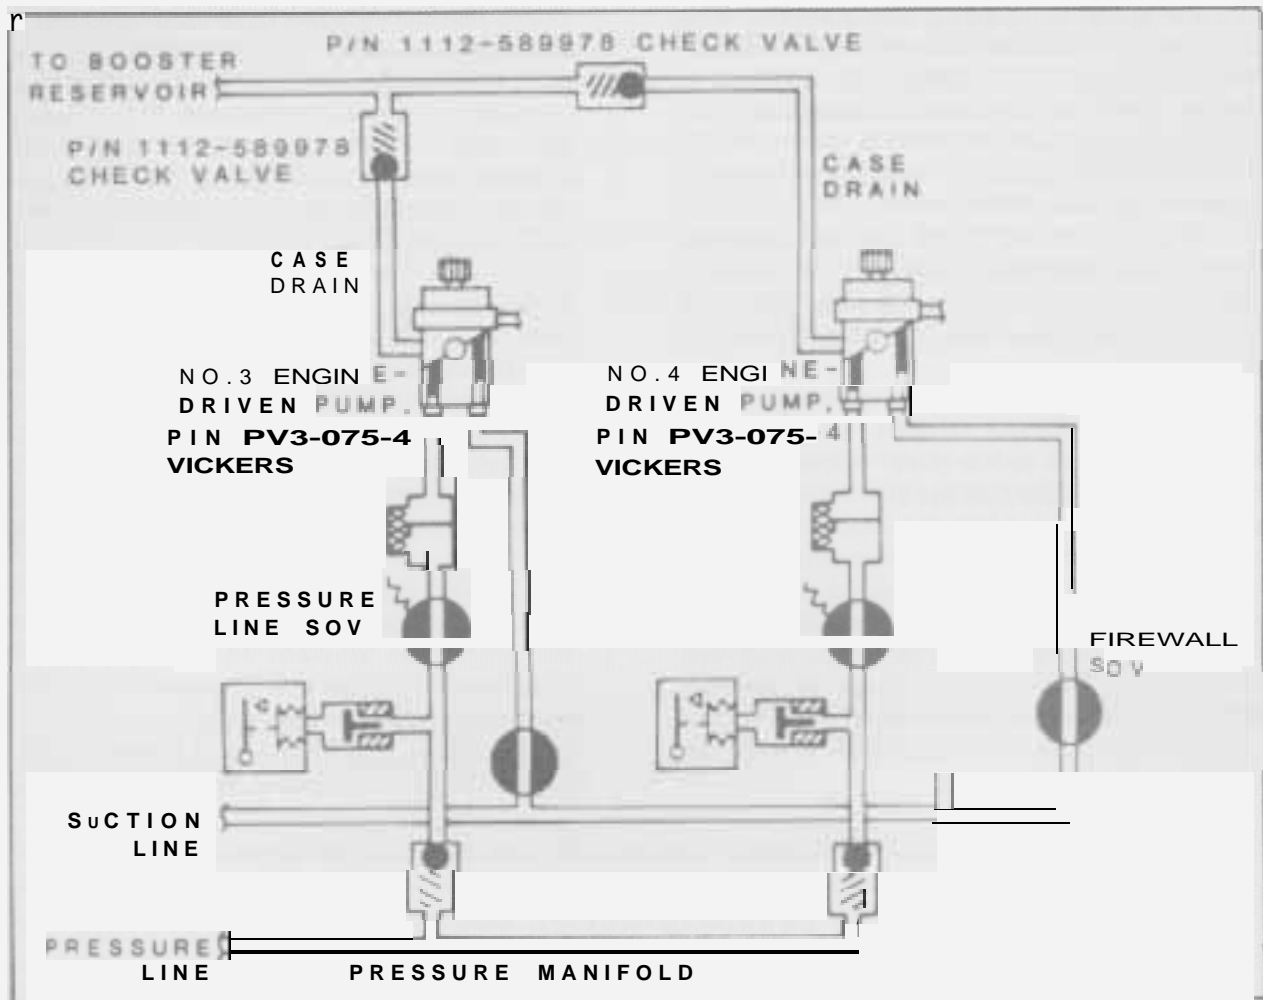
Figure 4. The baseline configuration of LAC 4458 to LAC 4652 | ne ~~float~~ valves have been replaced by check valves.

Note that the 695903-3 relief valve remained in the case drain line in this configuration. Tests performed at Lockheed later determined that a check valve could be installed in place of the 695903-3 relief valve, and that a cost saving would result. The relief valve was therefore deleted, and a P/N 1112-589978 check valve used in its place starting with Lockheed serial number LAC 4459 (Figure 4).

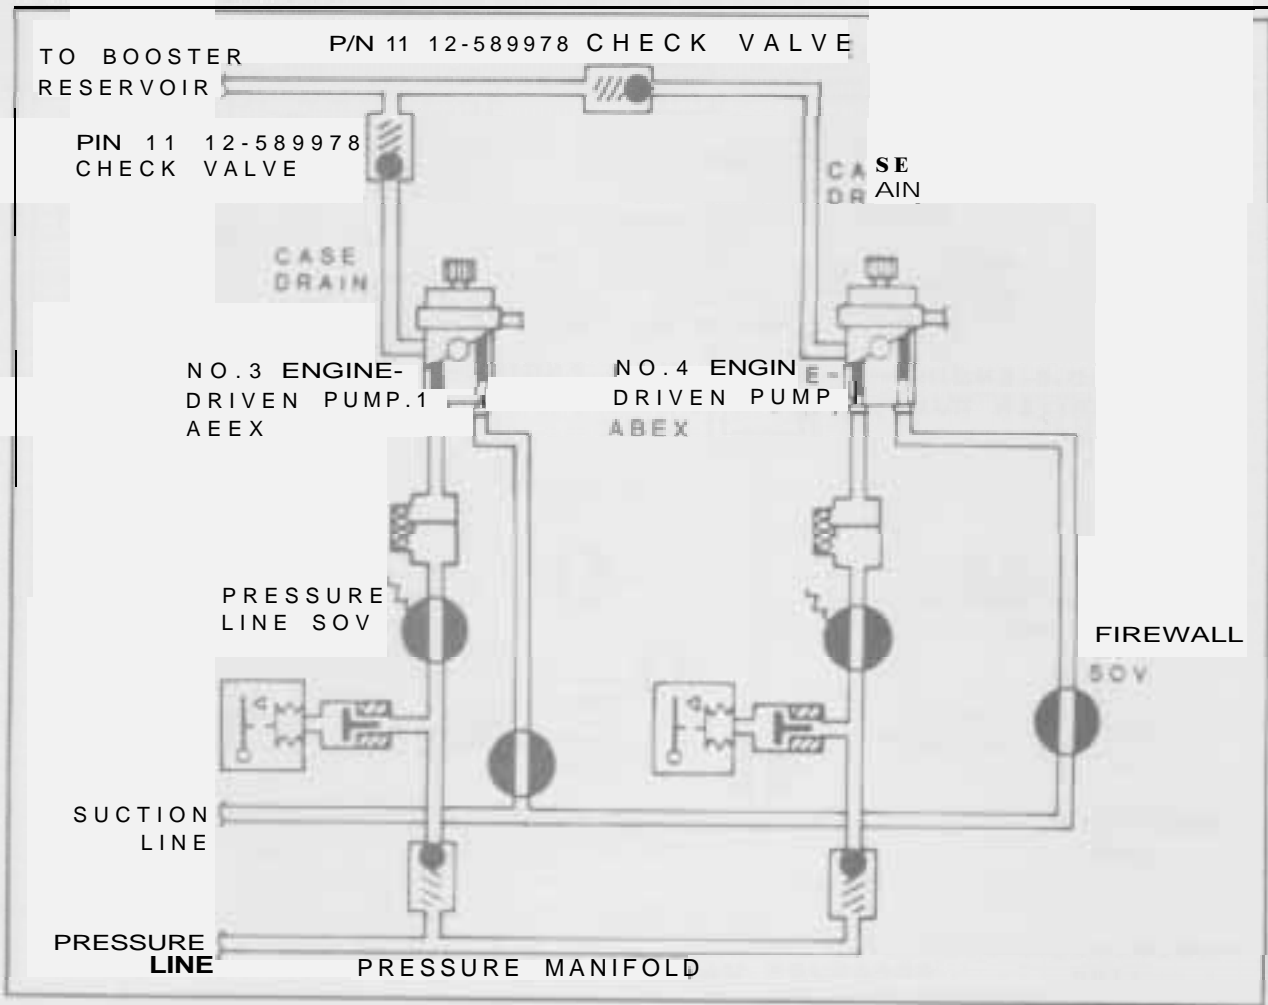
Figure 5 The Abex pump was introduced at Hercules aircraft LAC 4653 No changes were required in the basic system design.

pumps (Figure 5). The P/N 66039 Abex pump contains a thermal off-stroke feature which allows it to be used in any of the four hydraulic plumbing configurations we have previously described. It can be used with or without a bypass loop, and with either a relief valve or check valve in the case drain line. The baseline configuration starting with LAC 4653 and presently in effect uses the 66039 Abex pump, no bypass loop, and a 1112-589978 check valve in the case drain line.

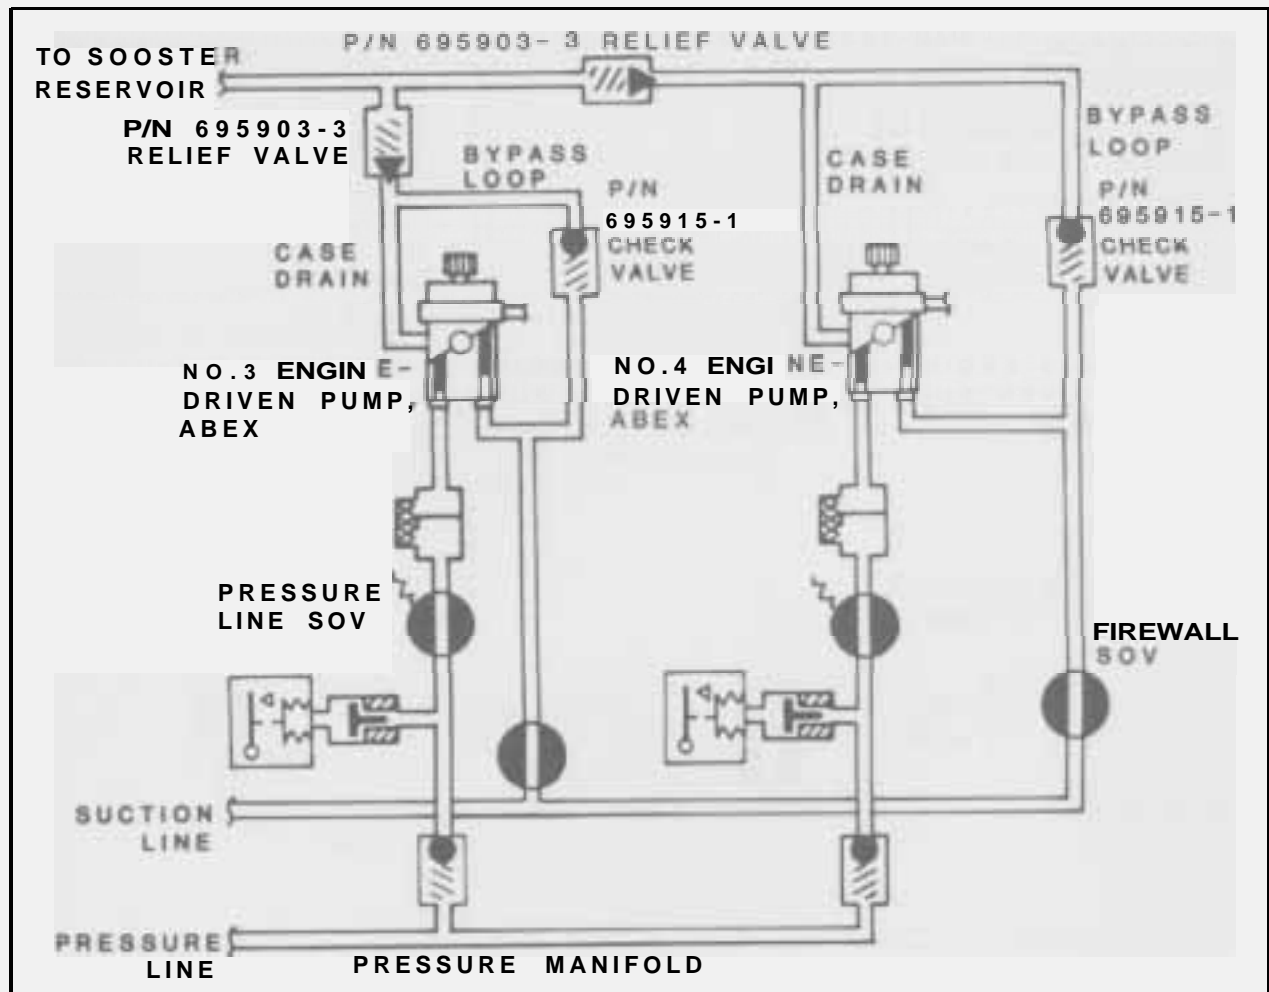
Figure 6. System plumbing configured for use with either NYAB or Abex pumps.

If a repeat customer originally bought Hercules aircraft equipped with NYAB pumps, Abex pumps with bypass loops and 695903-3 relief valves would be installed on the subsequent aircraft purchase (Figure 6). This would provide the customer with a Hercules fleet in which NYAB or Abex pumps could be used interchangeably.

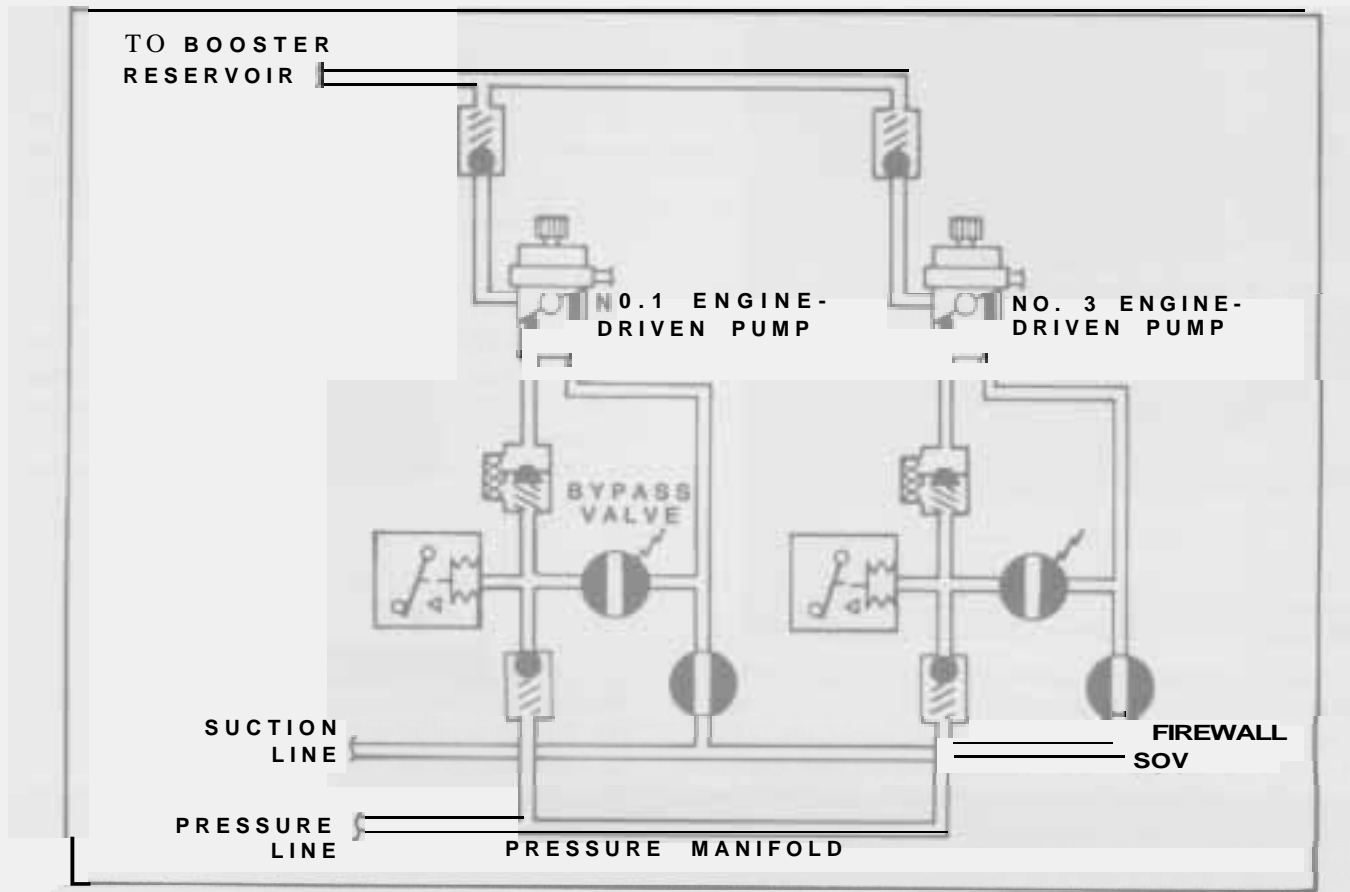
Figure 7. C-130A plumbing configuration; note bypass valves

We have not up to this point made any mention of the engine-driven hydraulic pumps of the C-130A. The reason is that the interchangeability of pumps on the A-model Hercules aircraft is not governed by the internal lubricating characteristics of the pump themselves. C-130As, originally equipped with NYAB pumps, have a bypass valve connecting the pressure and suction lines (Figure 7). The bypass valve will open to allow lubricating flow through the pump anytime the engine-driven pump switch is placed to OFF or the fire emergency handle is pulled. This plumbing configuration never changes, regardless of the type of replacement pump that might later be installed.

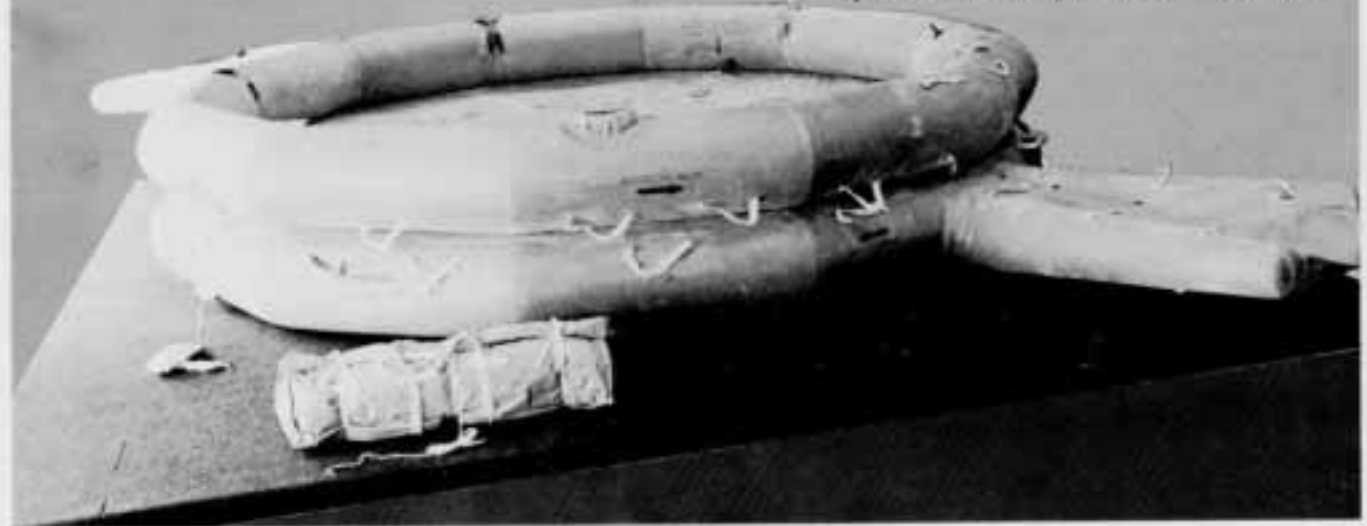
**Figure 1. Vent valve positions.**

this partial inflation occurs. Lockheed engineering has long suspected that the majority of these unscheduled life raft deployments occur either because the raft was incompletely evacuated prior to installation, or because the P/N 9153 vent valve on rafts so equipped has been left in the closed position. Figure 1 illustrates the appearance of the vent valve in both the closed (SHUT) and open (VENT) positions.

Additional evidence has recently come to light which tends to underscore the role that improper positioning of the vent valve plays in these life raft incidents. During a recent investigation of an inadvertent life raft deployment on a C-130H, the life raft compartments of several in-service Hercules aircraft were inspected at random. In one airplane, a life raft was discovered with the vent valve in the closed

position. The raft appeared to have been properly evacuated and installed, except for the valve position, but the access door clearly showed signs of damage. Each time the aircraft went to altitude, the air trapped in the raft expanded, pushing on the door latches. How long the raft had been installed could not be determined, but loss of the life raft appeared imminent because of bending of the door latches.

It is very important that the vent valve be left in the open (VENT) position once the life rafts are installed in their compartments. The porosity of the life raft material will not permit the raft to remain evacuated indefinitely, and venting of the raft is therefore required to avoid expansion at altitude. Also, if the vent is left closed, any leakage from the CO2 cylinders used to inflate the rafts for use cannot escape to the atmosphere and will enter the raft itself.
