SERVICE NEWS

VOL. 9, NO. 3, JULY-SEPTEMBER 1982

3 Thermocouples and TIT

Understanding thermocouples and their relationship to engine overtemperature conditions.

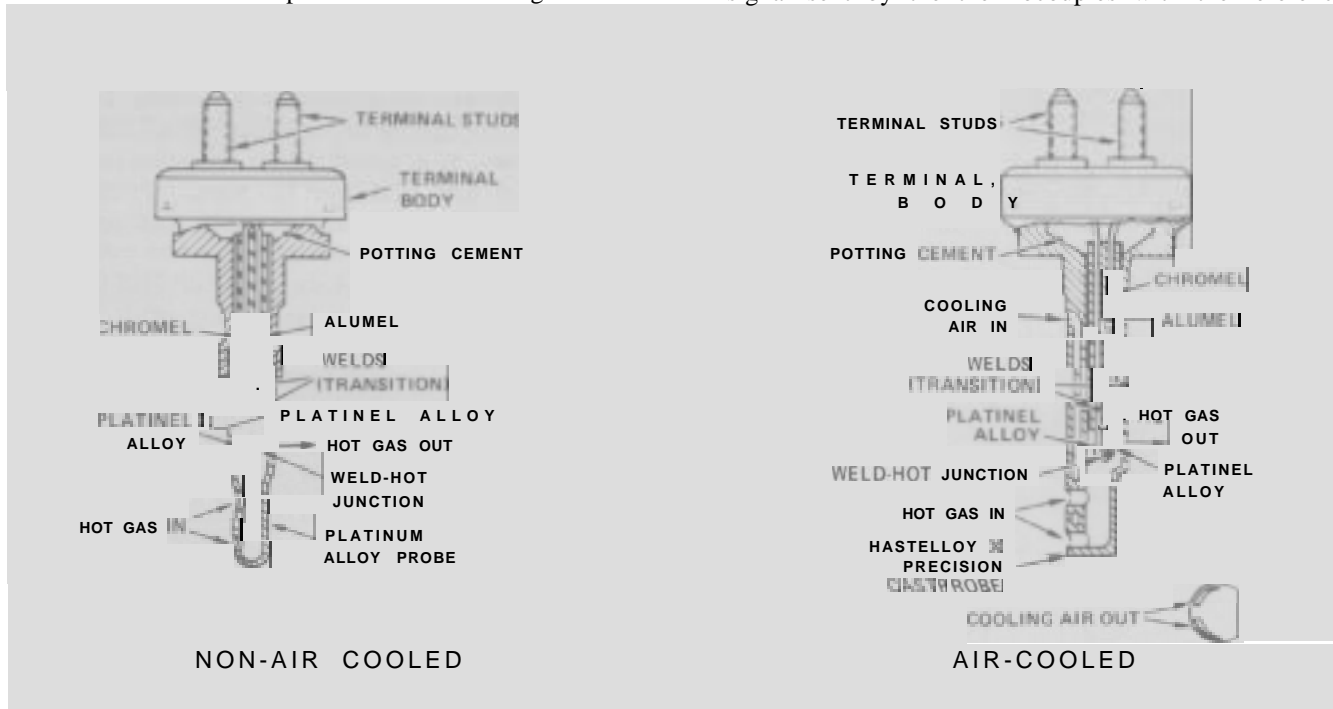
Figure 1. Principal features of non-air-cooled and air-cooled thermocouples.

Two basic types of thermocouples are used in 501/T56 engines, one that has no special provision for cooling and one that is air-cooled (Figure 1). A somewhat awkward convention in terminology has become established in which the one type is referred to as “non-air-cooled,” and the other as air-cooled. Note in particular that there are two configurations of the non-air-cooled type of thermocouple. One is used with T56-A-9, T56-A-7, and 501-D22 engines, and the other was installed in earlier T56-A-15, T56-A-16, T56-A-423, and 501-D22A engines. The two configurations are physically similar but functionally distinct. They should never be intermixed in any installation.

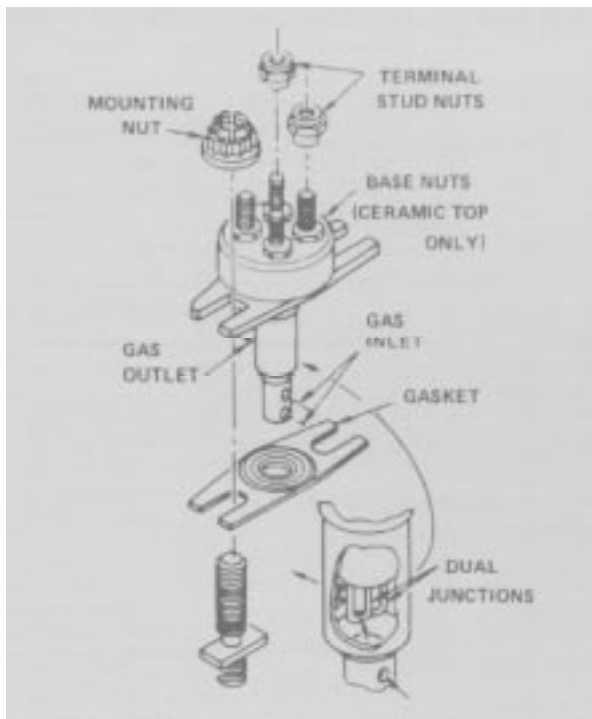
Figure 2. A typical thermocouple: note the two sensing elements (dual junctions).

The thermocouples used in 501/T56 engines have two separate sensing elements (Figure 2). One sensing element of each of the 18 thermocouples is connected in

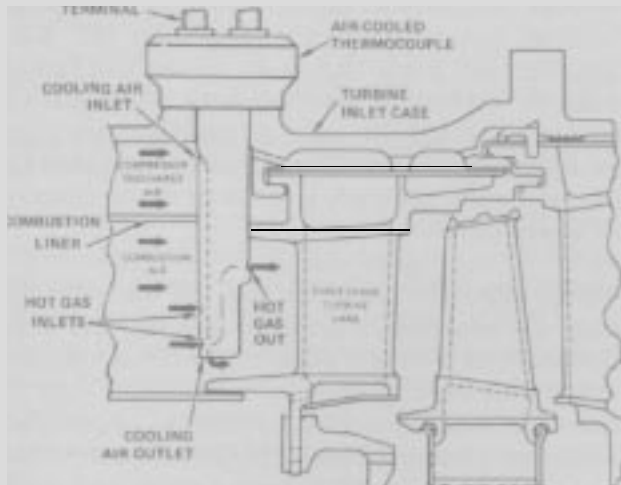
Figure 6. Air-cooled thermocouple installed, showing combustion gas and cooling air flows.

The reason that aft probe tip wall erosion can have this effect is related to specific features of the thermocouple design. Fundamentally, the thermocouples used in 501/T56 engines are temperature-sensing, gas-sampling devices. Their bimetallic junctions are not exposed directly to the hot gas, but are instead enclosed in a probe. This probe is designed to obtain samples from two different immersion levels in the gas stream, mix the samples, and then direct the composite sample over the sensor junctions within the probe. After the temperature of the composite sample has been measured, the gas is exhausted from the downstream side of the probe (Figure 6).

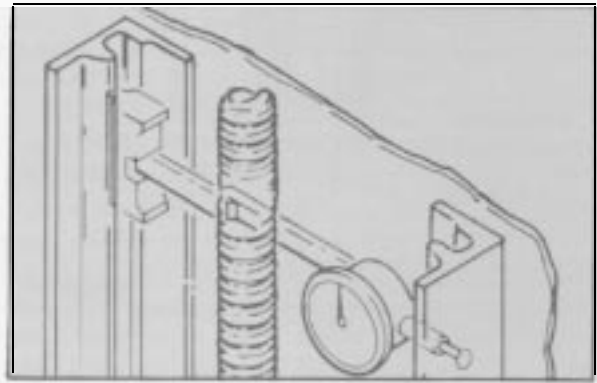
Figure 1. Track width indicating tool.

Last, but by no means least, the clearance between the tracks and shoes should be checked frequently. A minimum of 0.010 inch fore and aft clearance should be maintained at the minimum clearance location. (The original minimum of 0.005 inch was revised several years ago.) The procedure for checking the track clearances on C-130A aircraft involves the use of a feeler gauge, but the preferred method of checking and adjusting tolerances on B, E, and H models is to

use a track width indicator, P/N 3402044-1 (Figure 1). Detailed instructions for checking shoe-to-track clearances are contained in the authorized landing gear maintenance manuals. Further information can also be found in an article entitled "MLG Track Shoe Clearances," which appeared in Volume 6, Number 1 (January – March 1979) of *Service News*.

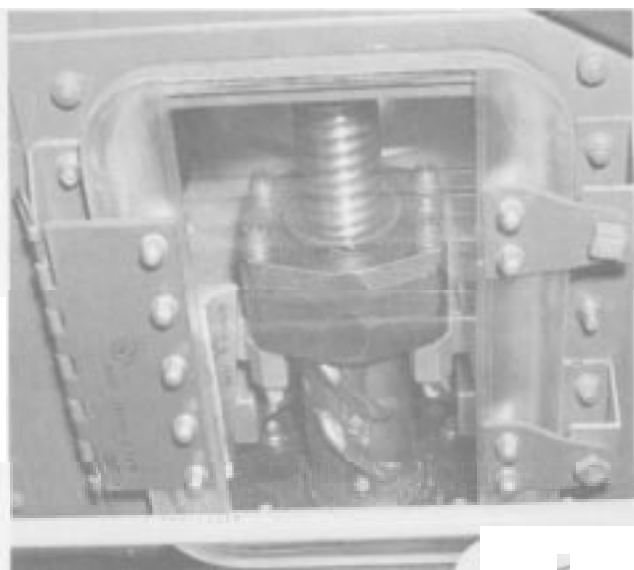
Figure 4. MLG inspection window-gear in down position.

Most military versions of the Hercules aircraft are equipped with MLG inspection windows located in each wheel well side wall at FS 522 and FS 583. It is a good idea for all flight crew personnel to be familiar with the appearance of the main landing gear in the down position when viewed through these windows (Figure 4). A potential cause of gear malfunction can sometimes be detected visually well before trouble actually develops, permitting timely corrective action.

If your aircraft is equipped with landing gear inspection windows, they should be cleaned as often as necessary to ensure a clear view. Remove dust from the surface of the plastic windows with a soft, clean cloth that has been saturated with clear water. Do not use a dry cloth. Wipe the windows carefully with a soft, damp cloth or sponge. Keep the cloth or sponge free from grit by rinsing frequently in clean water. Finish up by cleaning the windows with an approved non-abrasive plastic polish.

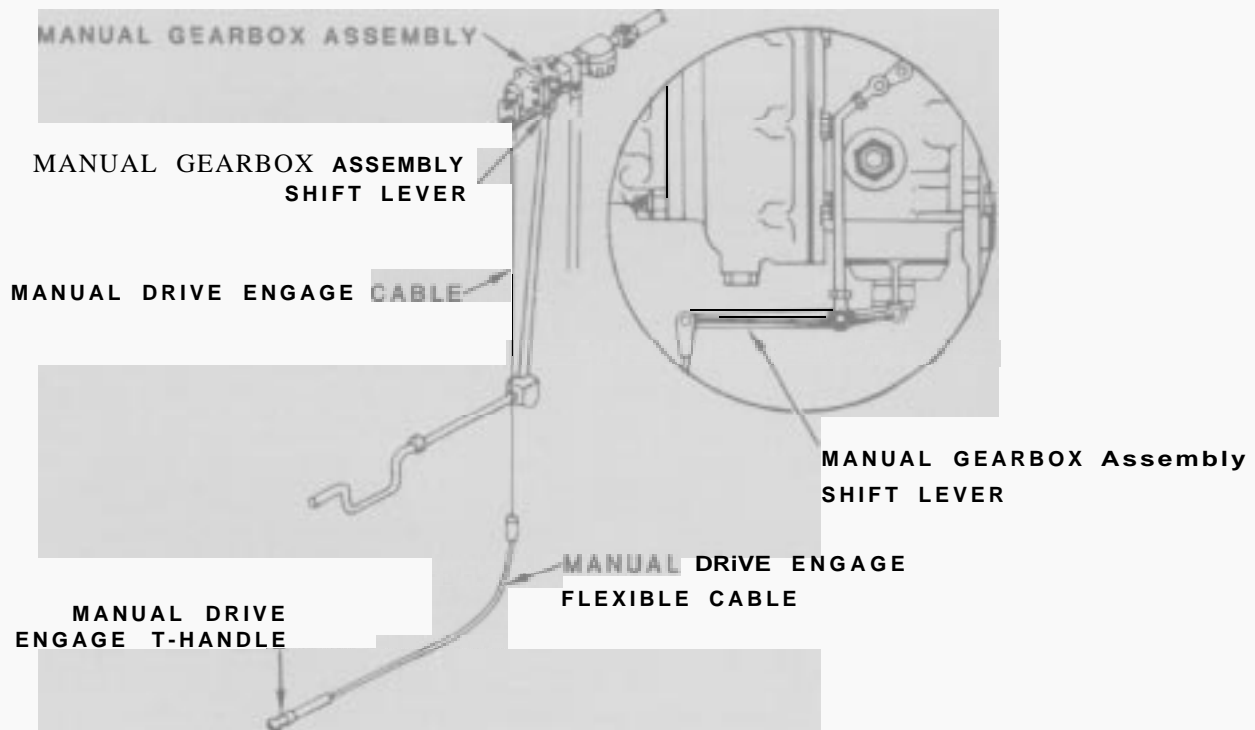
Figure 5. MLG manual extension system components.

1. Carefully disconnect the T-handle cable from the manual gearbox assembly shift lever (Figure 5).
2. Operate the T-handle several times to check that the cable is free to move.
3. Reconnect the T-handle cable to the shift lever.

Since the motion of the aft gear opens the gear doors, disconnect the aft gear first and extend it approximately halfway down, using the emergency wrench. Extend the forward gear next. Finally, extend the aft gear the rest of the way. You can extend the aft gear only part-way initially because the torque strut will bind under the bottom of the piston if the gear is extended beyond about 50 percent. This binding may load the shoes against the tracks and stop the gear from further extension. If jamming does occur, it will then be necessary to retract the low gear slightly to relieve the strut binding before either the front or rear gear can be extended any further.
