# *SERVICE NEWS*

CONSERVING TURBINE LIFE

**Vol. 14, No. 1, January-March 1987**

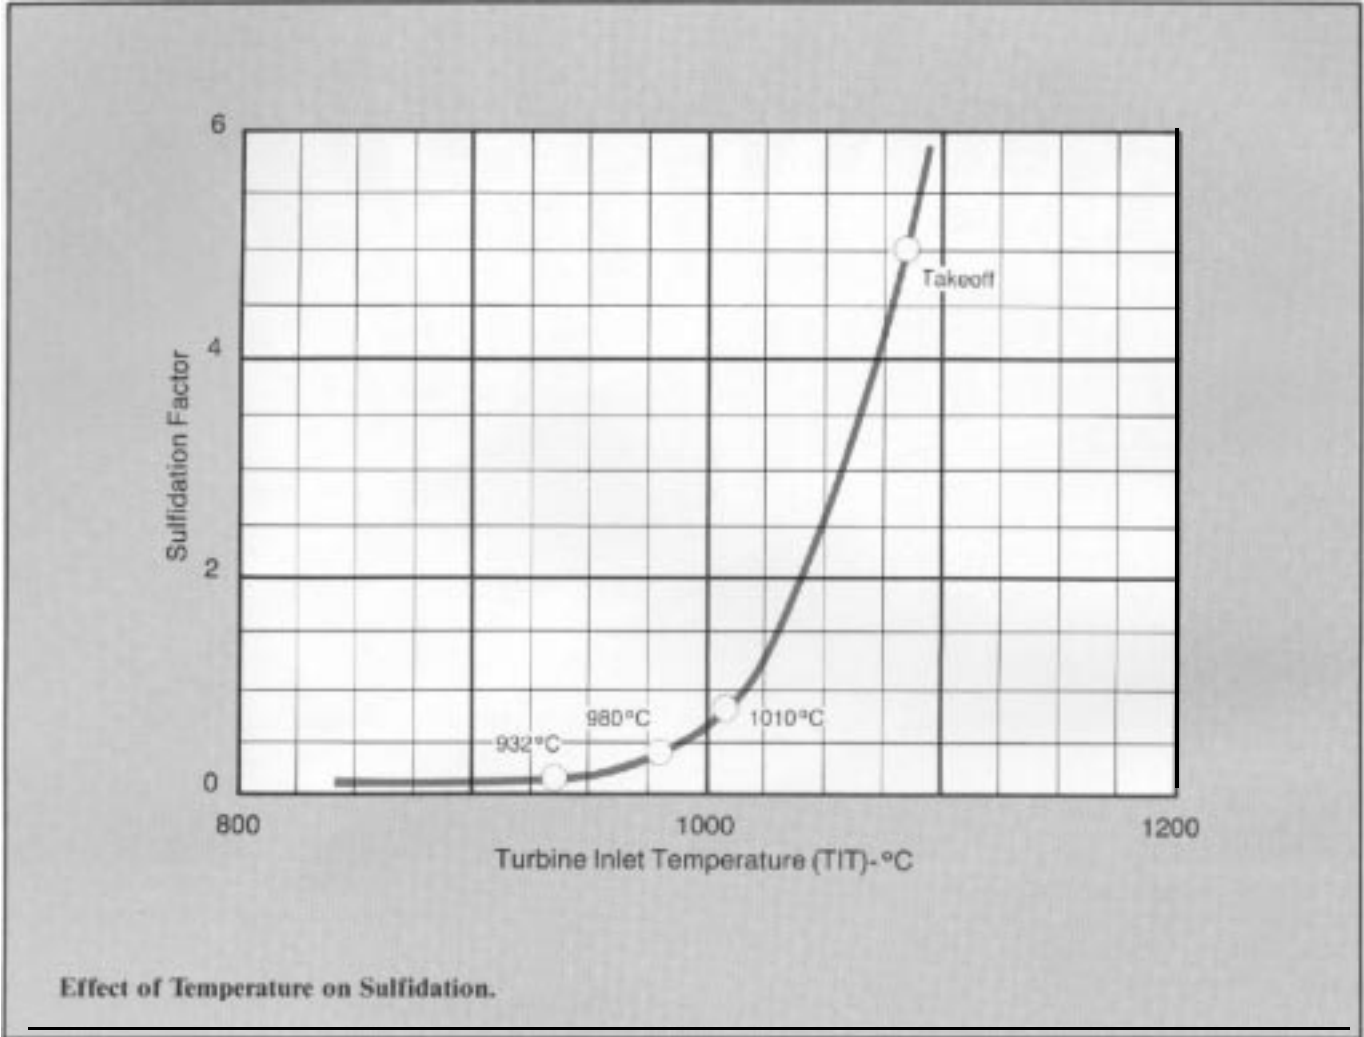
Turbine blades and vanes are subject to gradual deterioration as engine operating hours accumulate. This process is commonly referred to as sulfidation. Turbine sulfidation is caused by the accelerated oxidation of metals in the presence of sulfur ions, in particular sulfides and sulfates. The oxidized metal goes out the tailpipe, leaving eroded blade and vane surfaces behind.

Close-up of turbine blade sulfidation damage.

To help prevent such damage to the metal surfaces and extend the service life of the turbine section components most often affected by sulfidation, diffused coatings of aluminum or aluminum and chromium (often referred to as Alpak and AEP, respectively) are applied to new turbine blade and vane surfaces.

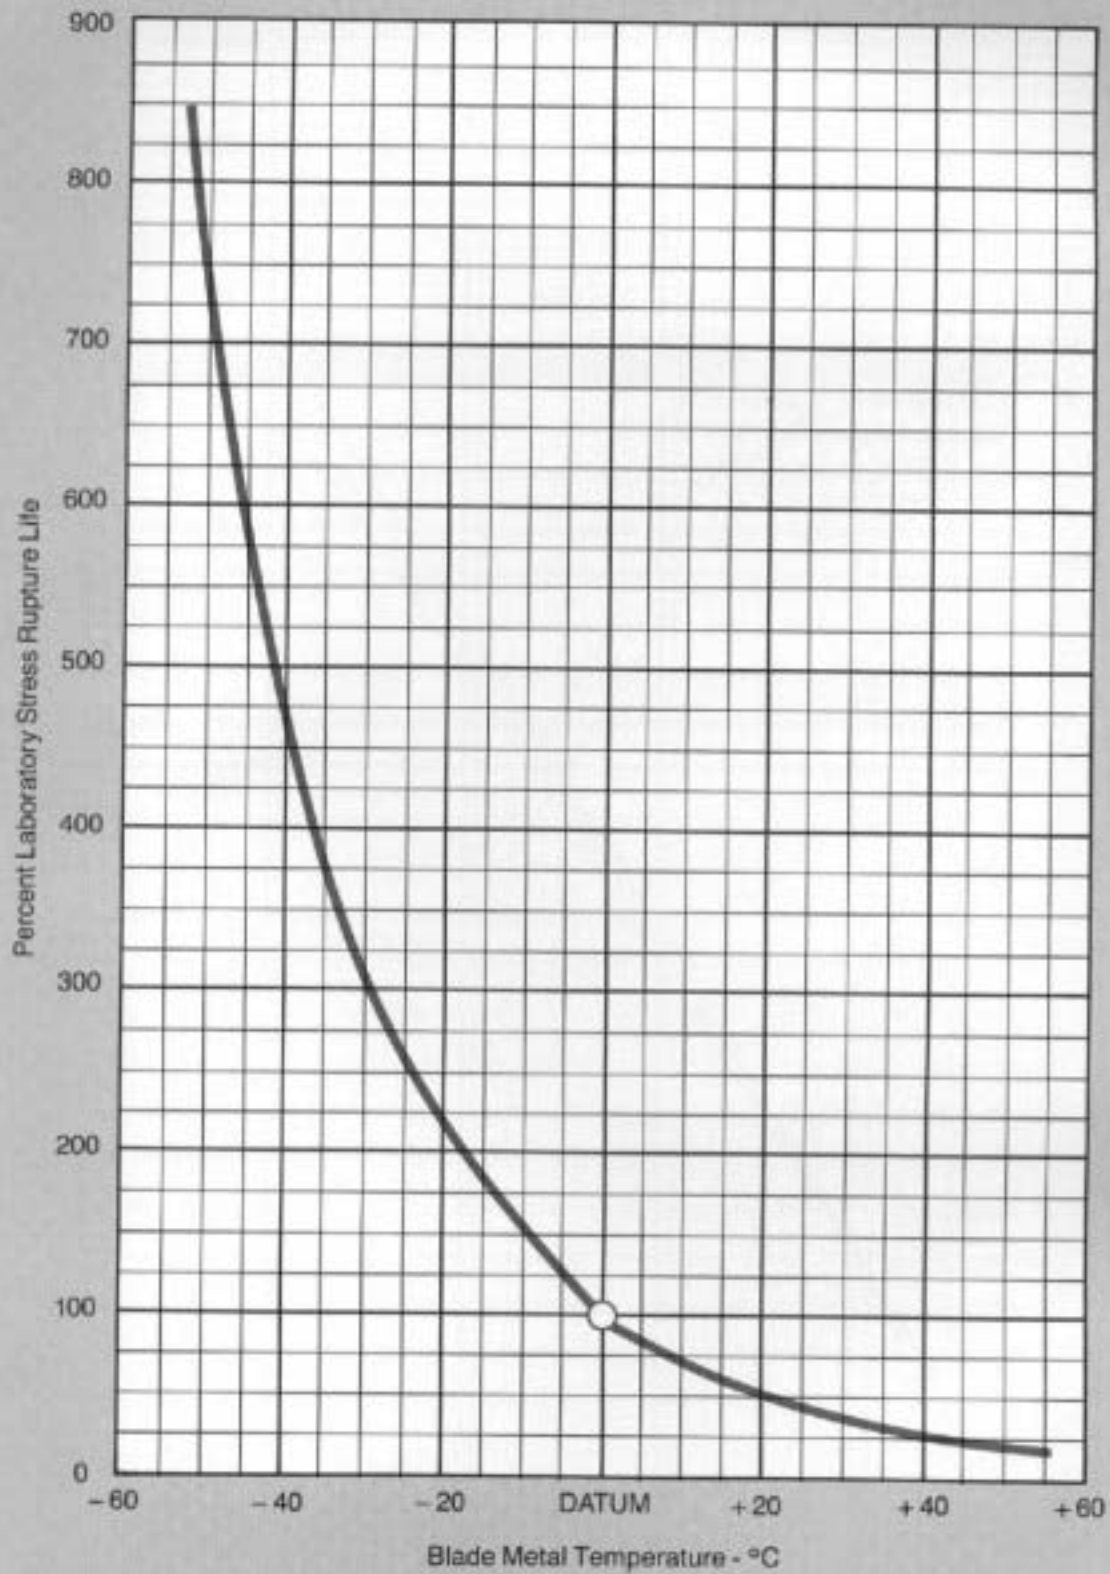
Effect of Temperature on Turbine Blade Materials

The relationship between temperature and turbine blade "stress rupture life," a measure of resistance to breakage of this type, is shown on the chart on page 10. Note how a 30-degree C increase above the normal operating temperature will decrease the stress rupture life by two-thirds. On the other hand, a 30-degree C decrease in blade metal temperature can triple stress rupture life.
