Lockheed

VOL. 18, NO. 2 APRIL-JUNE 1991

# ***SERVICE NEWS***

***Engine Run Safety***

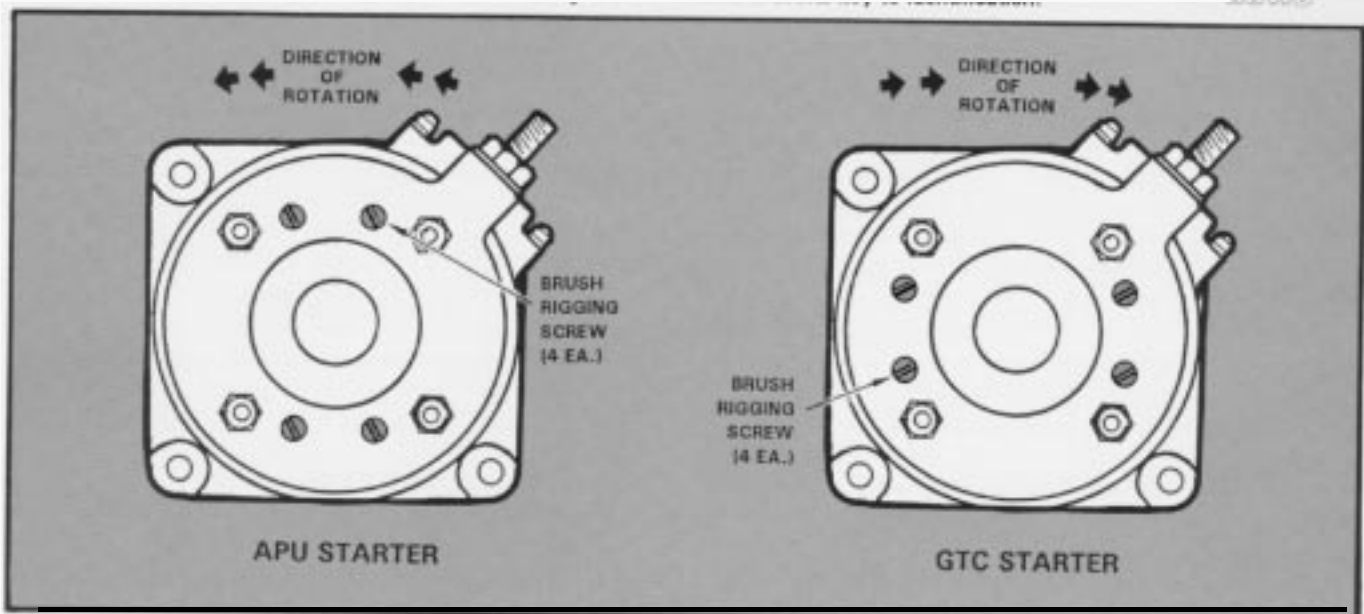
The position of the brush rigging screws relative to the ground terminal is a useful key to identification

A close visual inspection of the clutch ratchet on the starter will indicate the direction of rotation, but an easier way to determine the direction of rotation is to examine the starter end cap and note the position of the brush rigging screws relative to the ground terminal. As shown in the accompanying figure, there is a 90-degree difference in the alignment of the brush rigging screws on the two different starters. Careful attention to these details will help preclude damage to the units and ensure smooth maintenance operations.

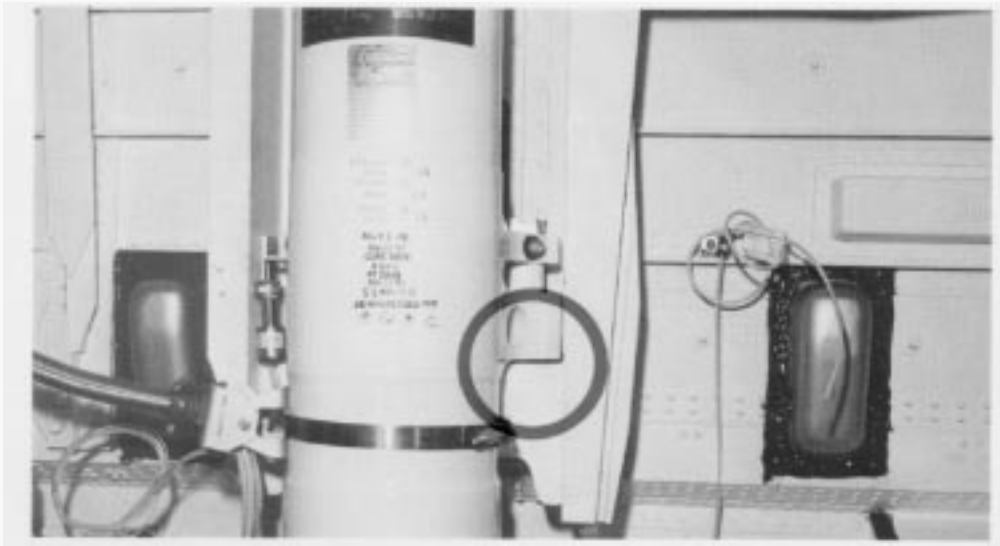
Figure 7. Normal landing configuration: the drag pin has fully engaged the shelf bracket (view looking inboard).

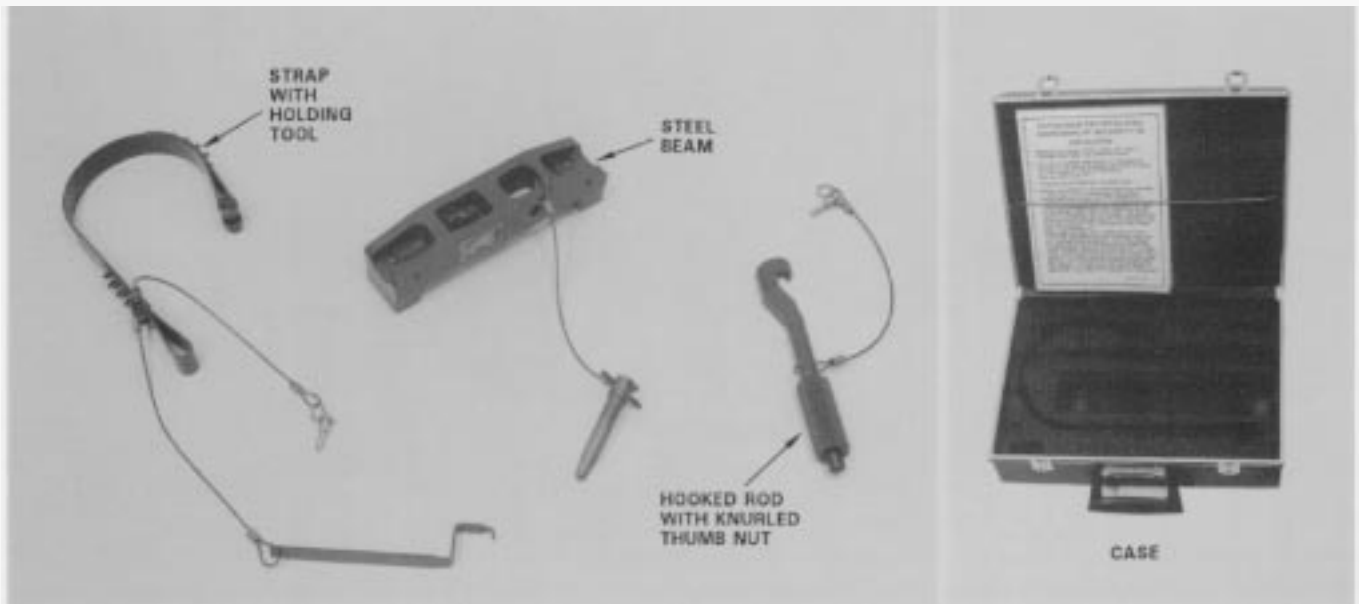
**Figure 3. The MLG Emergency Tiedown Fixture for Hercules aircraft, PN 3402900-1**

and comes in a sturdily constructed, compact case that is easy to carry and store (Figure 3).

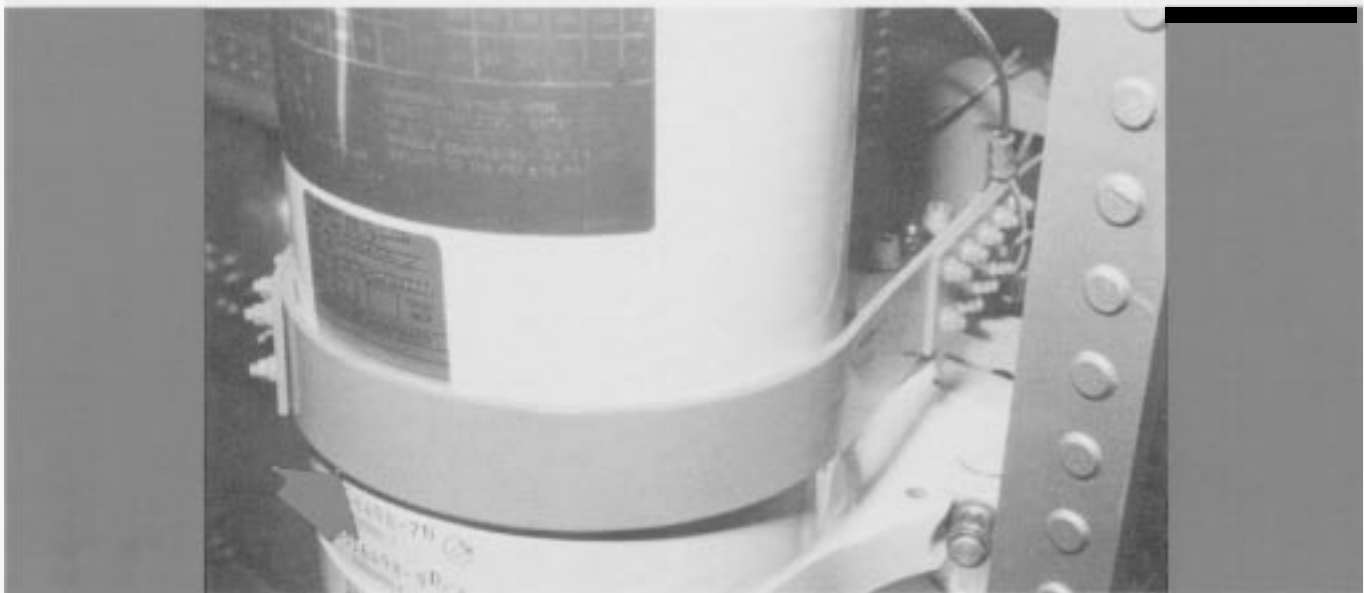
**Figure 4. The tiedown fixture strap in position, as seen from the MLG wheel well.**

end of the strap is inserted through the lower access window and guided around the affected strut with the help of the holding tool (Figure 4). The hooked rod is inserted through the steel beam and can engage the hook retaining pin in the end of the strap when the beam is held positioned at the access window (Figure 5). The knurled cylindrical nut on the hooked rod is used to tighten the strap assembly and rod to the steel beam (Figure 6). Pliers or a pipe wrench can be used on the knurled knob to apply additional tension on the steel strap.

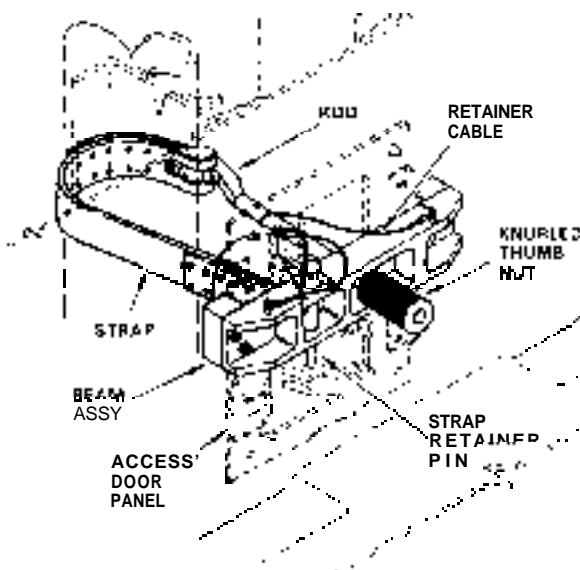
Figure 6. The PN 3402900-1 tiedown fixture fully installed.
