Akron Airdock PCB Exterior Remediation Strategy

June 22, 2007

Lockheed Martin Corporation
1210 Massillon Road
Akron, Ohio 44315

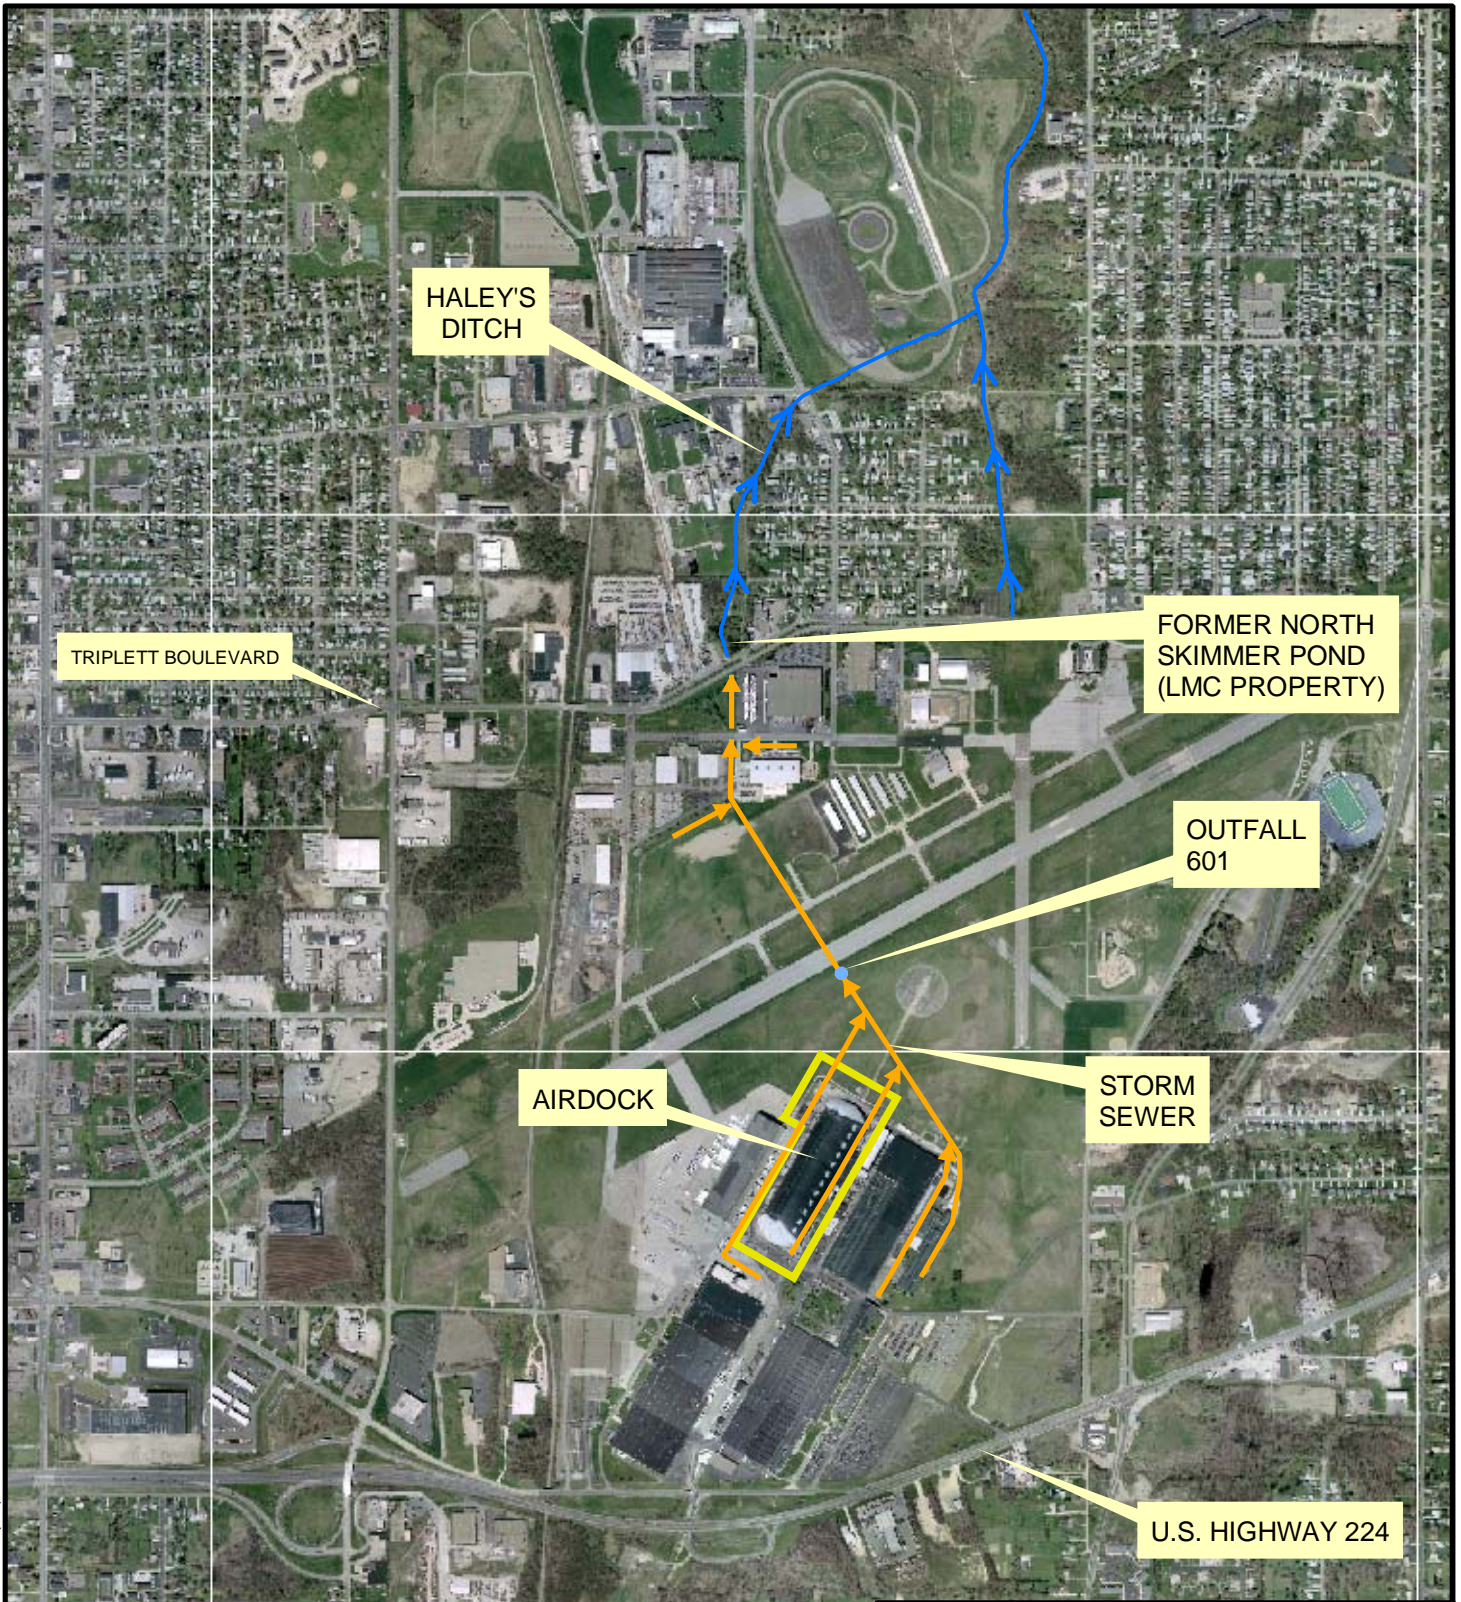
FIGURE 1
SITE AERIAL PHOTOGRAPH

Stormwater from the Airdock and surrounding area drains through a storm sewer system to Haley's ditch just beyond Triplett Boulevard approximately 1 mile north of the Airdock. Exterior portions of the Airdock parcel and adjoining parcels to the east and west are drained by a stormwater sewer system regulated under Ohio EPA National Pollution Discharge Elimination System (NPDES) General Permit (OHR000004), facility permit 3GR00733*DG, effective September 28, 2006. The permit holder is Valley Association Corporation. Parallel branch sections of the sewer system run north to the airport to join a trunk line that extends northwest to eventually discharge at a former retention pond known as the North Skimmer Pond, and continues to Haley's Ditch (Figure 1).

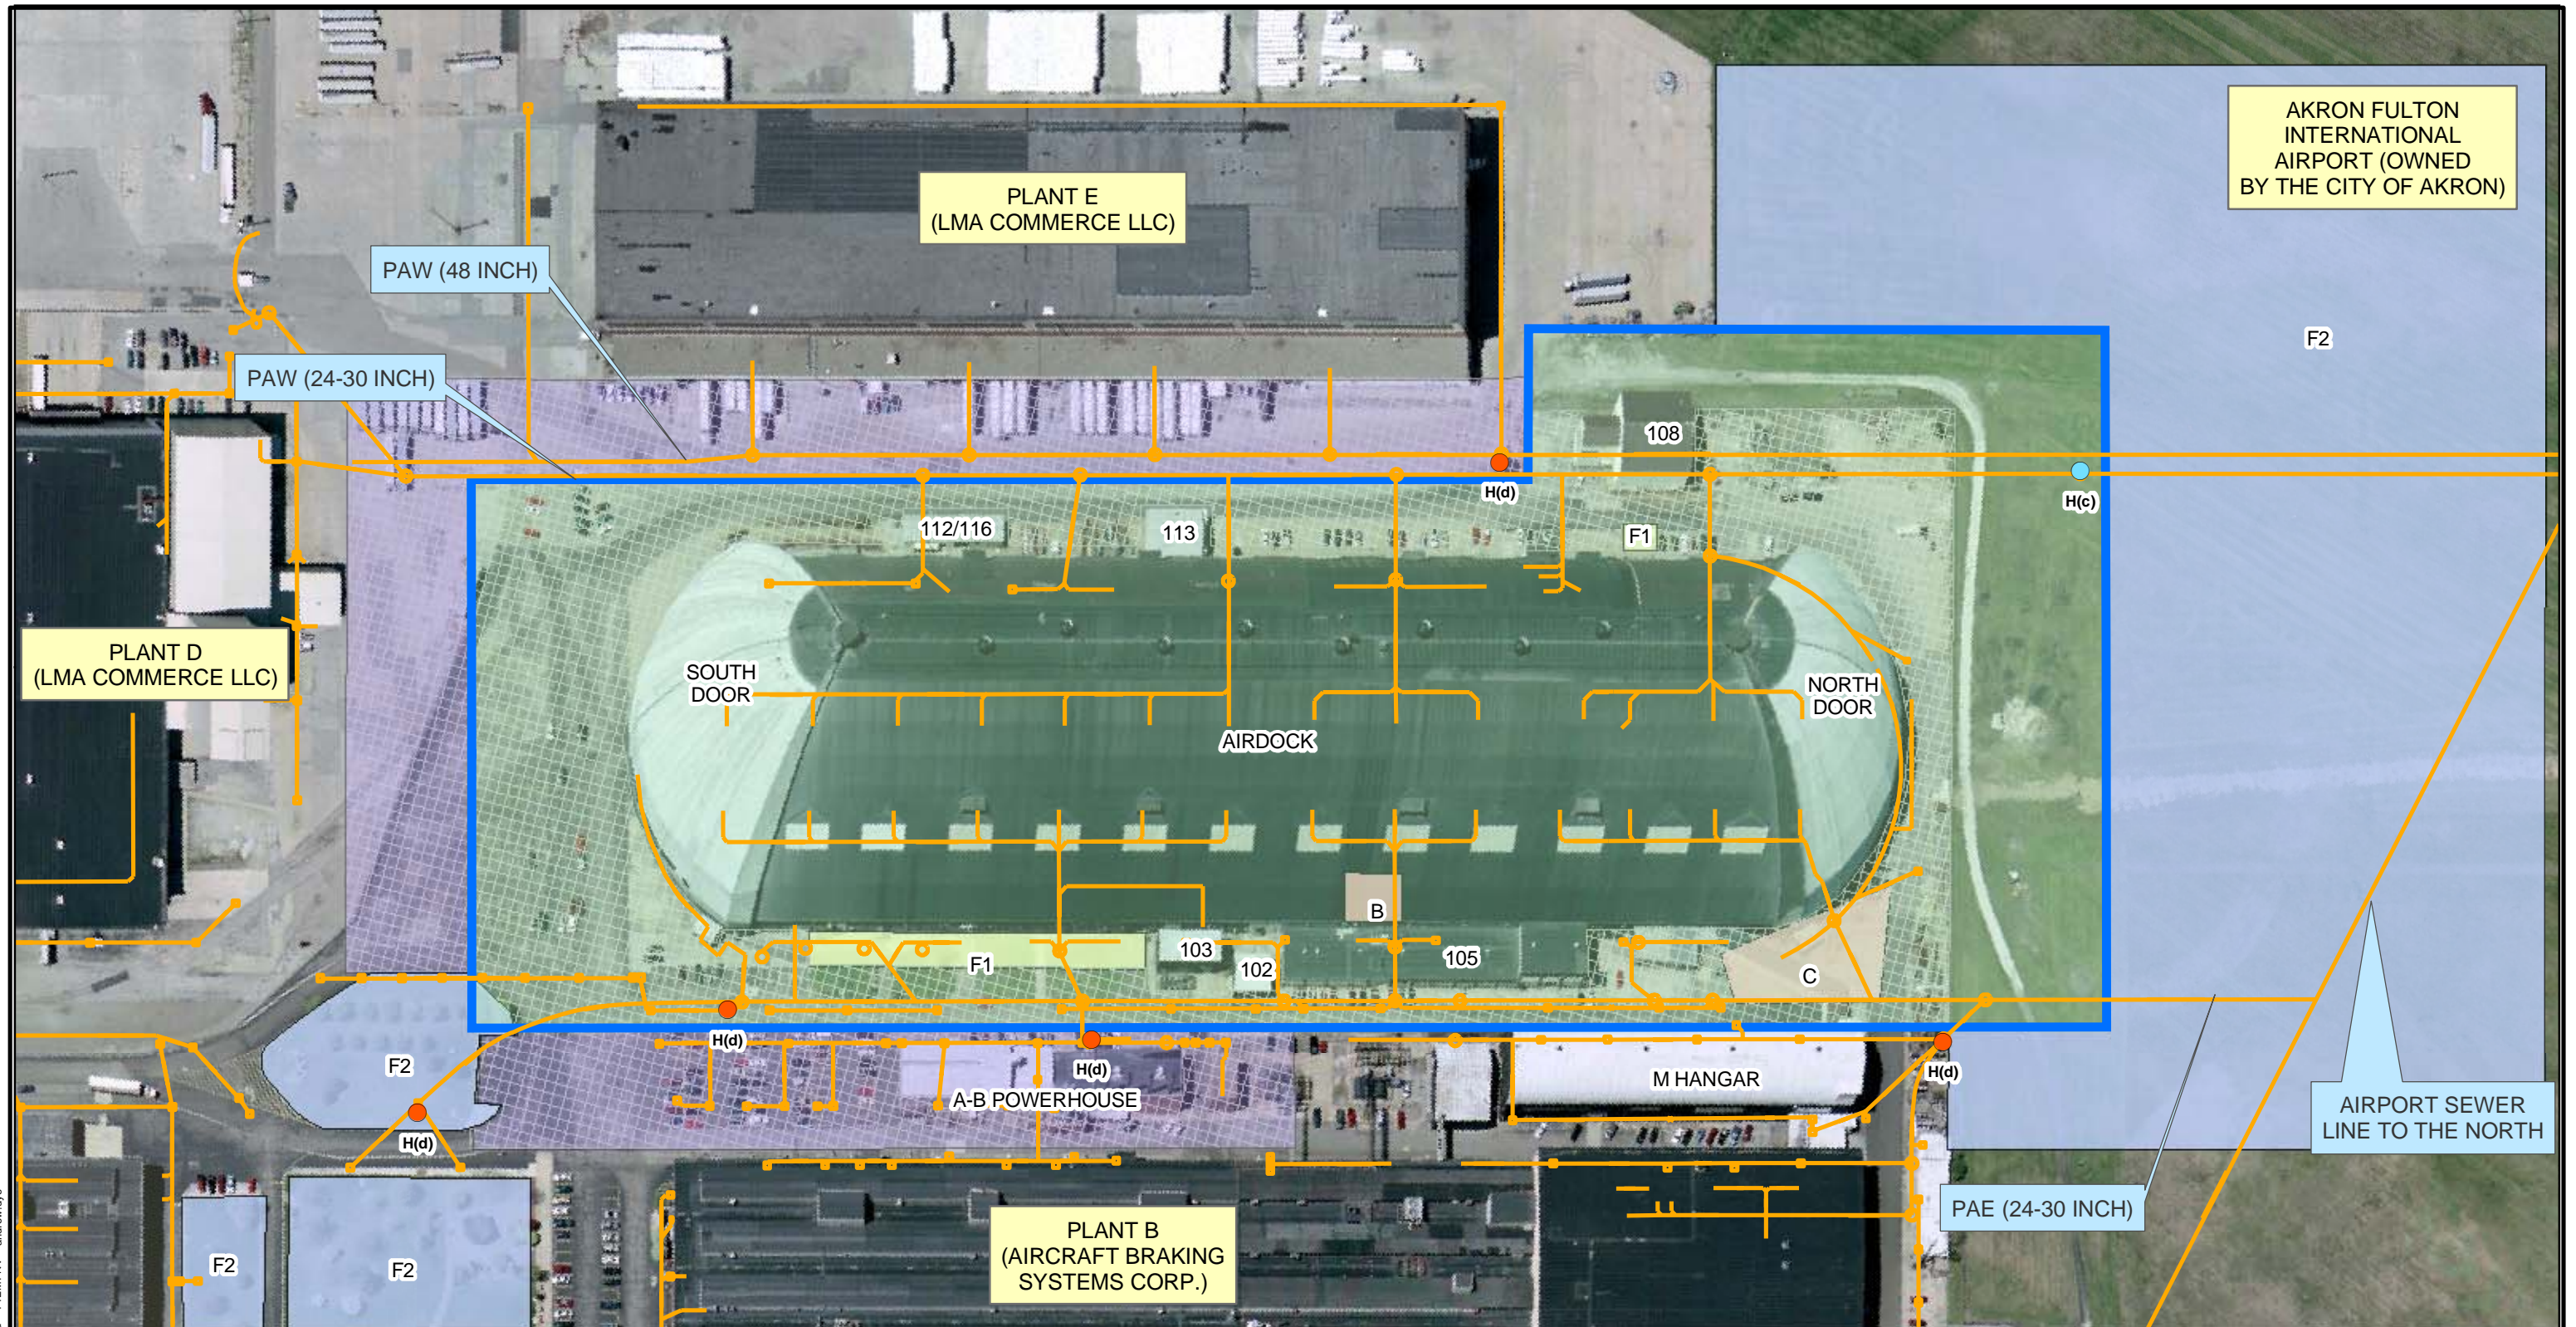
FIGURE 2
AIRDOCK REMEDY ELEMENTS

A soil removal action will occur in the grassy area directly outside the southeastern area of the Airdock (Figure 3) and from an isolated area below pavement on the northwest corner of the Airdock (designated with the box labeled F1 on Figure 2). Soil samples have been collected from 20 locations at different depth intervals and analyzed for PCBs, including Aroclor 1268. The sampling and analysis data show that PCB concentrations in soil decline rapidly with depth and distance away from the building, a pattern consistent with the non-mobility of the chemical.

No soil removal, capping, remediation, or additional sampling is required at off-parcel areas, defined as the three properties adjoining the Airdock parcel: the airport, LMA Commerce, and ABSC (area F2 in Figure 2). An applicable standard for exposure to PCBs in soil for unrestricted land use at adjoining off-property areas was established using a combination of property-specific risk assessment methods specified in OAC 3745-300-09 and generic direct contact standards for residential land use (OAC 3745-300-08). The 95 UCL for total PCBs based on existing sampling data is 0.34 mg/kg and is equivalent to a risk level of 4E-07 and a hazard of 3.1E-02, which are well below the risk and hazard goals for adjoining off-parcel areas (area F2 in Figure 2).

A post-cleaning stormwater sampling point is anticipated as the northernmost manhole (point H(c)) of the Plant A West (PAW) 24-30-inch storm sewer depicted on Figure 2. Background sampling will also occur for possible PCB loading to the sewer system from legacy releases or from other active sources (see upstream manhole sampling points designated “H(d)” on Figure 2).

Certain activity and use restrictions will be established for the Airdock parcel as part of the overall site remedy. The Airdock parcel, legally defined as Summit County Tax Parcel No. 71-000064, is currently used for industrial purposes. A legal restriction to limit land use will be recorded through an Environmental Covenant. The restriction will apply to the entire 19-acre parcel as depicted in Figure 2.

Following the siding replacement and soil removal actions, pavement cleaning will occur as a presumptive remedy to remove remaining loose siding and roofing debris and particles. The area to be cleaned includes all paved surfaces on the exterior Airdock parcel and a buffer zone of 100 feet beyond the parcel boundary (Figure 2, Area D). The 100-foot zone beyond the Airdock property line encompasses the drainage divide surrounding the Airdock. The cleaning activity will include sweeping, vacuuming, and power washing the paved surfaces using manual and mechanical means depending upon the condition of the pavement and access limitations. Cleaning will be conducted to a visual standard. Solids and liquids generated during the cleaning activity will be properly managed and disposed of.
