# Service News

**Vol. 27, No. 1, January - March 2000**

# Flight Instrumentation Test Set

# Reverse Current Cutout Relays

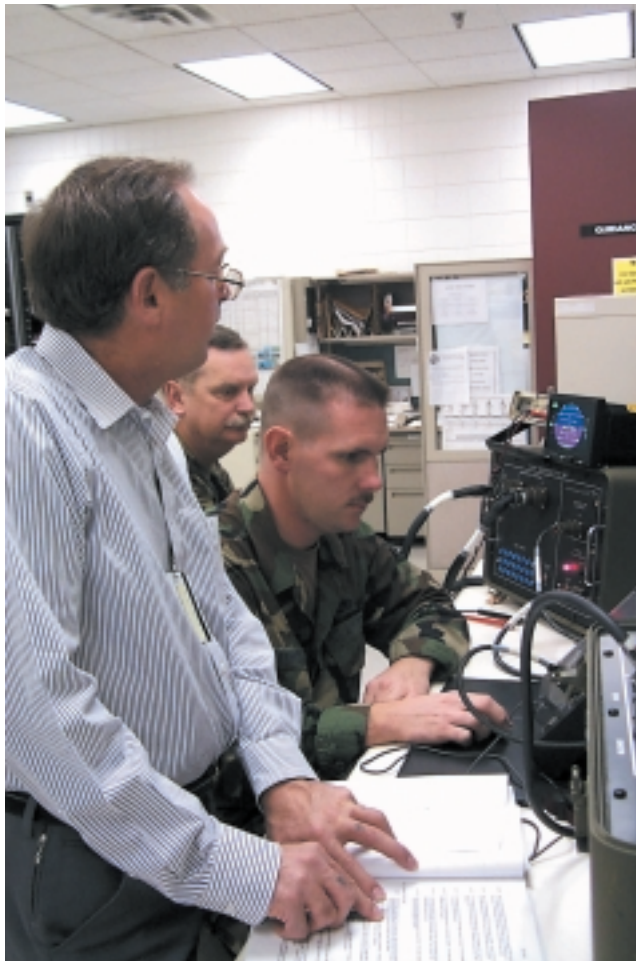
**Photos this page: Lockheed Martin Field Service Representative John DeLion demonstrates the Flight Instrumentation Test Set to TSgt. Jeff Cornwell of the North Carolina Air National Guard.**

interface, it simulates every input required of these units. Housed in a rugged, transportable case, the unit is easily transported to the repair shop or flight line where it is used to diagnose problems with the EFI and RDU.

The test set includes a display unit and a base unit. The display unit connects to the base unit, sending communication signals over a RS232 port and receiving power from the base unit. A hand-held mouse connects to the display and allows the user to make selections from the screen. The display unit is run by a 133 MHz Pentium processor running the Win95 operating system, and uses a solid state disk drive to store the necessary software. The base unit operates with a 100 MHz 486DX4 processor in a PC/104 form factor, and it connects to other PC/104

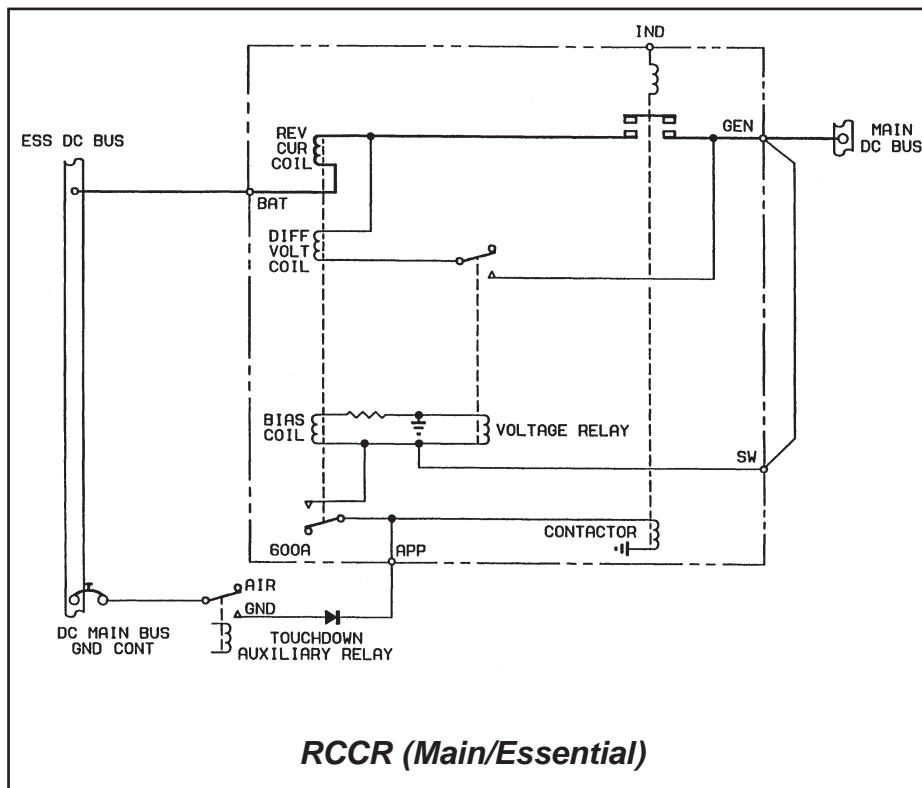
Each RCCR is made up of three individual relays. They are the voltage sensing, control, and current relays. The RCCR allows current in one direction as a normal relay, but opens the circuit with sufficient reverse current. Normal flow is from the generator (GEN) terminal to the battery (BAT) terminal.

The reverse current coil is a large metal bar wrapped by the bias and differential voltage coils.

Under normal conditions, its field has little effect. If the voltage level at the BAT terminal becomes greater than the GEN terminal, the current reverses between the GEN and BAT terminals. The reverse current flow sets up a field opposite the bias field. This opposition will be

great enough to force the bias contacts open. The circuit between the source and the load (GEN and BAT terminals) is opened.

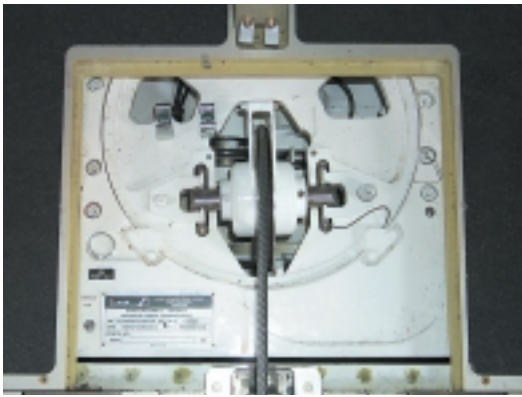
The integral cargo winch is installed under the floor on Buttock Line 0 between Fuselage Stations 257 and 277. Operation of the winch is accomplished by removing a quick access panel and locking the sheave into place. This sheave is capable of swiveling 360° to accommodate a variety of loading situations. The photo at the top of this page shows the winch in a deployed state and the photo at the bottom of the page shows it in a stowed state with the cover off.

Among the advantages of this retrofit, a loadmaster gains the ability to safely operate the winch from any location within the vicinity of the load through the use of the control pendant. The pendant may be connected to one of two different length cords and plugged into either of two outlets located in the forward and aft cargo compartment. Also, the reel-out/reel-in speeds

are infinitely variable with the thumbwheel on the control pendant.
