SERVICE NEWS

Propeller Blade Care

3 A Guide to Propeller Blade Care
 Maintaining and protecting propeller
 blade leading edges from erosion and
 corrosion.

by William Hack, Service Engineering
Hamilton Standard Division of United Technologies

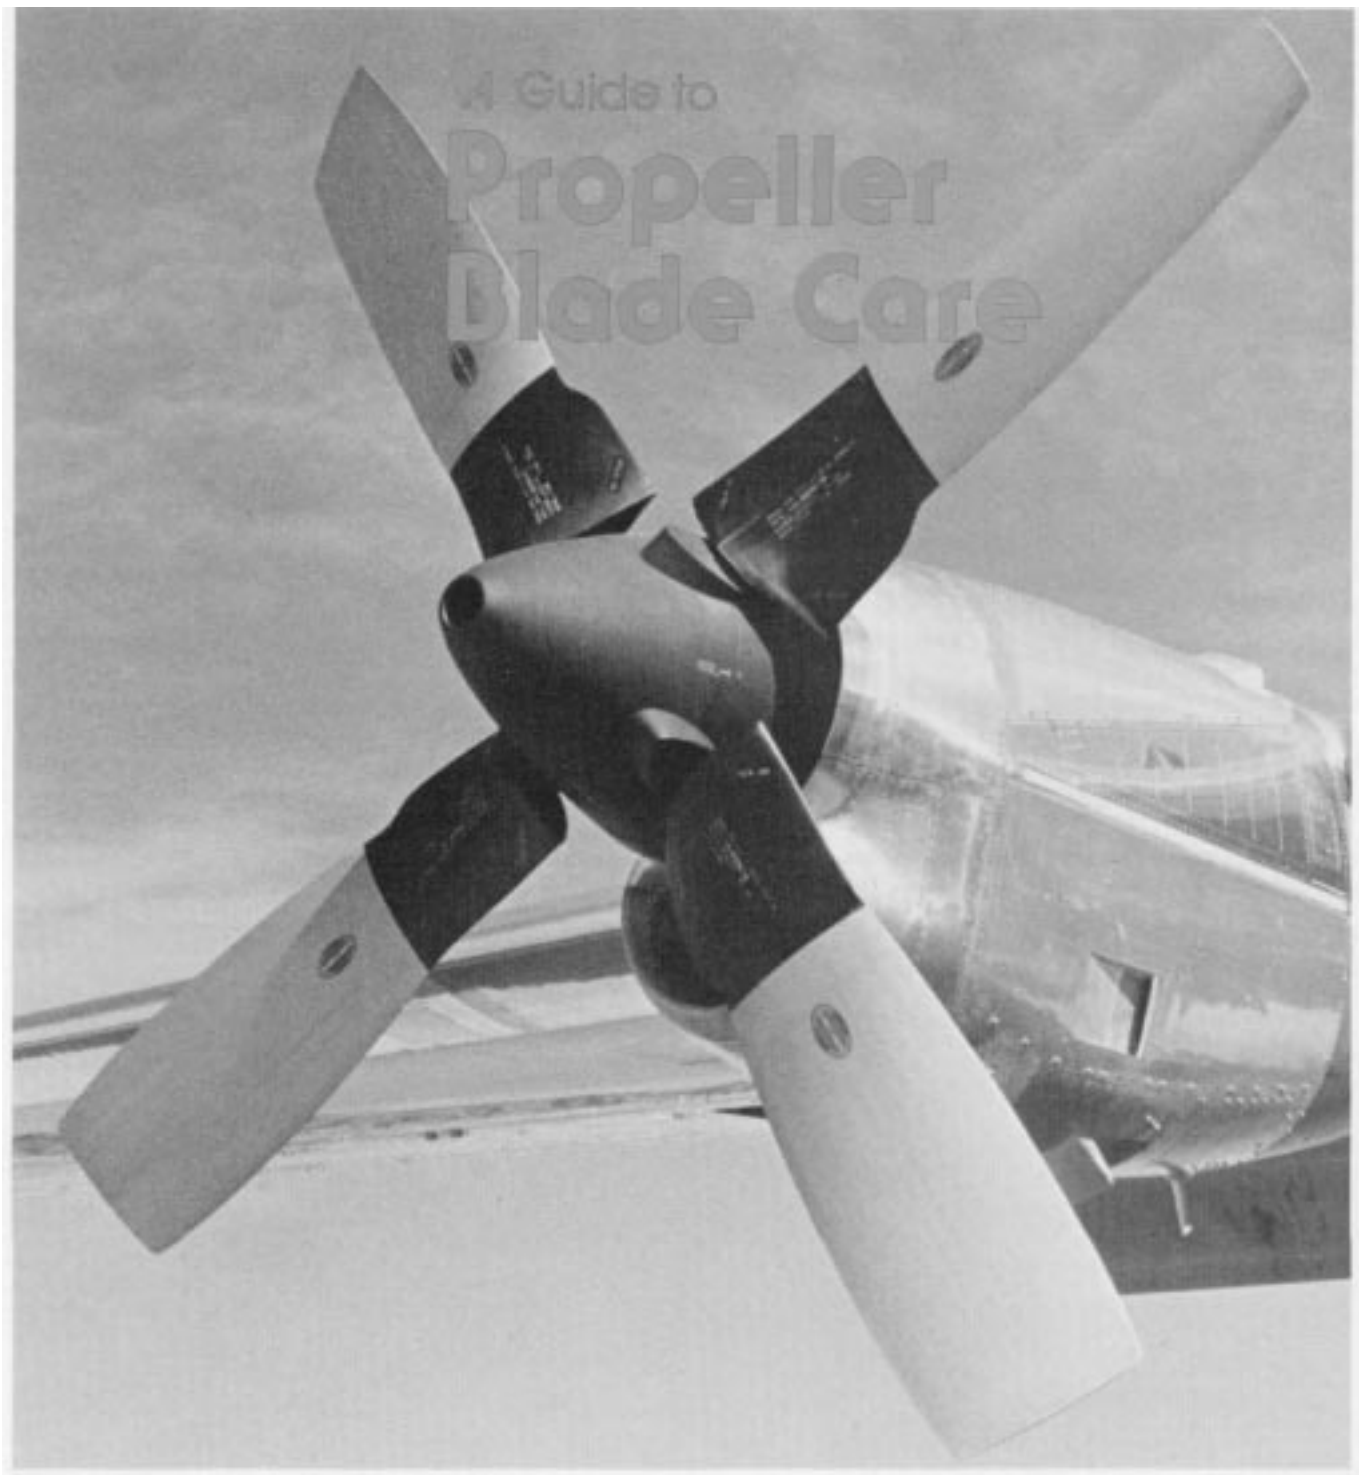
The 3-inch long "split" in this blade leading edge was caused by corrosion.

The leading edge “splitting” reported by some Hercules aircraft operators starts with minor pitting of the blade leading edges, caused by the impact of heavier-than-air particles like sand or dirt. Such mechanical damage can even be traced to the hydraulic forces of water drawn into the propellers as the airplane is taxied on wet surfaces, to say nothing of the effects of precipitation encountered in flight.

As these pits on the leading edges increase in number and become deeper, they serve as pockets in which corrosive materials can accumulate. The presence in these pits of salts from sea water or other alkaline substances sets up conditions which are highly damaging to stressed aluminum alloys. The result is corrosion along the grain boundaries of the aluminum alloy from which the propeller blades are forged. This condition is known as intergranular corrosion.

6 While this process is taking hold, the blades continue to be stressed in the course of normal operation. As the stress cycles accumulate, the individual pits will tend to develop into microscopic holes which penetrate into the blade structure. If the pits are so close together that they produce what are actually lines of leading edge damage rather than isolated pits, splits or cracks will form in the blade leading edges. If a leading edge crack progresses to the point where it undermines the damaged aluminum above it, a tiny piece of blade will flake off — and possibly cause damage or injury.

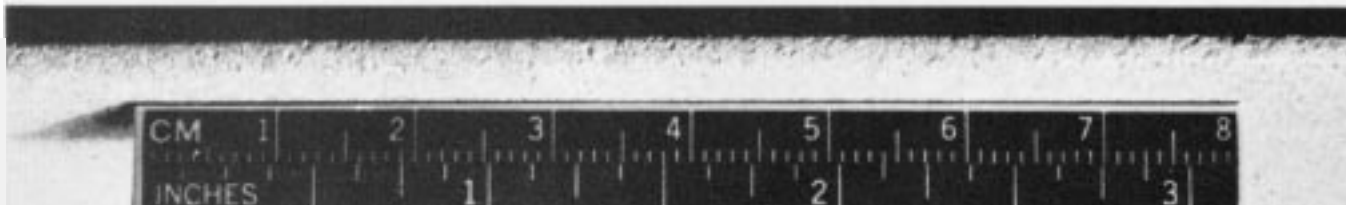
This blade leading edge is in need of rework. Note coarse surface texture.

If a blade inspection does in fact reveal a leading edge that resembles coarse sandpaper, what kind of tools

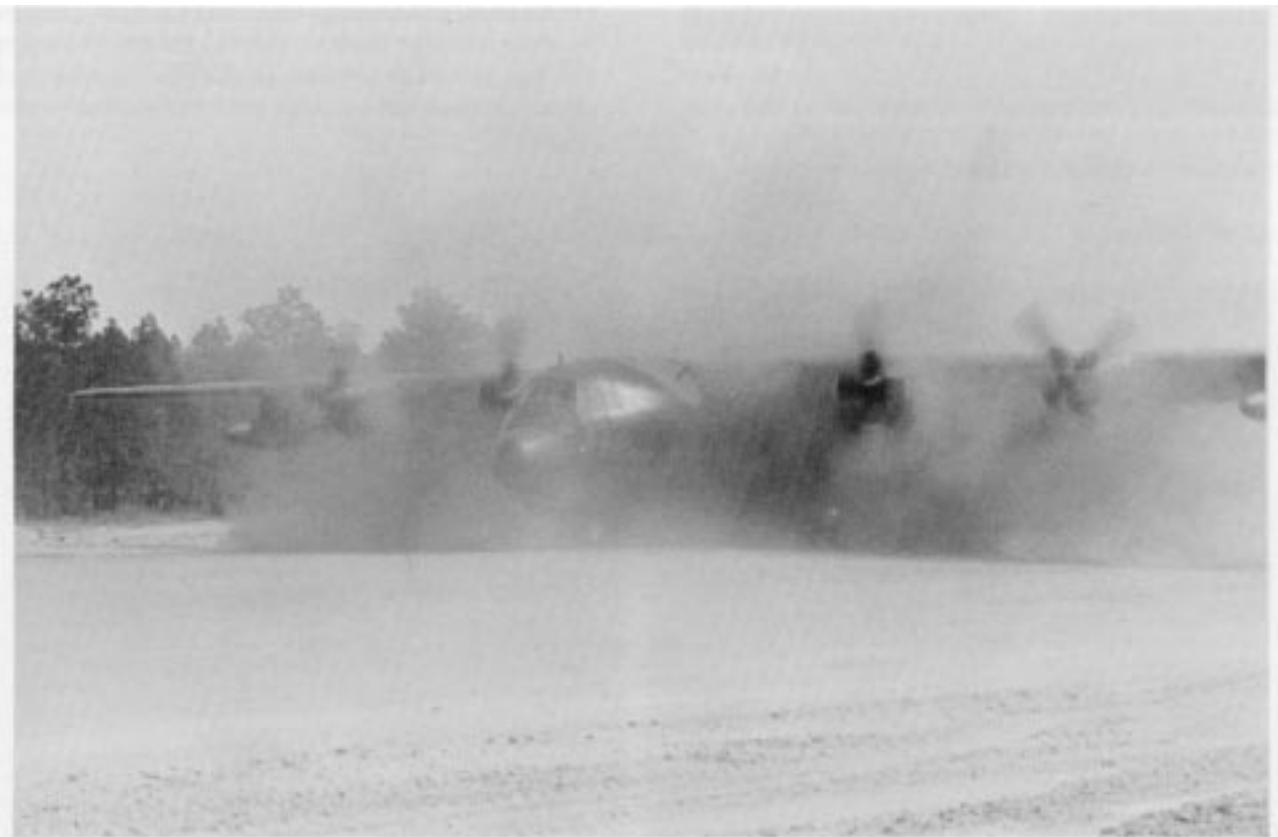
Hercules aircraft are at home in the toughest operating environments, but the props sometimes take a beating.

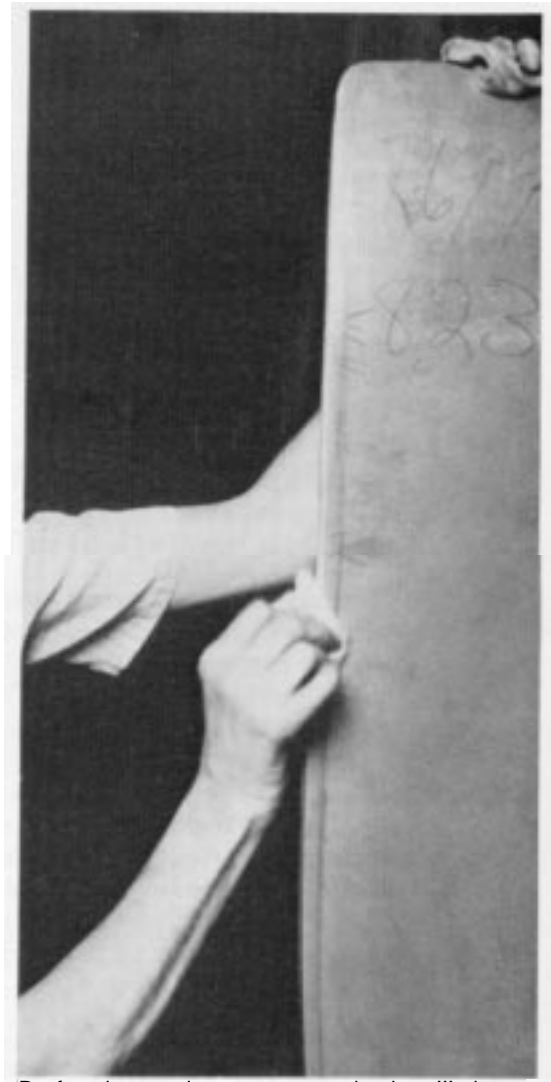
Performing a dye penetrant check will determine if all corrosion cracks have been removed.

The surest way to check for hidden corrosion cracks is to perform a dye penetrant check on the leading edge. First, clean the leading edge surface with penetrant remover and wipe it clean with a dry cloth. Next, apply the dye penetrant solution to the leading edge, using clean cotton swabs.

Allow the penetrant to dry for a minimum of twenty minutes to a maximum of two hours. After the penetrant has dried for the specified time, remove the dye from the surface with penetrant remover. Finally, spray penetrant developer on the leading edge and allow it to remain for 15 minutes. This will bring out any of the dye which has penetrated into hidden corrosion cracks. The dye — usually red in color — will easily be seen against the white color of the developer and will appear as thin and slightly wavy lines. Red lines that are very straight or parallel with other lines are most likely file marks that have not been completely removed by polishing. It is the presence of irregular lines that indicates intergranular corrosion and the need for additional filing.

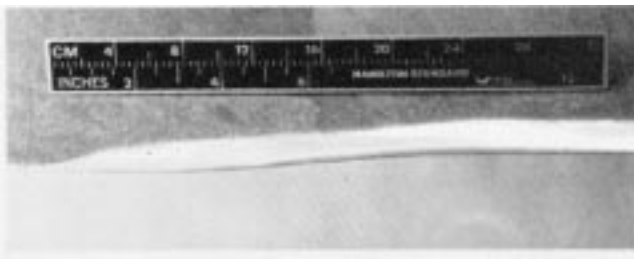
Blade with reworked leading edge, ready for service.
